WATER RESOURCES AUTHORITY

WATER RESOURCES SITUATION REPORT

July 2018 to June 2019

AUGUST 2019

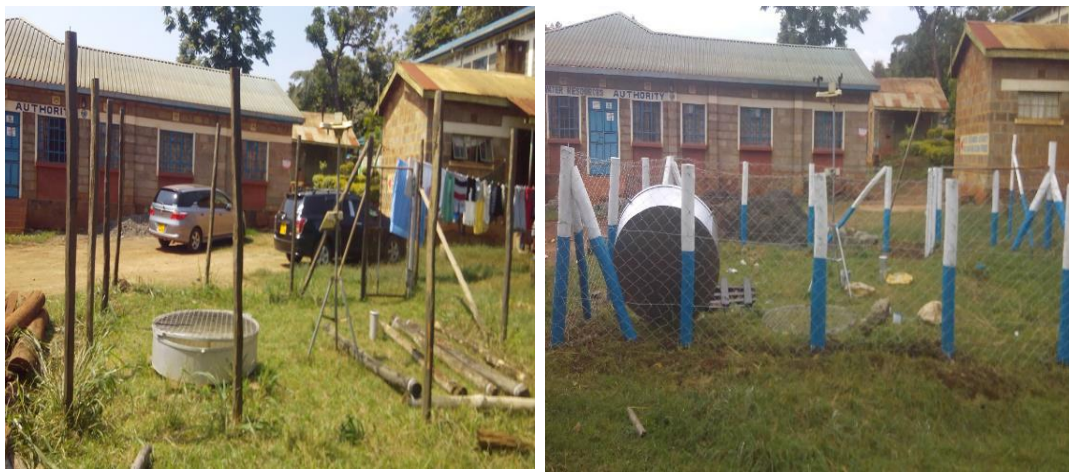
Figure 2.2: Murang'a Met station before and after installation

For the LVSCA, LVNCA and ENNCA, no met station station was rehabilitated during the 2018/2019 hydrologic year. However, ENNCA entered into an agreement with Cetrad to obtain a link into their 6 No. Telemetric weather stations. Currently the office is able to get real time data from these stations (Nyanbene, Naromuro, Nyahururu, Wamba, Kangeta and Marsabit). At RVCA, Lodwar sub met-86350001 was assessed and rehabilitated. For TCA, 3 No. weather stations were assessed and rehabilitated. They include; Sagana state lodge met station 9036017, Mwingi Water office Hydro Met station 168 and MWO-Murang'a 9036017. Figure 2.2 shows Murang'a met station before and after installation.

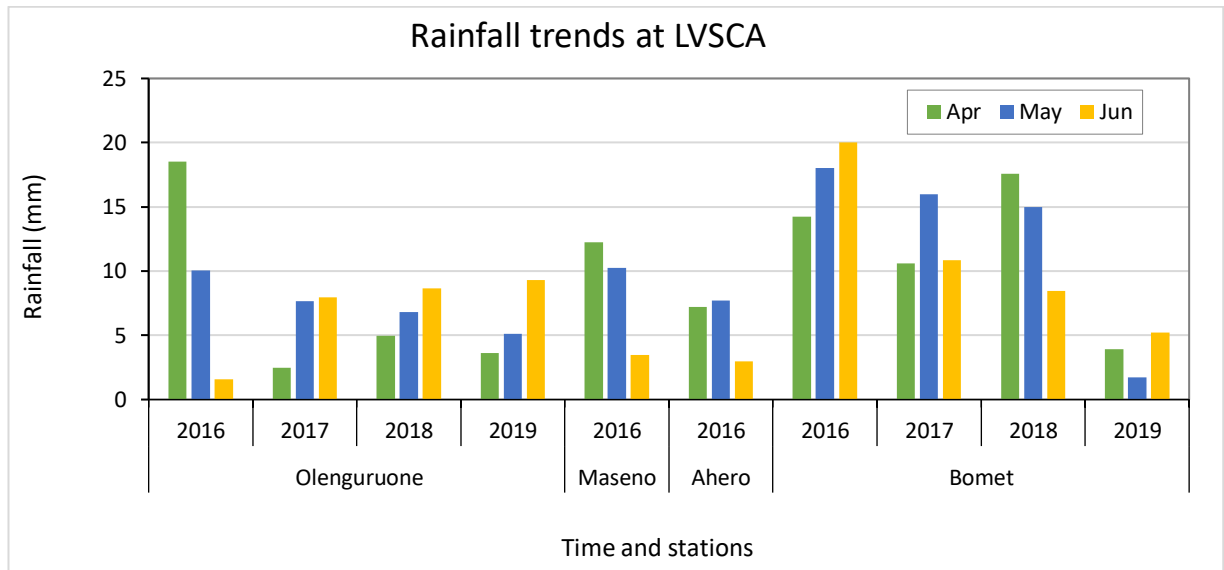
June was wettest period. For the Year to long term comparison the year was generally relatively dry as compared to the long-term average. This is as represented by Bomet station.

Figure 2.2: Rainfall trends at LVSCA

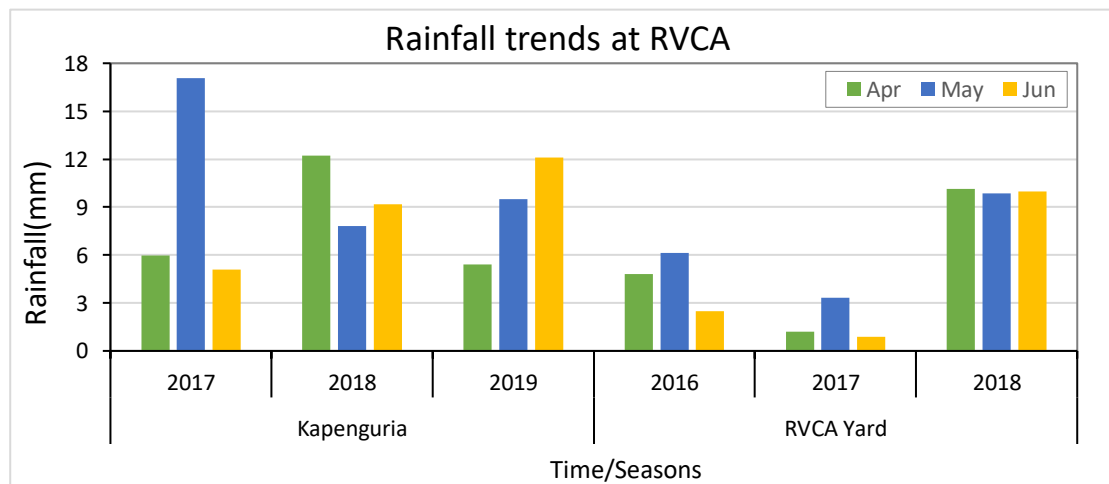
For RVCA, in general the region received less rainfall in the FY 2018/19 as compared to FY 2017/18 as it can be seen in the charts below, Figure 2.3. The rainfall in the stations can be assumed to represent the status in the Rift valley catchment area. The catchment has a mean annual rainfall range between 200 mm to about 1200mm in the upper catchment. At Kapenguria and RVCA yard Met station, an average of 10mm of rainfall was received. More rainfall amounts were recorded in the year 2019 as compared to 2017 and 2018 at RVCA.

Figure 2.3: Rainfall trends at RVCA

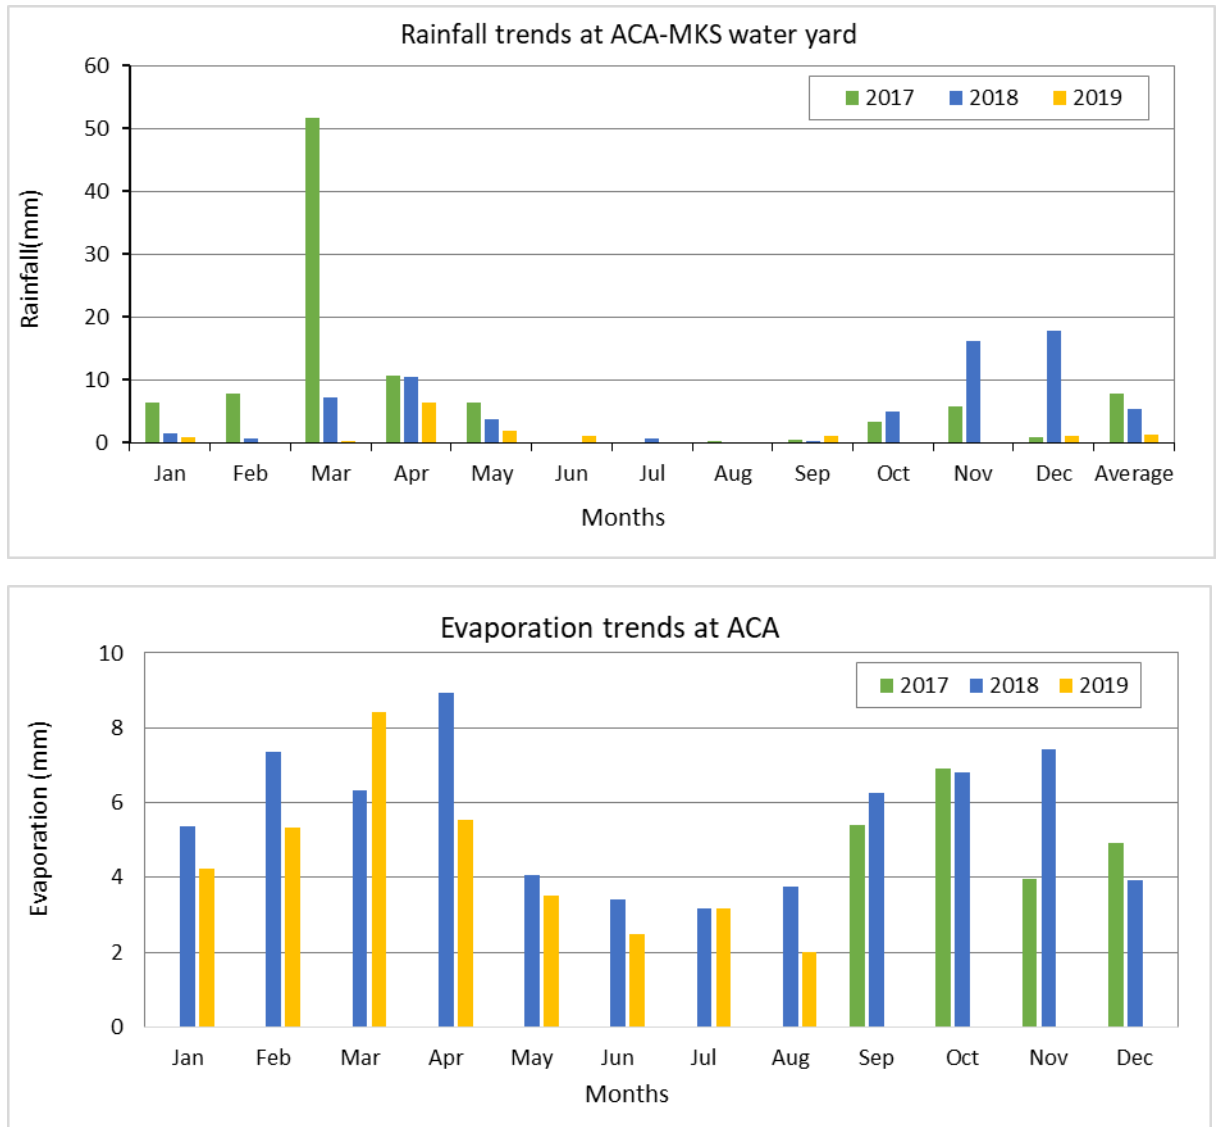
For ACA, analysis was based on rainfall data for the MKS water yard station for the years 2017, 2018 and 2019. The rainfall in the station can be assumed to represent the status in the Athi catchment area. On average basis, more rainfall amounts were received in 2017, (7.8 mm) compared to 2018 that had 5.29 mm and 2019 that had 1.24 mm. From the monthly averages, 2019 was a drier year with the onset of the long rains (MAM) delaying only to be realized in April 2019 and consequently the following months did not experience substantial amounts of rainfall. This is shown in Figure 2.4.

Figure 2.4: Rainfall and Evaporation trends at ACA

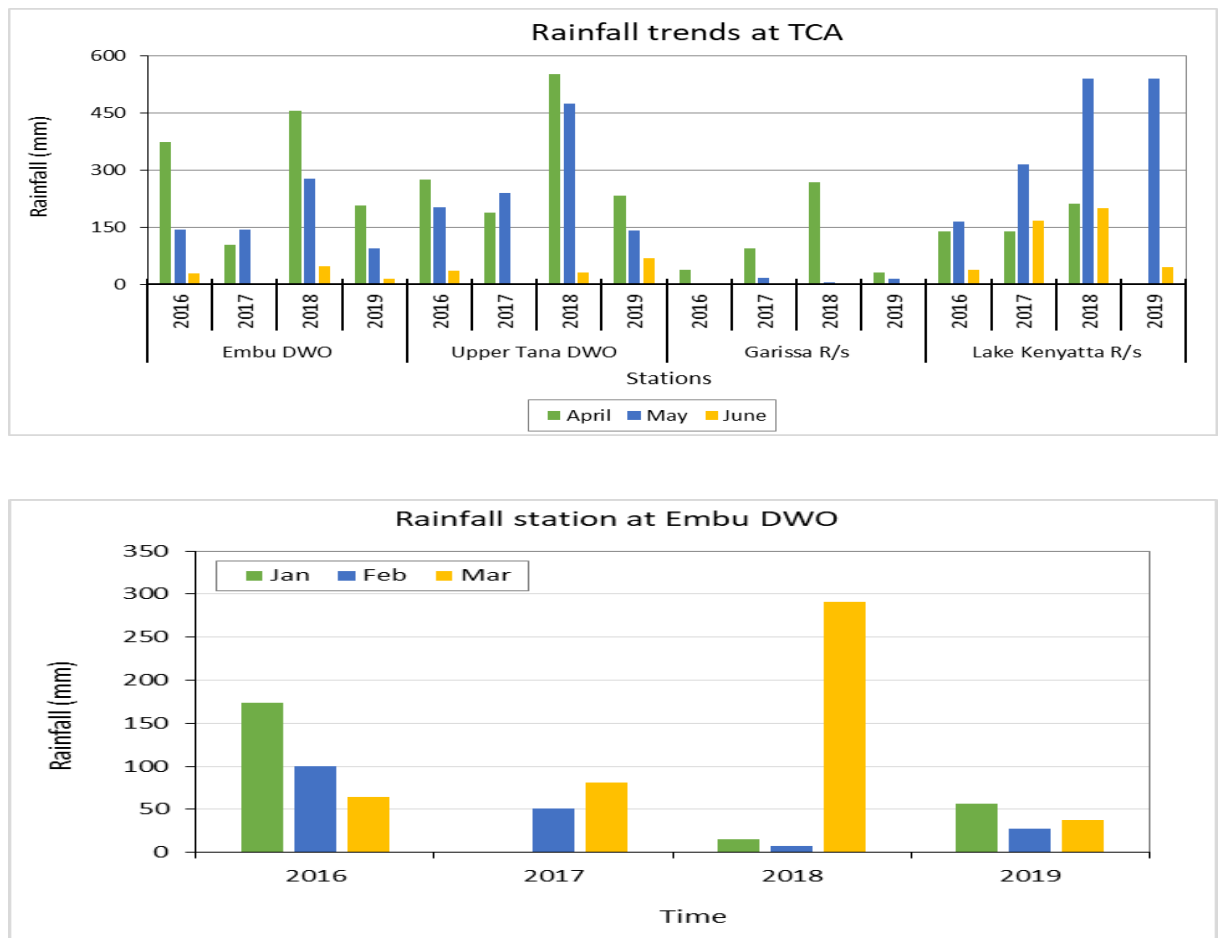
For TCA, an analysis of the Long-term rainfall averages for the years 2016, 2017, 2018 and 2019 was done to get an overview of the rainfall trends for the Tana region. With reference to the chart below, (Figure 2.5) 2018 April received the highest monthly rainfall of 455mm followed by 2016. DWO Murang'a Rainfall station at Upper Tana for the year 2018 in the months of May and June had the highest and most years had recorded above 400mm which can be attributed to occurrence of floods during period. For Lower Tana at Garissa, there is an indication that the rainfall received during the period under review was very low with June recording zero rainfall but in lake Kenyatta flash floods were experienced.

Figure 2.5: Rainfall trends at TCA

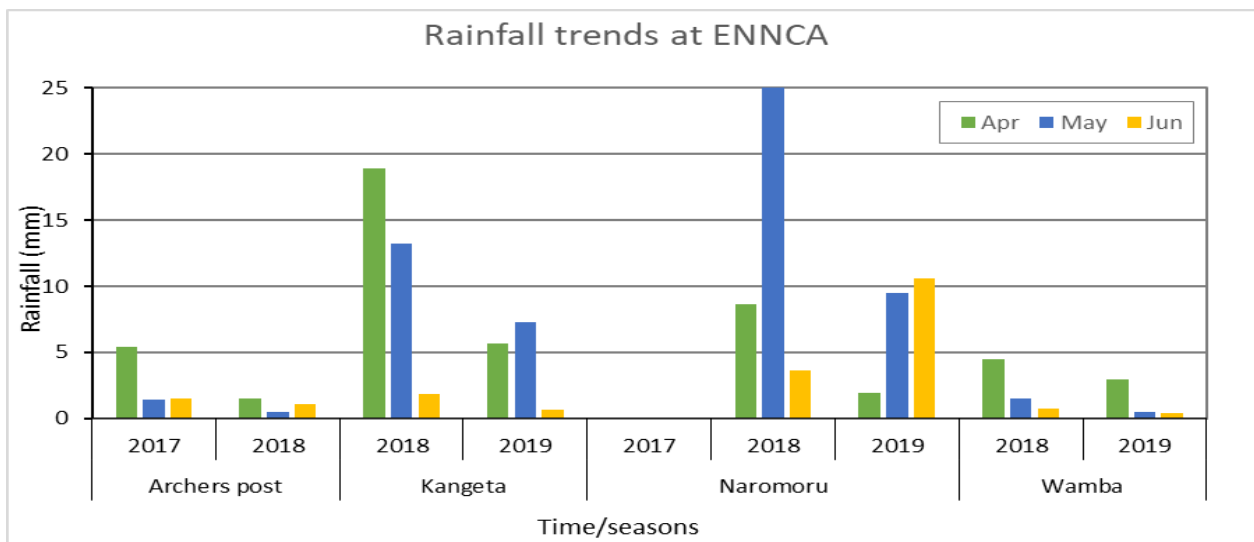
Ewaso Ng'iro North catchment area. The rainfall variability and monthly rainfall have been analysed for the four stations. In all the four stations, in the year under review they received lesser rainfall than previous year 2017/2018. This resorted to rivers having lesser flows. For the preceeding months before the onset of the short rains it is expected that the river flows will be at their minimum. If no rains, for the month of July farmers who depend on rain fed agriculture may witness crop failure.

Figure 2.6: Rainfall trends at ENNCA

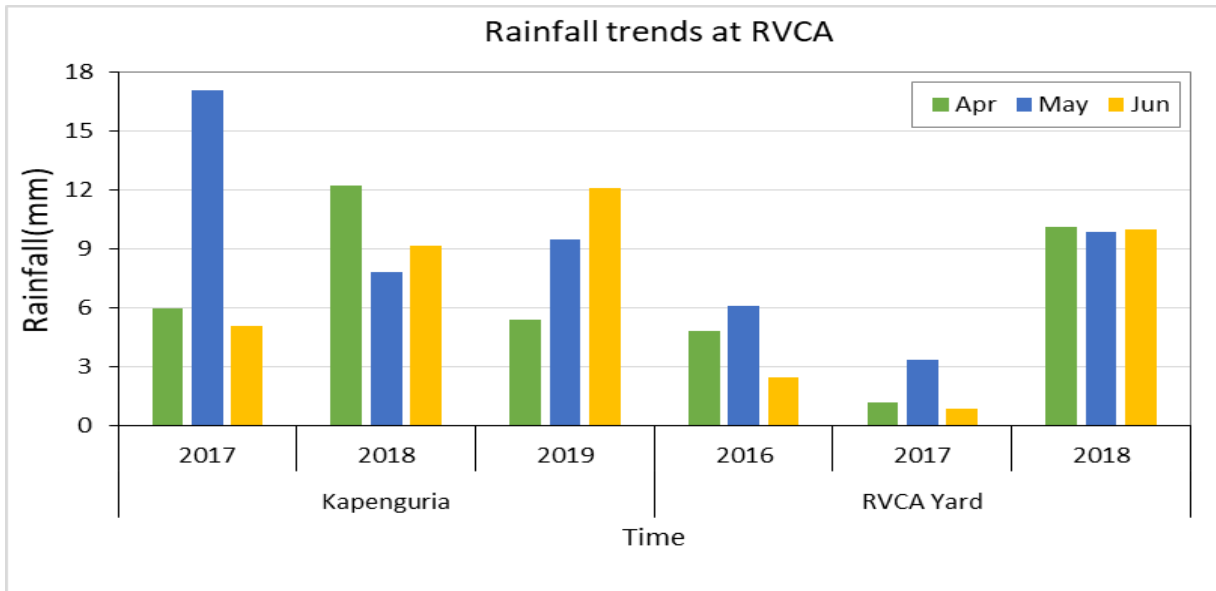
Figure 2.7: Rainfall trends on yearly basis at RVCA

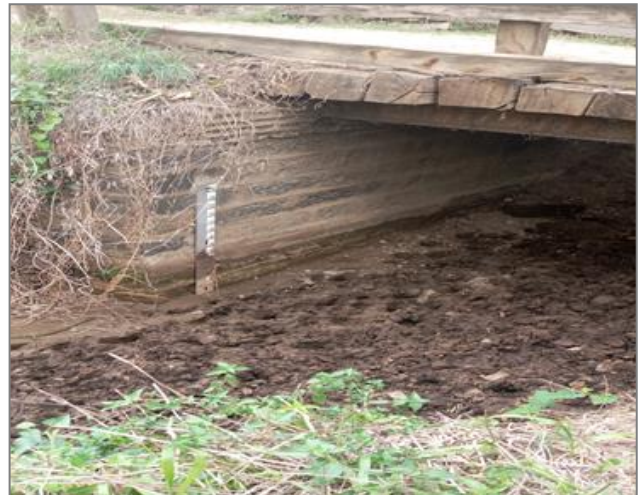
At LVSCA, the basin was affected by a dry period that resulted in significant reduction in water availability between Nov 2018 and April 2019. At ENNCA, from the rainfall station data analysed it informs that rainfall in the period under review was below the mean. It was also noted that the rains delayed and, in some areas, setting as late as May. Overall, the surface water situation in the region could be classified as “alert” during this period. There were a number of water related conflicts which was as a result of water scarcity.

Figure 2.8: Dry Mereroni river (2FA08) at RVCA

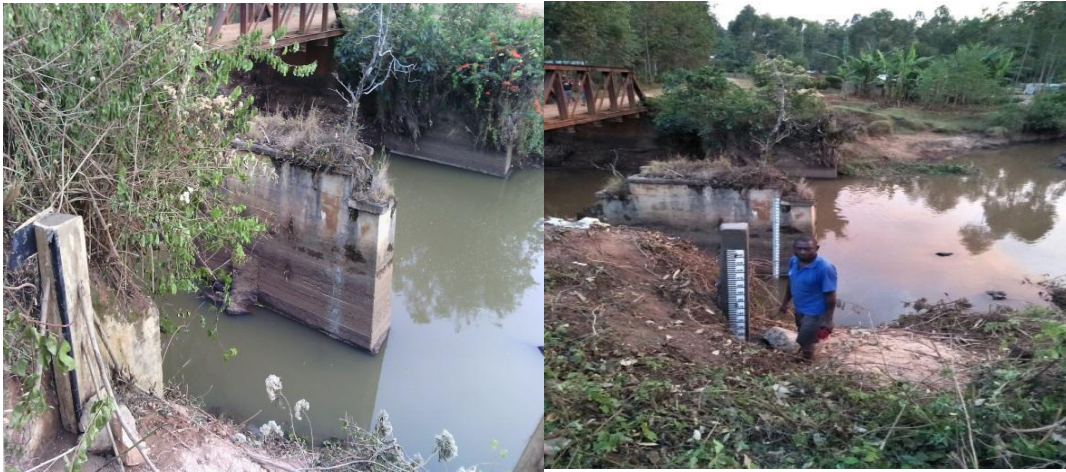
Figure 3.1:Yala-1FE02; Before (Erection of the pillar) and after (1st & 2nd gauges installed) the installation.

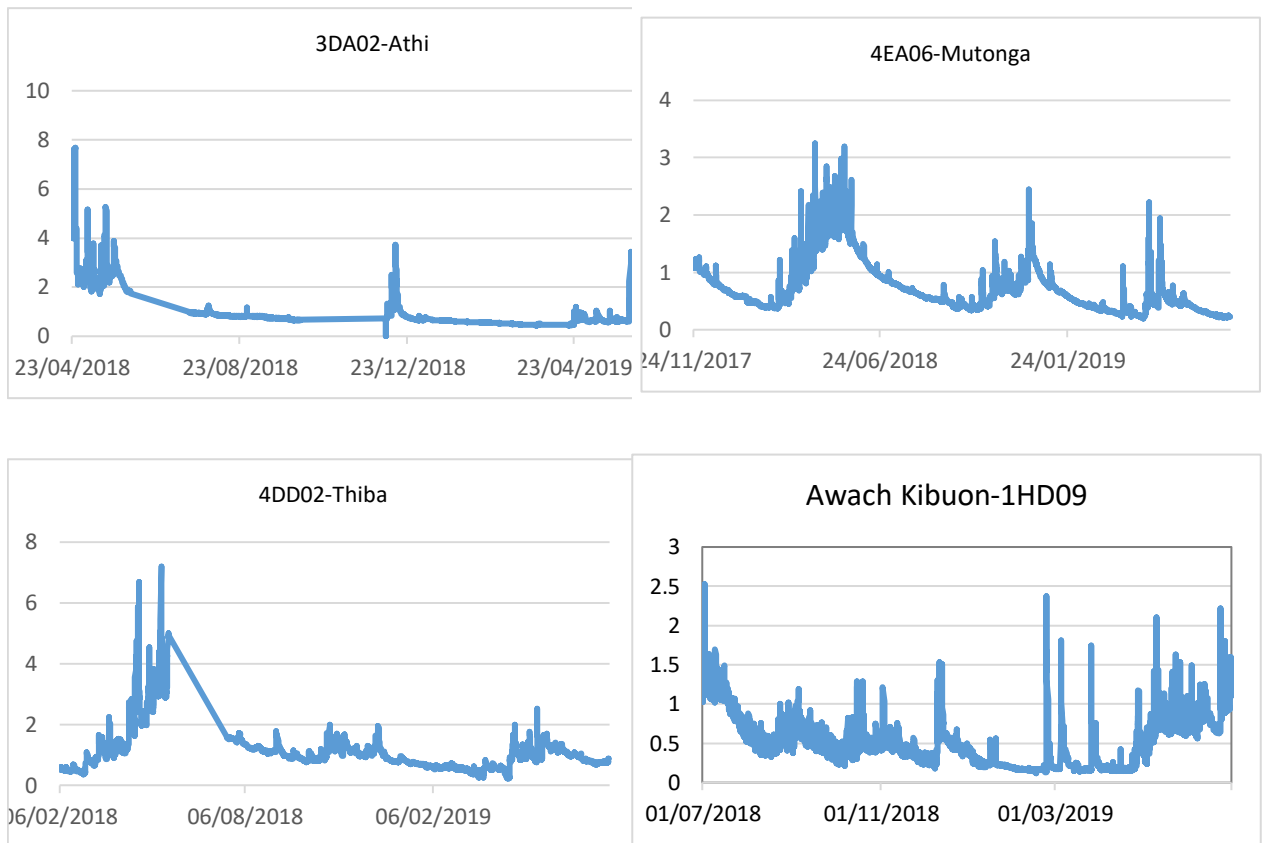
The availability of Telemetric system of data logging has ensured near real time data transmission to the server. The manual gauge readings are used as a reference to validate the gauge readings acquired from the telemetric stations. They are also used to configure the readings for the telemetric equipment. These telemetric stations require regular maintenance to check and change batteries promptly to avoid losing data. The charts below (Figure 3.4), displays water level data for various telemetric stations. The trends of the data are quite good.

Figure 3.4: Telemetric stations water levels.

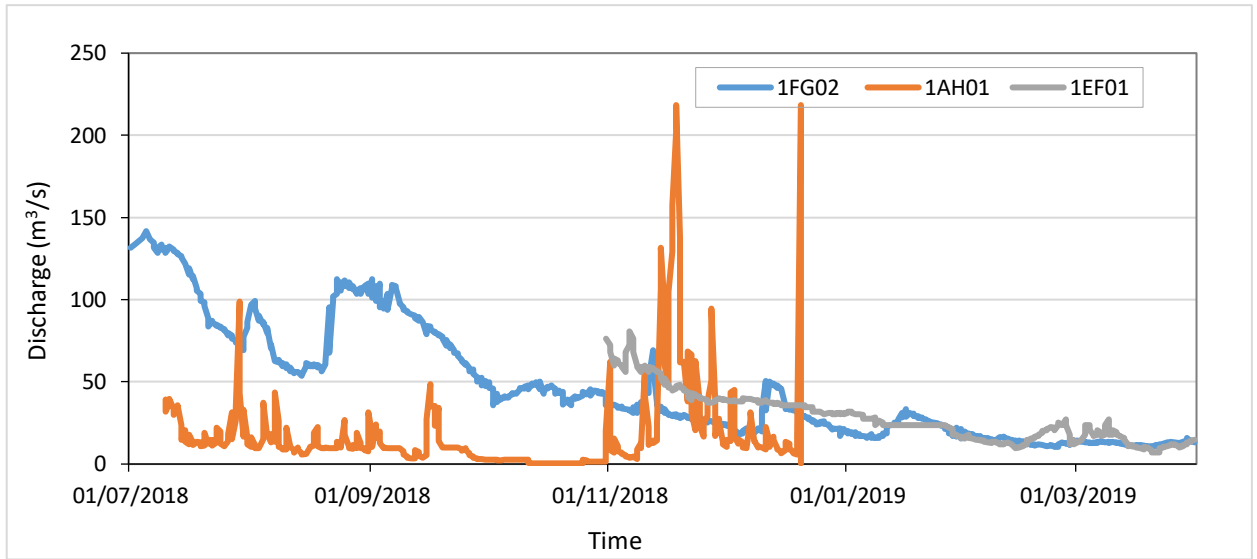
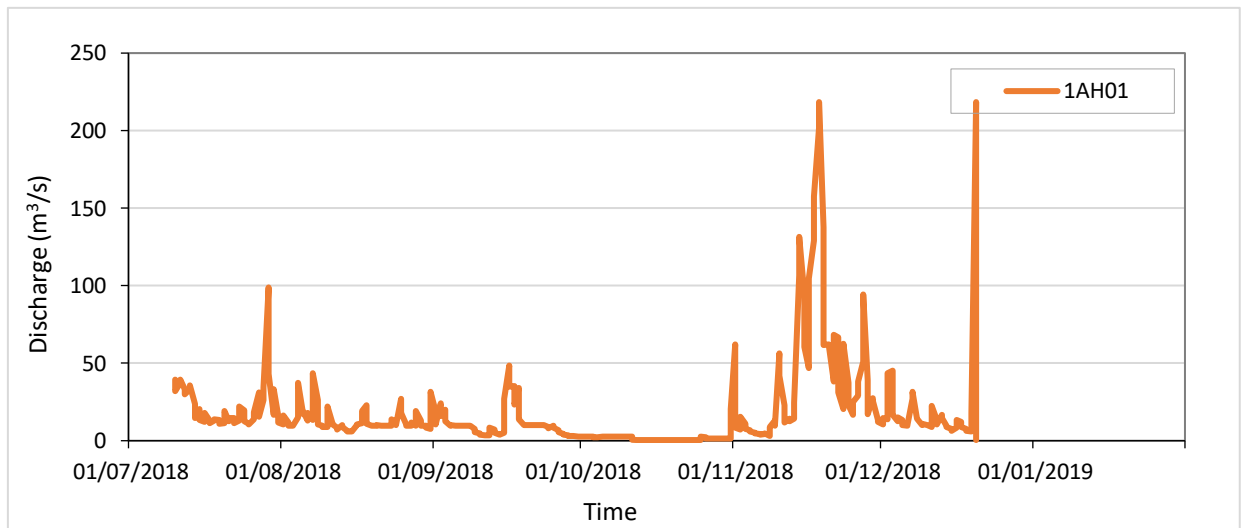
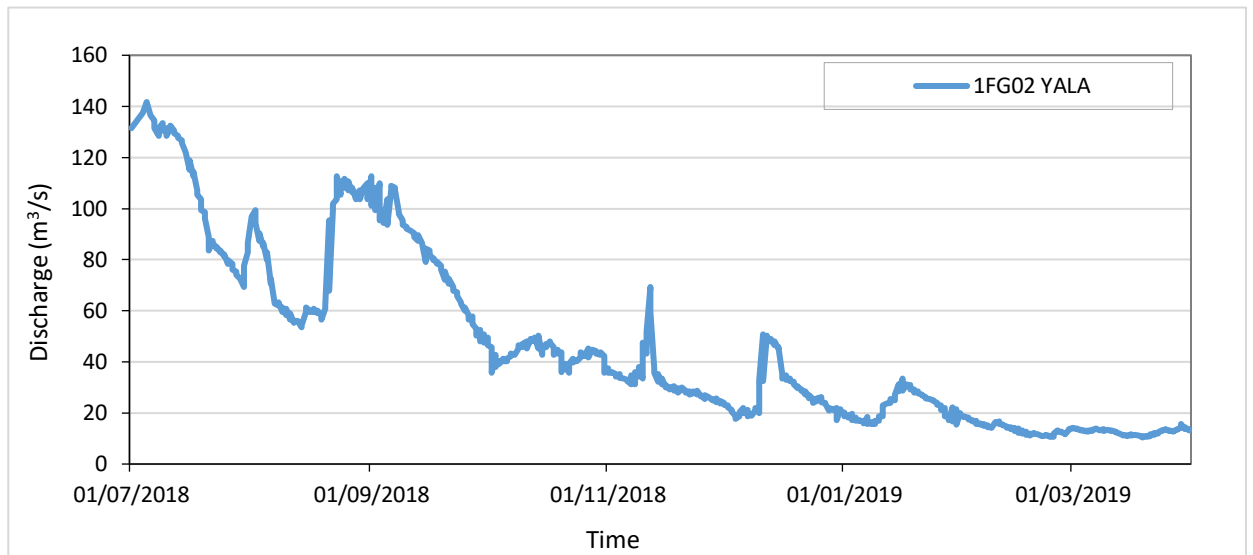
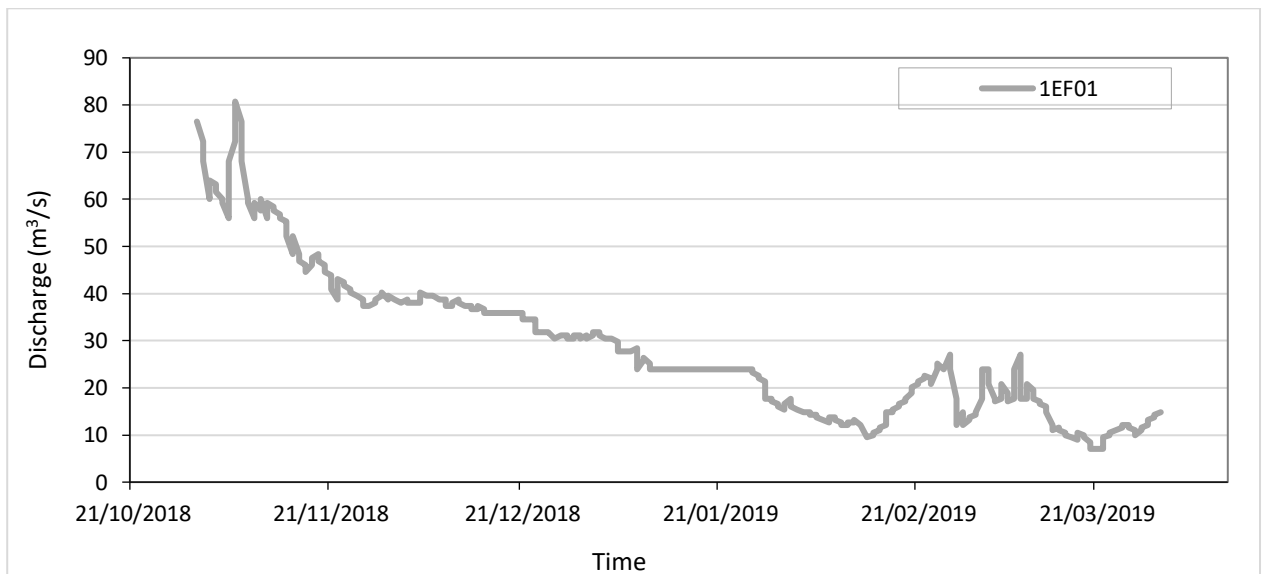
For LVNCA, 1FG02 (Yala) and 1AH01 (Sio) and 1EF01 (Nzoia) RGS stations were used for analysis. This was based on data availability. Comparing Yala, Sio and Nzoia daily flows show that there was more flow in the Yala River on average basis but comparing the three river systems based on maximum flows Sio river had the highest maximum flows compared to Yala and Nzoia. Sio had $218.42 \text{ m}^3/\text{s}$ while Yala and Nzoia had $141.71 \text{ m}^3/\text{s}$ and $80.73 \text{ m}^3/\text{s}$ respectively. Sio river had the lowest minimum daily flows of $0.42 \text{ m}^3/\text{s}$ followed by Nzoia river ($7.05 \text{ m}^3/\text{s}$) and then Yala river with $10.39 \text{ m}^3/\text{s}$. The reserve flows in most of the rivers was not violated.

Figure 3.6: Daily flow trends at LVNCA

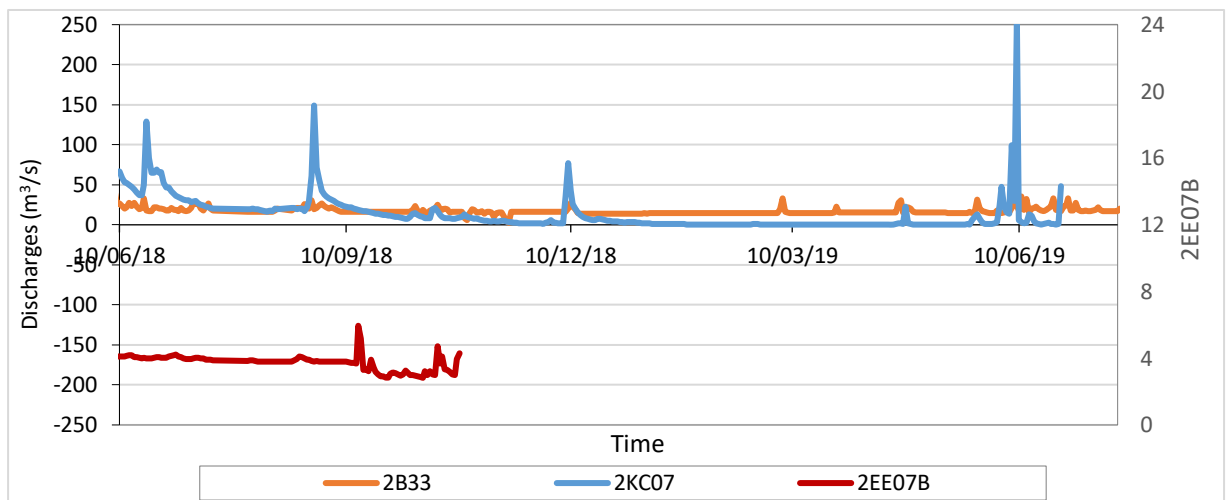
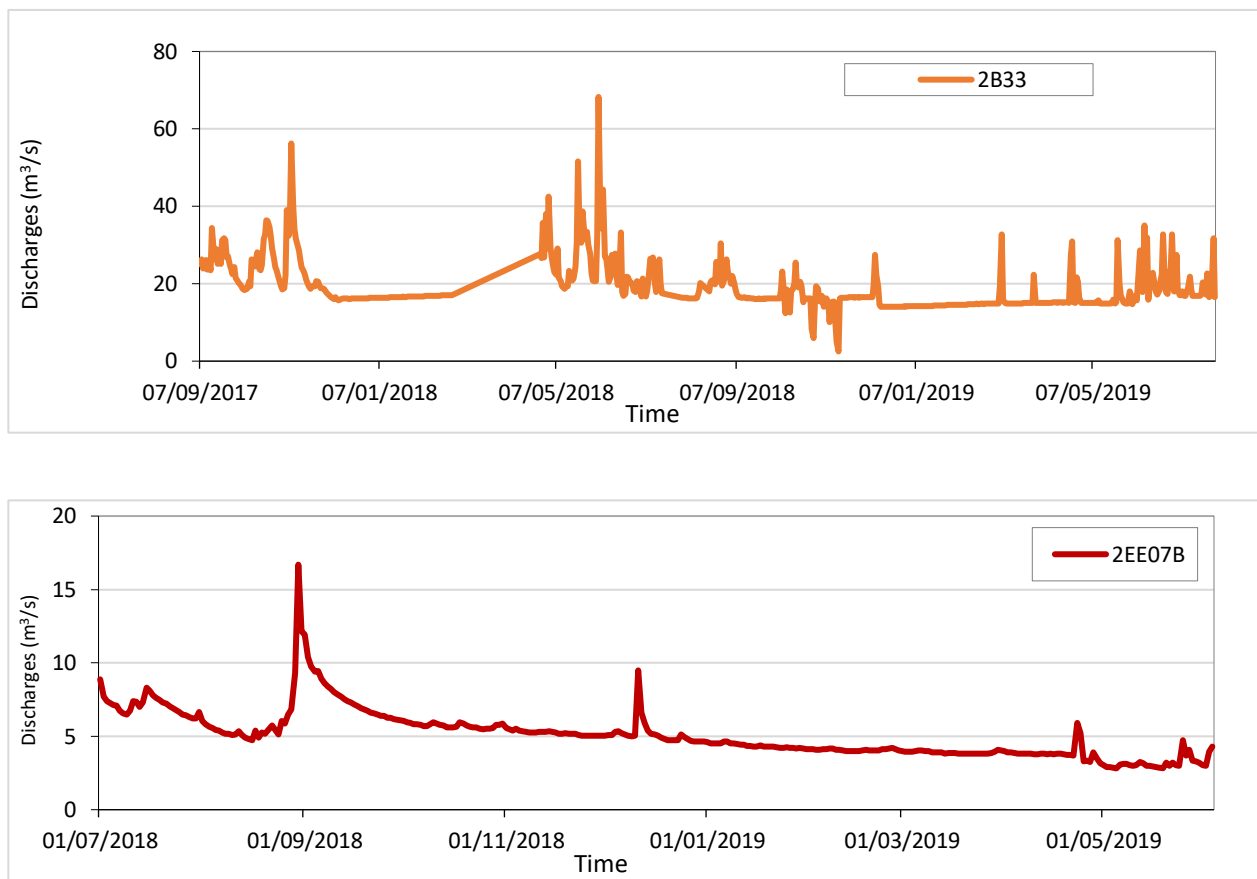
RVCA is the second largest Kenyan catchment which is an internal drainage basin with its streams flowing into its constituent lakes. Water scarcity is highly linked to over-dependence on surface water resources, as it is estimated that surface water and ground water are only 12% and 88% respectively. In certain occasions the region becomes highly vulnerable to drought during the dry period and flooding during the wet periods. 2C07, 2B33 and 2EE07B stream flows at RVCA were used to analyse the trend in the flows and as a representation of the basin. Flow variations were experienced at different river systems as evident from KC07, KB33 and 2EE07B. An average of 12.73, 16.95 and 5.11 m³/s were received at KC07, KB33 and 2EE07B stations respectively. While 2KC07 had the highest maximum flows, it also receives the lowest minimum flows of 0.12m³/s.

Figure 3.8: Daily flow trends at RVCA

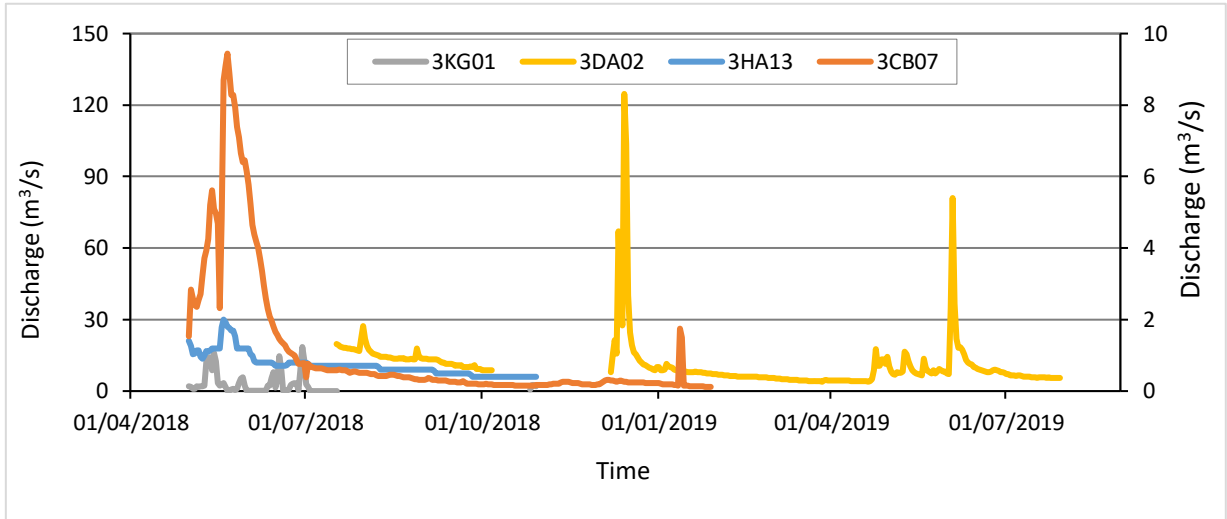
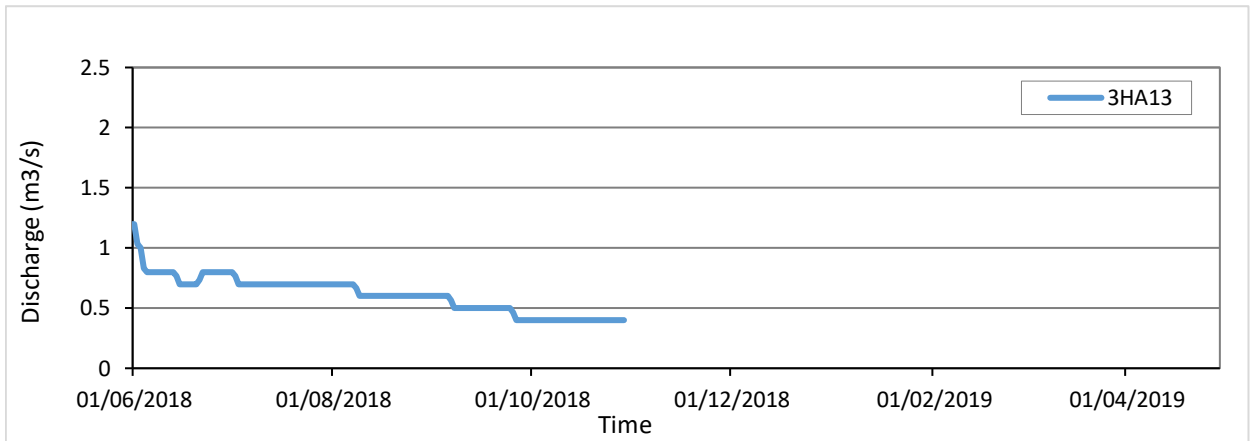
For the ACA, 3DA02, 3CB07, 3KG01 and 3HA13 were used for the analysis. The graph depicts considerable flows in both the short and the long rains seasons. 3DA02 ($124.672\text{m}^3/\text{s}$) had the highest maximum flows especially in the months of December 2018 and June 2019 while 3HA13 had the least maximum flows ($2\text{m}^3/\text{s}$). 3DA02, 3CB07, 3KG01 and 3HA13 had average flows of $10.92\text{m}^3/\text{s}$, $1.09\text{m}^3/\text{s}$, $2.97\text{m}^3/\text{s}$, $0.73\text{m}^3/\text{s}$ respectively. The minimum flows for the analysed stations, 3DA02, 3CB07, 3KG01 and 3HA13 were $3.92\text{m}^3/\text{s}$, $0.11\text{m}^3/\text{s}$, $1.16\text{m}^3/\text{s}$ and $0.4\text{m}^3/\text{s}$ respectively. The reserve flows in most of the stations was not violated.

Figure 3.9: Daily flow trends at ACA

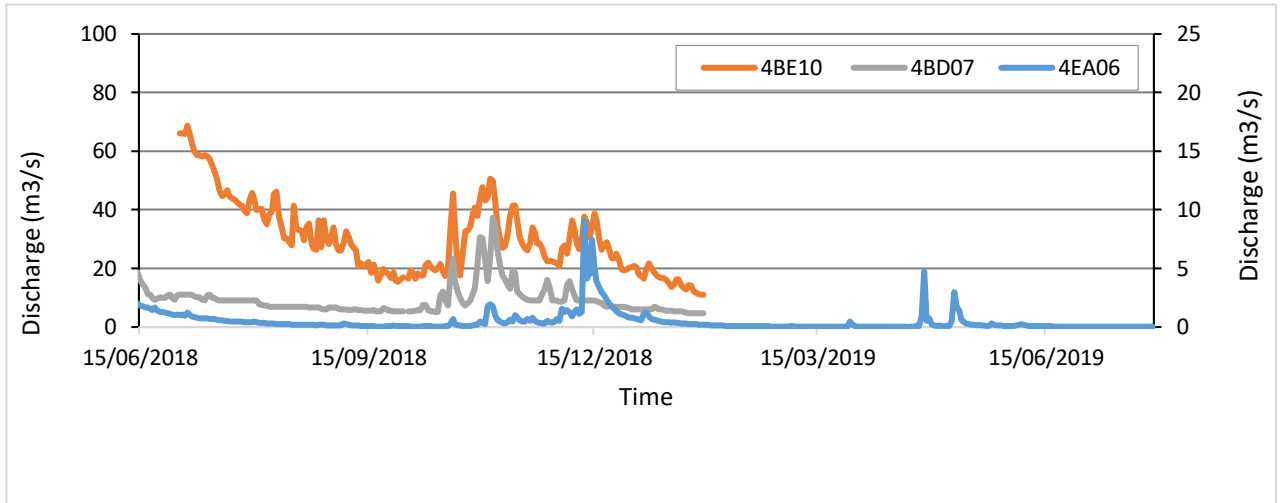
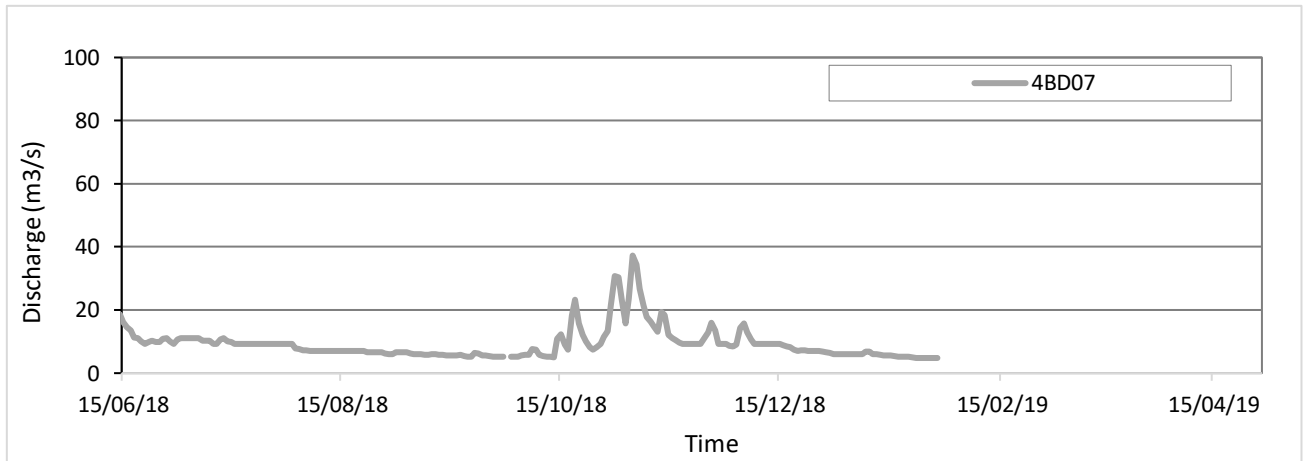
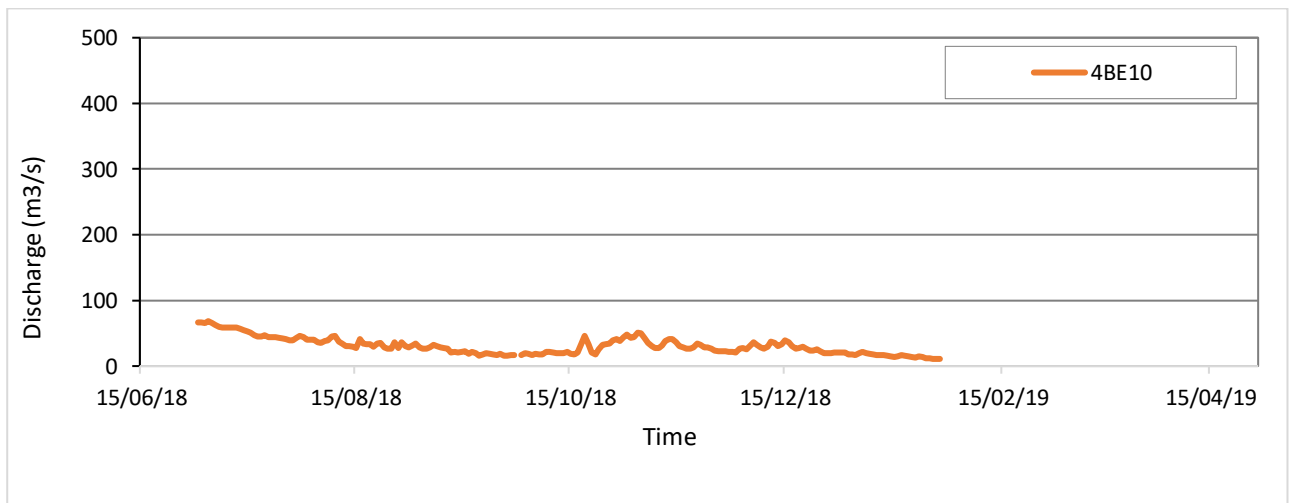
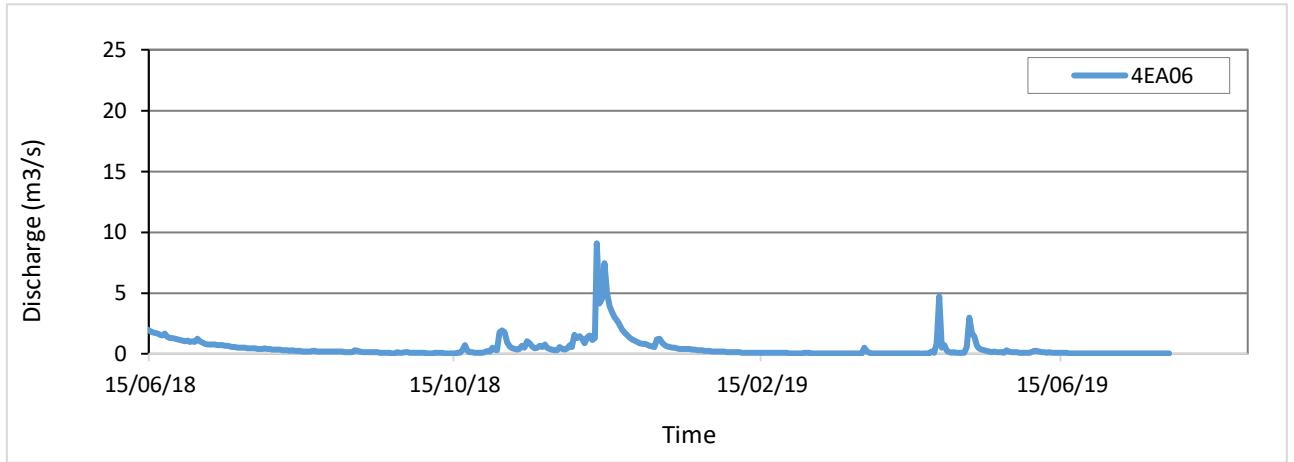
The lowest minimum flow was displayed at 4EA06-Mutonga with a discharge of 0.007 m³/s, while 4BD07-Mathioya and 4BE10-Rukanga had 4.81 m³/s and 10.95 m³/s respectively. The reserve flows were not violated during the period under review.

Figure 3.10: Daily flow trends at TCA

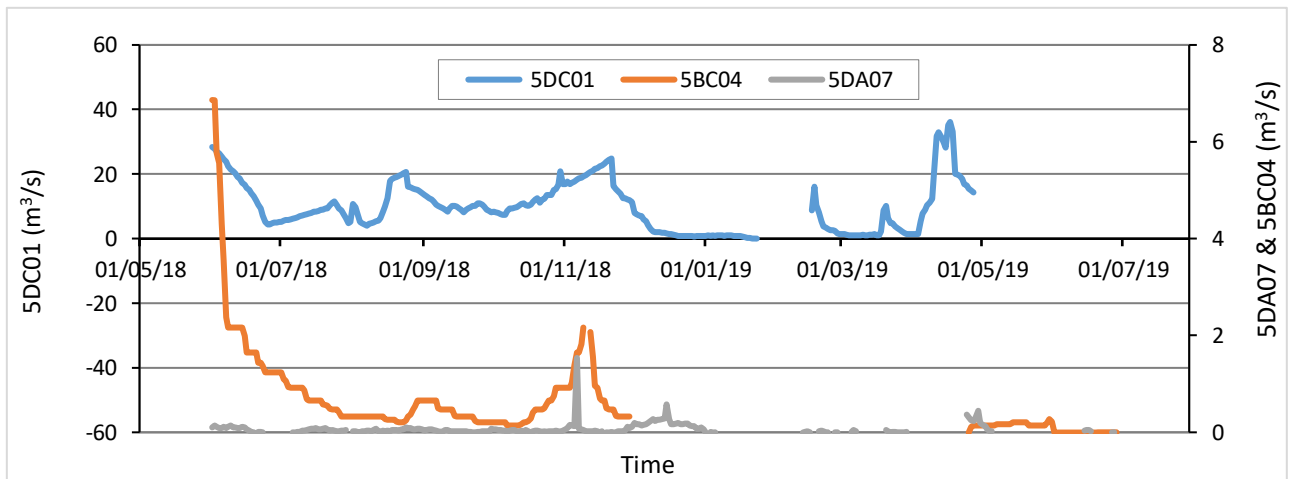
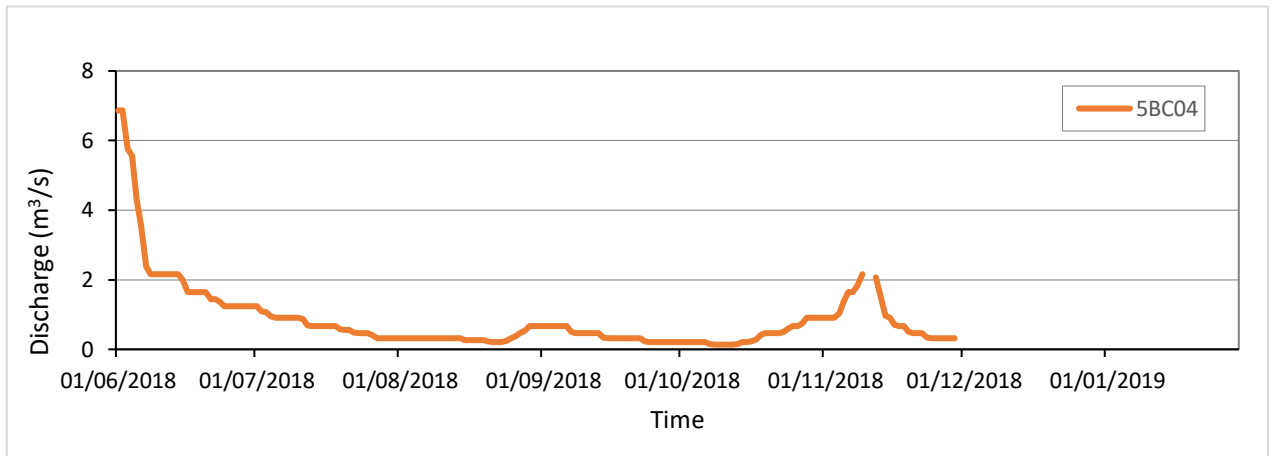
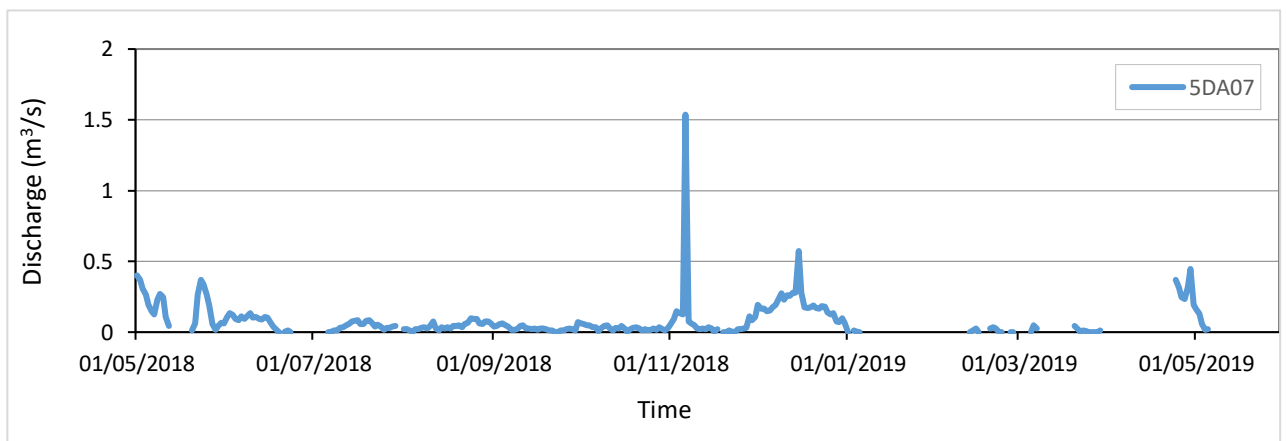
For ENNCA, 5DC01-Ewaso Ng'iro, 5DA07-Isiolo and 5BC04-Ewaso Ng'iro were used for the analysis. On average basis, 5DC01-Ewaso Ng'iro had the highest amount of daily flows of 9.088 m³/s, while 5DA07-Isiolo had the minimum flows of 0.071 m³/s. 5DC01-Ewaso Ng'iro also had the highest maximum flows ~36.14 m³/s, followed by 5BC04-Ewaso Ng'iro (2.16 m³/s) and 5DA07-Isiolo with a discharge of 1.54 m³/s. The three stations analyzed depicted different stream flow characteristics throughout the year.

Figure 3.11: Daily flow trends at ENNCA

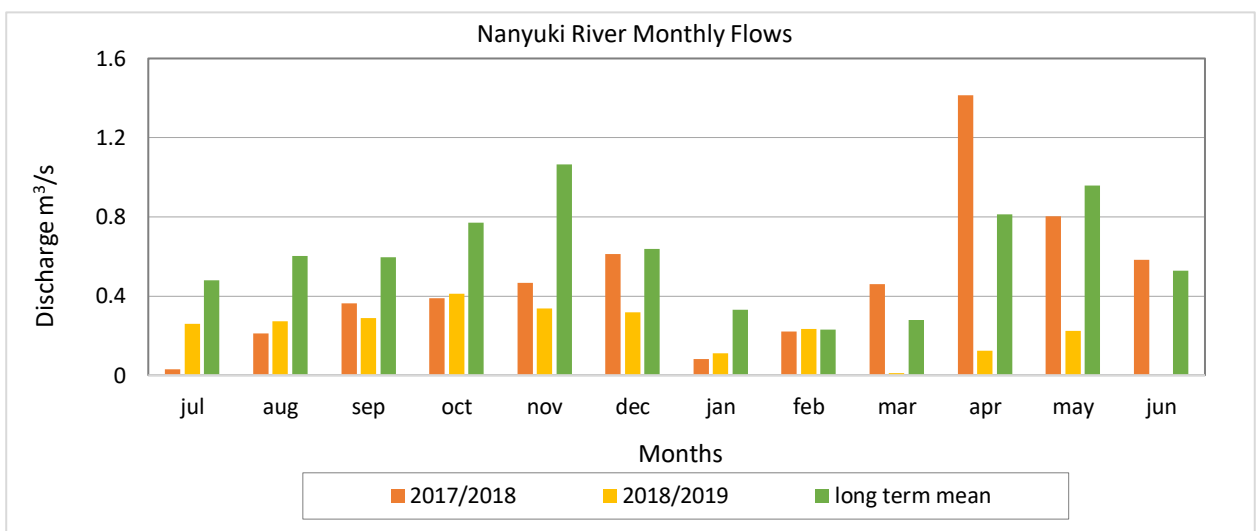
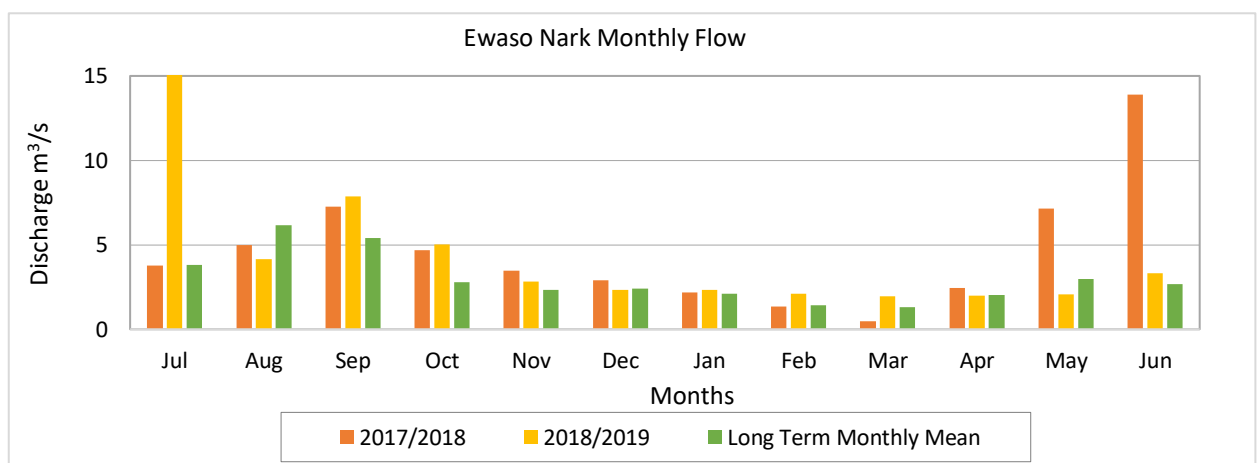
above the mean monthly flows in the year under review except for the months of April and May. The flows as observed had sharp rise which should have caused flash floods in the months of April and May. The flow pattern was in tandem with the long term mean in all the stations. Only that the flows in the year under review period were below the mean. This could be attributed to the low rainfall amounts experienced in the entire catchment area. Apart from Ewaso Narok whose flows almost compares with the previous year, 5BE01-Nanyuki show relatively lower flows. The situation could be considered as stable as at now but could very soon slide into alert considering the amount of rainfall received. For ENNCA, where analysis of flow was carried out, they experienced depressed discharge in the months of January, February and March compared to the long-term discharge. During these months incidences of reserve violation were experienced with the rivers drying up completely at some points. Due to the delayed onset of the long rains and the rains received being below the mean, the situation of the water resources availability could not be considered as stable but at an 'alert' level.

Figure 3.12: Comparison of long term and monthly mean for 2017/2018 and 2018/2019 at 5BE01-Nanyuki and 5AC15-Ewaso Narok

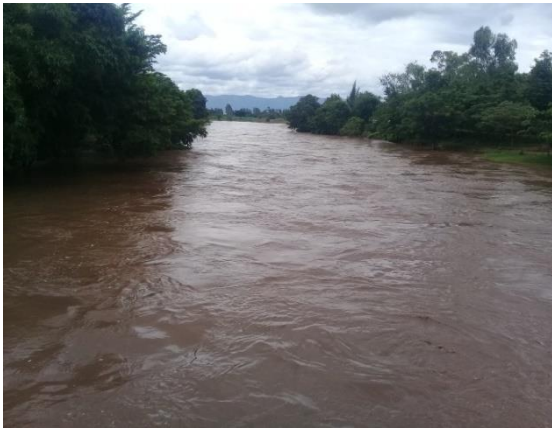
IGD01 at Ahero Bridge

For ENNCA and LVNCA no special events were experienced. The flood situation gives us an opportunity to collect data and information which will eventually help WRA and other stakeholders to work towards establishing effective structural and non-structural measures for the mitigation of floods in the flood prone areas and at the same time becoming resilient to climate change. The following photos (Figure 3.13) show flood impacts across the country.

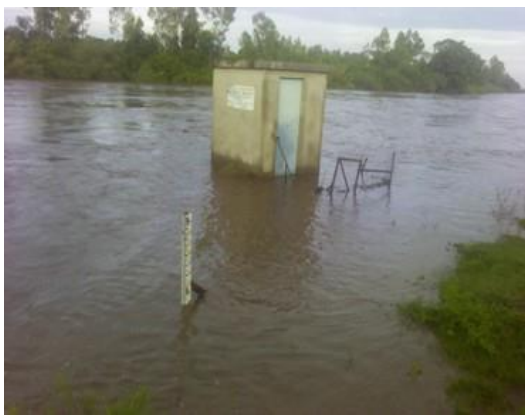
Wath 'Onger Logger house submerged

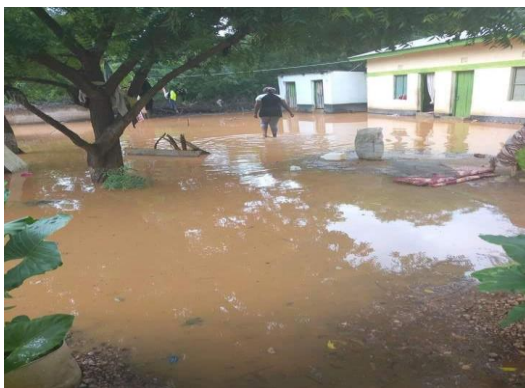
Flooded Widsor estate in Garissa

For the RVCA, most rivers recorded low levels in the months of April & May which is normally a high flow period. The onset of long rains was delayed. For ACA, impacts of flash floods in Buna, Habaswein, Modogashe, Khoromey and Ramu in Mandera in which the flash floods destroyed the roads and cut off communication were reported.

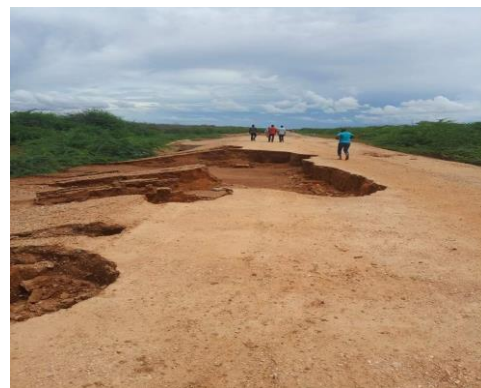
Road destruction in Garissa
