WATER RESOURCES AUTHORITY

WATER RESOURCES SITUATION REPORT

July 2018 to June 2019

AUGUST 2019

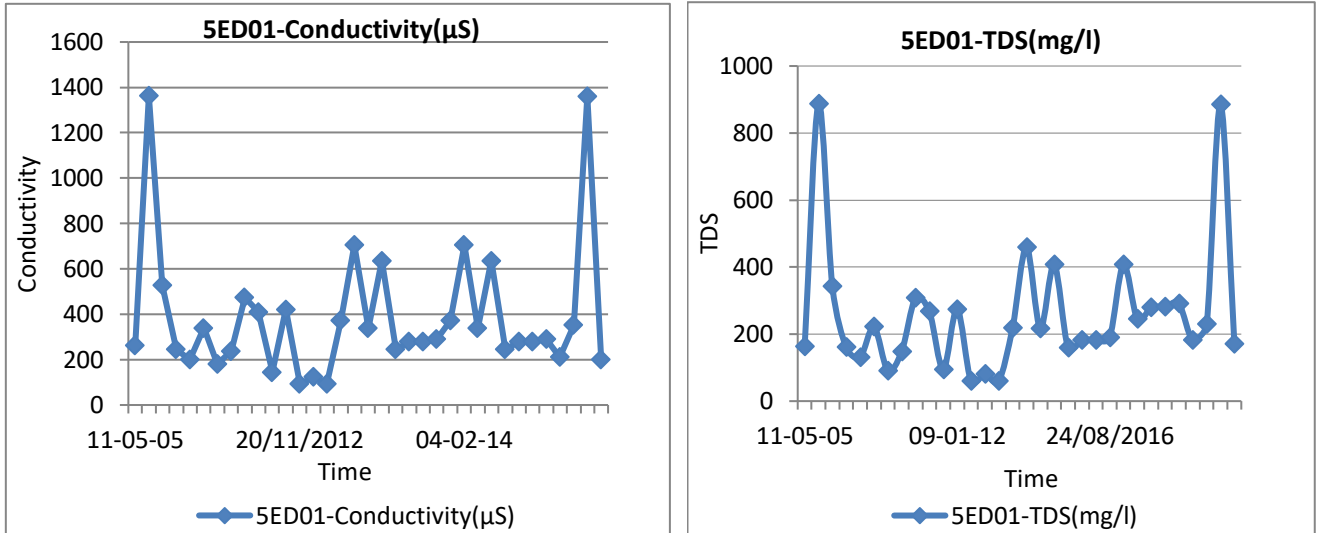
Figure 5.1: Conductivity and Total Dissolved Solids Ewaso Ng'iro River at 5ED01

Considering the national station Ewaso Ng'iro River at 5ED01, it is obvious from the above graphs that there is almost a direct correlation between Conductivity and Total Dissolved Solids. This is more so since one parameter can be empirically deduced from the other. Both parameters exhibit a very gradual increasing trend with only two high peaks in May and February of the year 2005 and 2018 respectively.

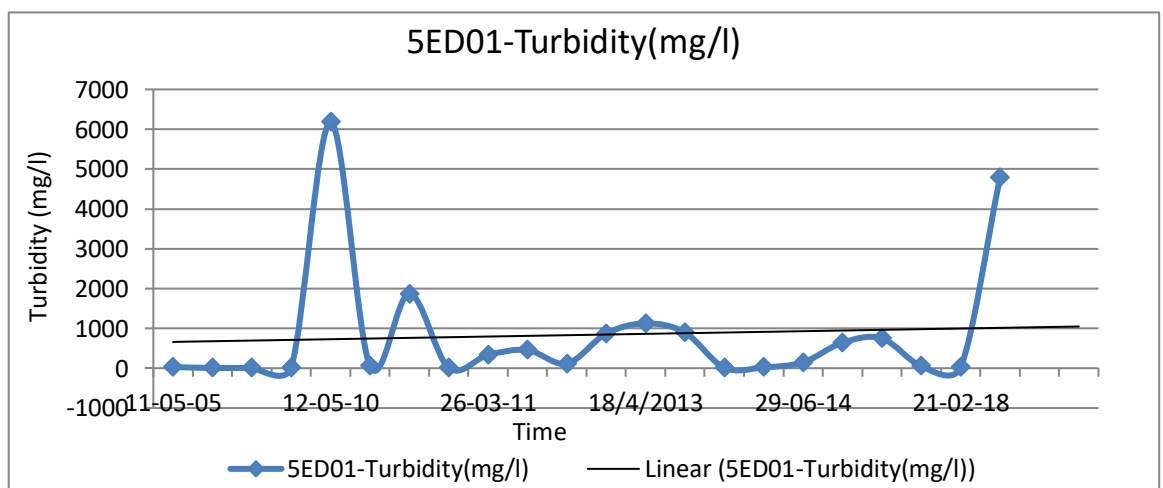
Figure 5.2: 5ED01-Turbidity(mg/l)

Turbidity exhibits an increasing trend as contrasted from the last quarters a situation brought about this quarters peak of 4780NTU which in turn has been contributed by the seasons heavy rains.

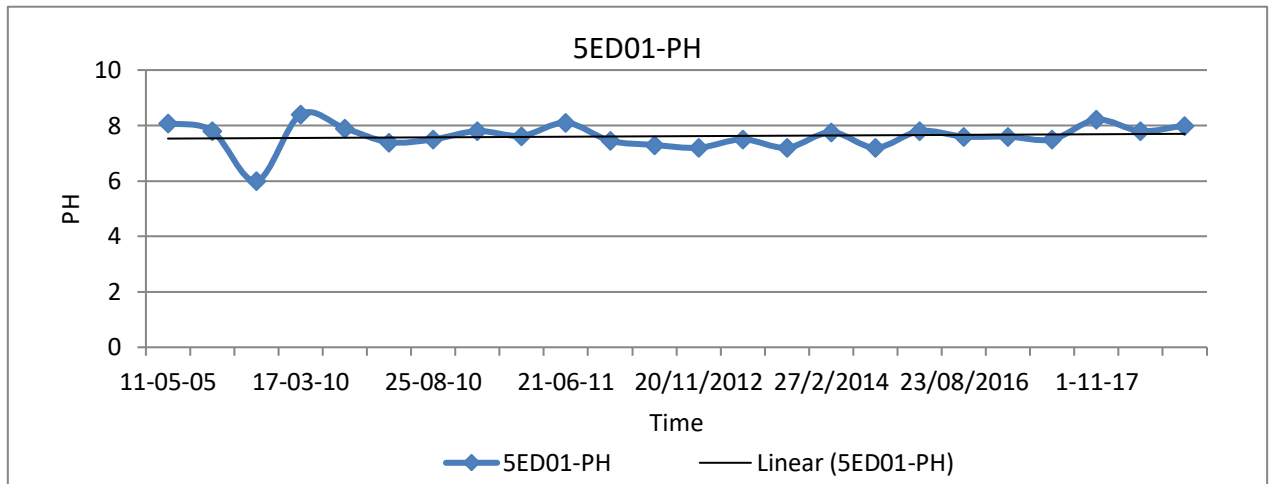
Figure 5.3: 5ED01-PH

The degree of seasonal variation of this parameter is within a very narrow margin and slightly above the neutral point. The parameter is insignificantly rising with time.

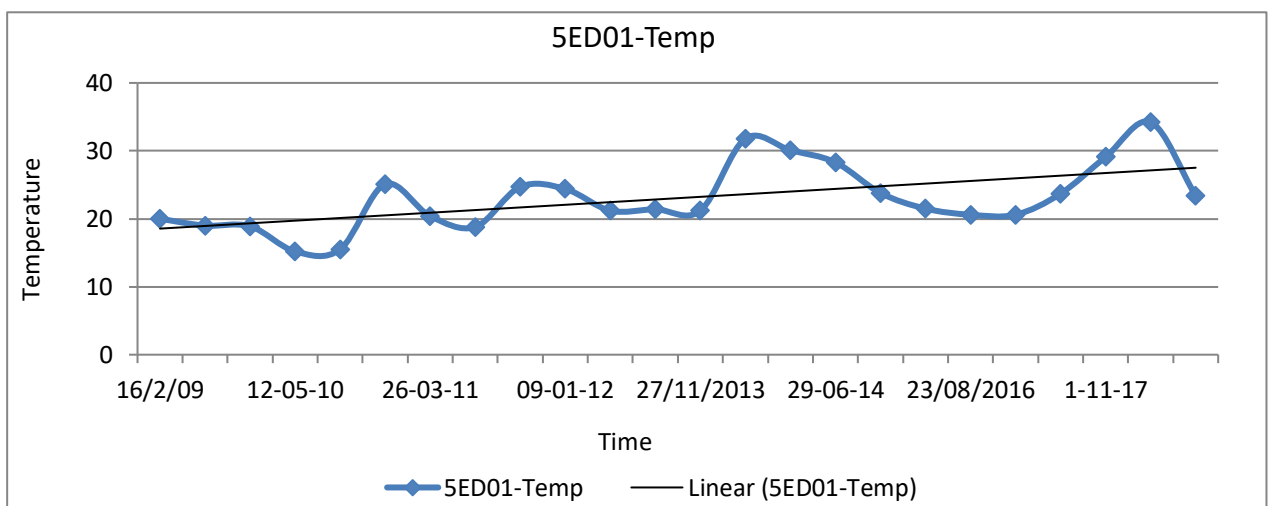
Figure 5.4: 5ED01-Temperature

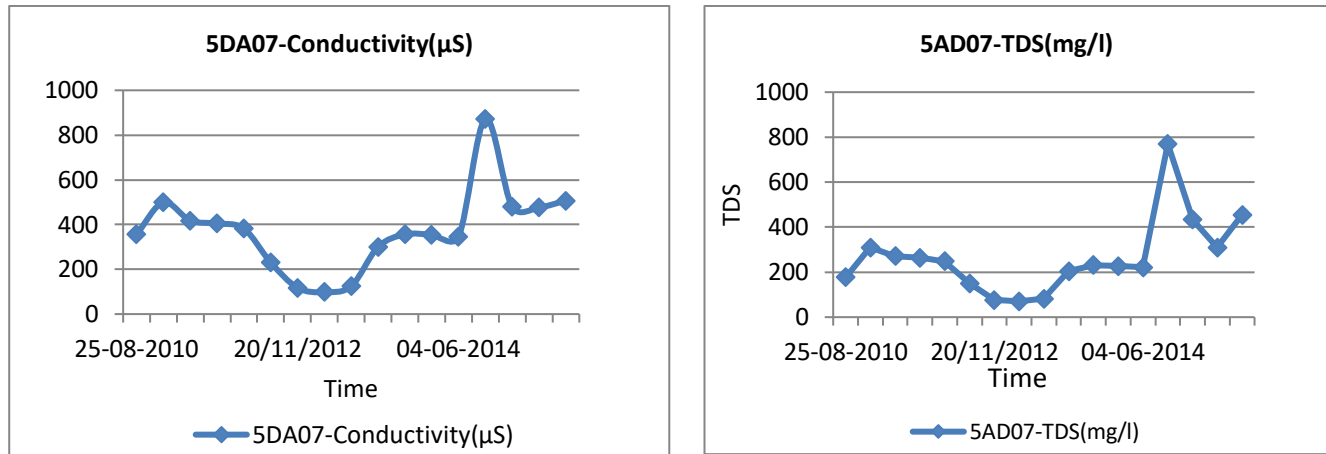
Figure 5.5: Isiolo River at 5DA07- MU station

This station is in the neighbourhood of the national station 5ED01 and the trend in these parameters are on an increasing trend.

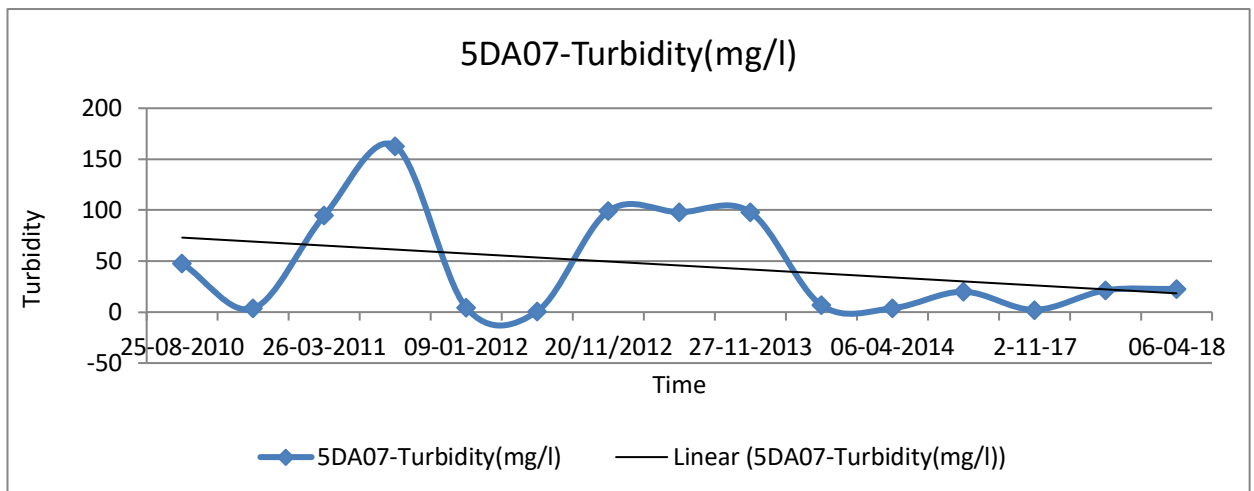
Figure 5.6: 5DA07-Turbidity(mg/l)

The decreasing trend in turbidity can be considered normal when the rain is considered to be decreasing. Contribution of this parameter to the national station is insignificant since it is the last permanent tributary to Ewasongiro River and both quality and discharge values are very low compared to the national station in order of magnitude.

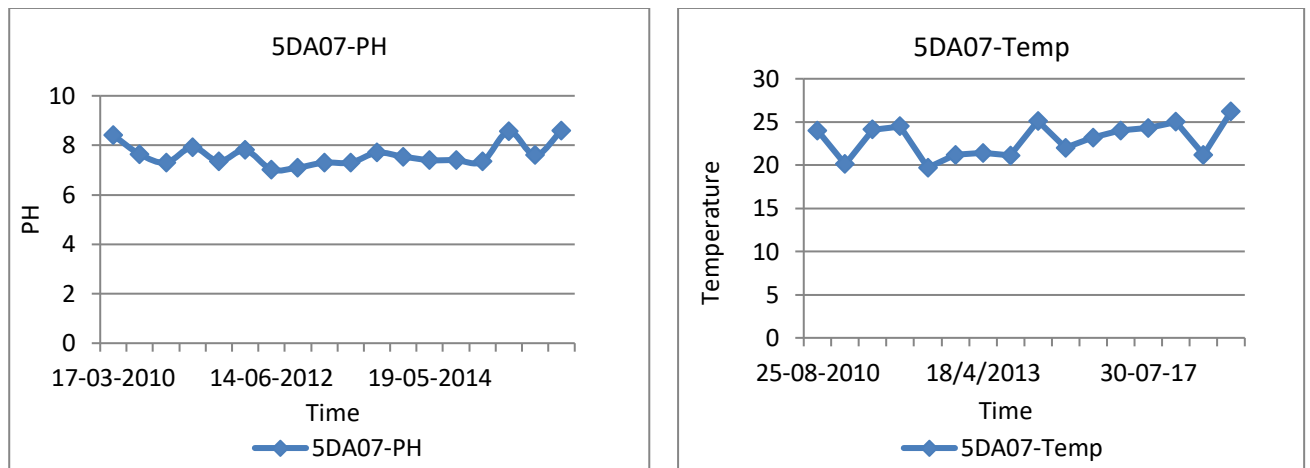
Figure 5.7: PH and Temperature at 5DA07

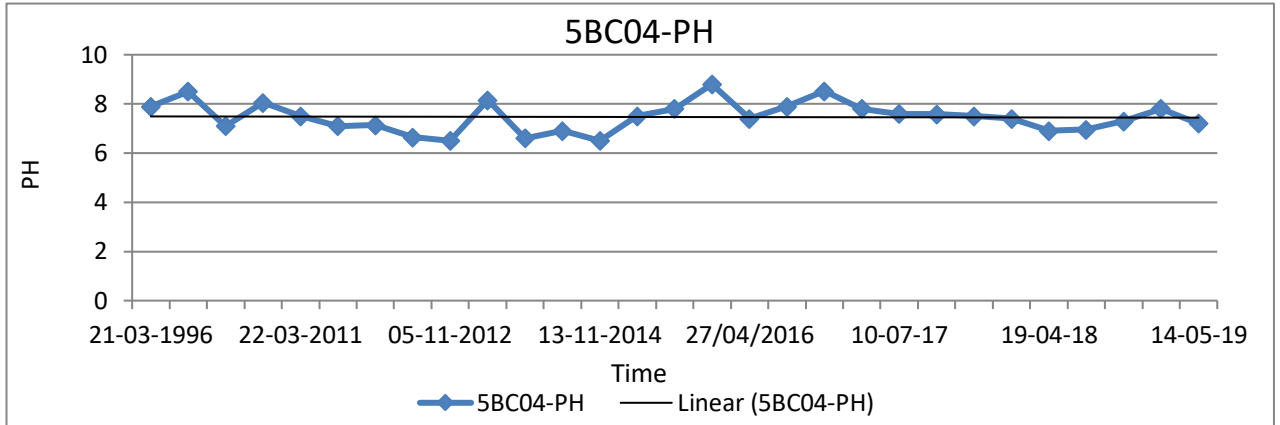
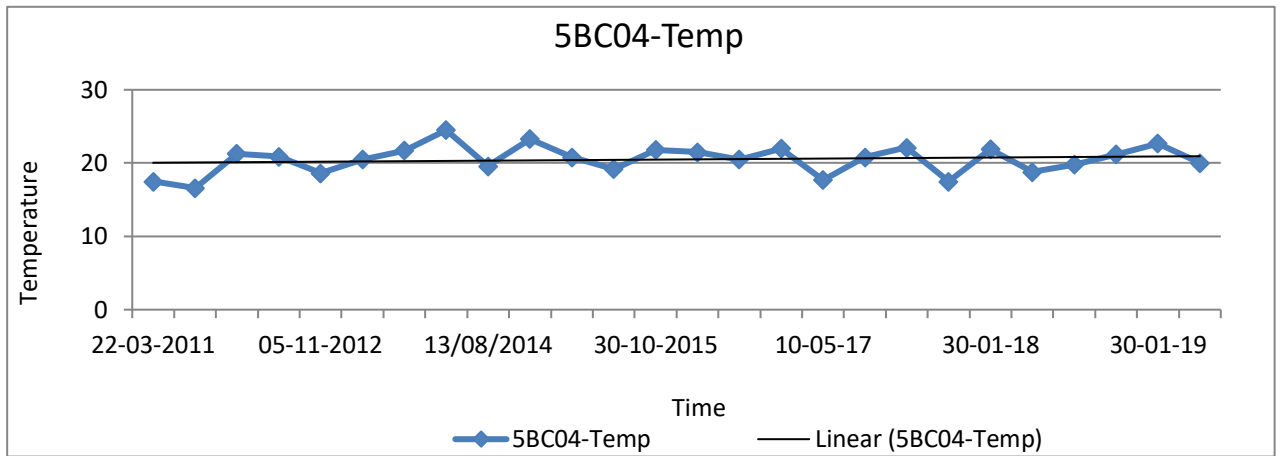
Figure 5.10: 5BC04 PH and Temperature

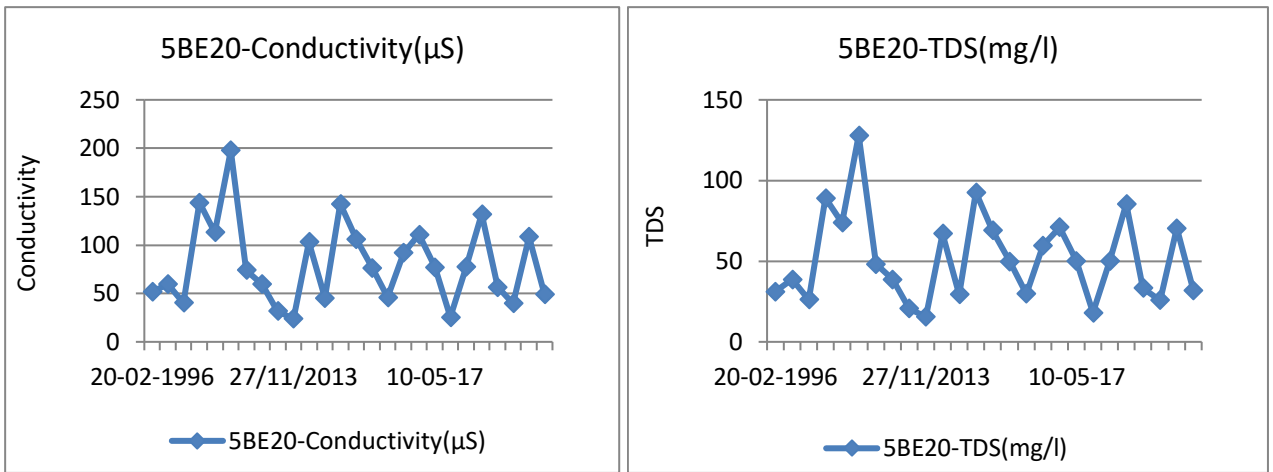
Figure 5.11: 5BE20-Conductivity(μ S) and TDSS

This station monitors waters from Mt. Kenya river systems. Both conductivity and TDS are generally decreasing insignificantly with time but with seasonal variations.

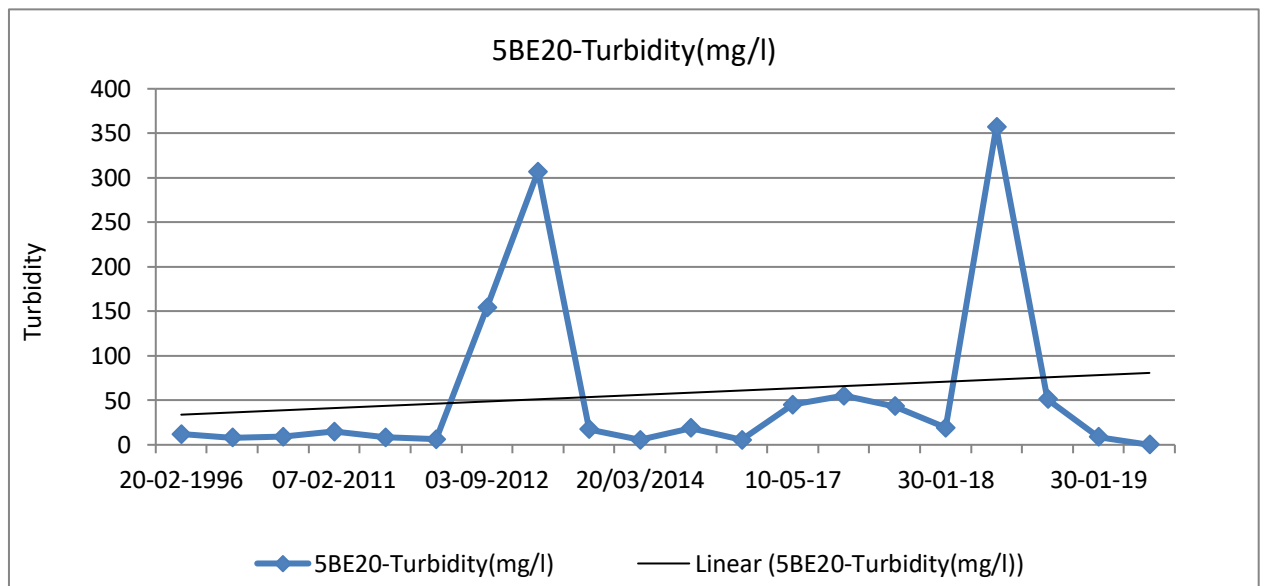
Figure 5.12: 5BE20-Turbidity(mg/l)

Turbidity values are low (≤ 15 NTU) in the beginning of monitoring period and sharply rising reaching a peak of 307mg/l in Nov 2012 with a sharp drop and then rising again to a peak of 357mg/l in April 2018 and then falling in the last two monitoring periods.

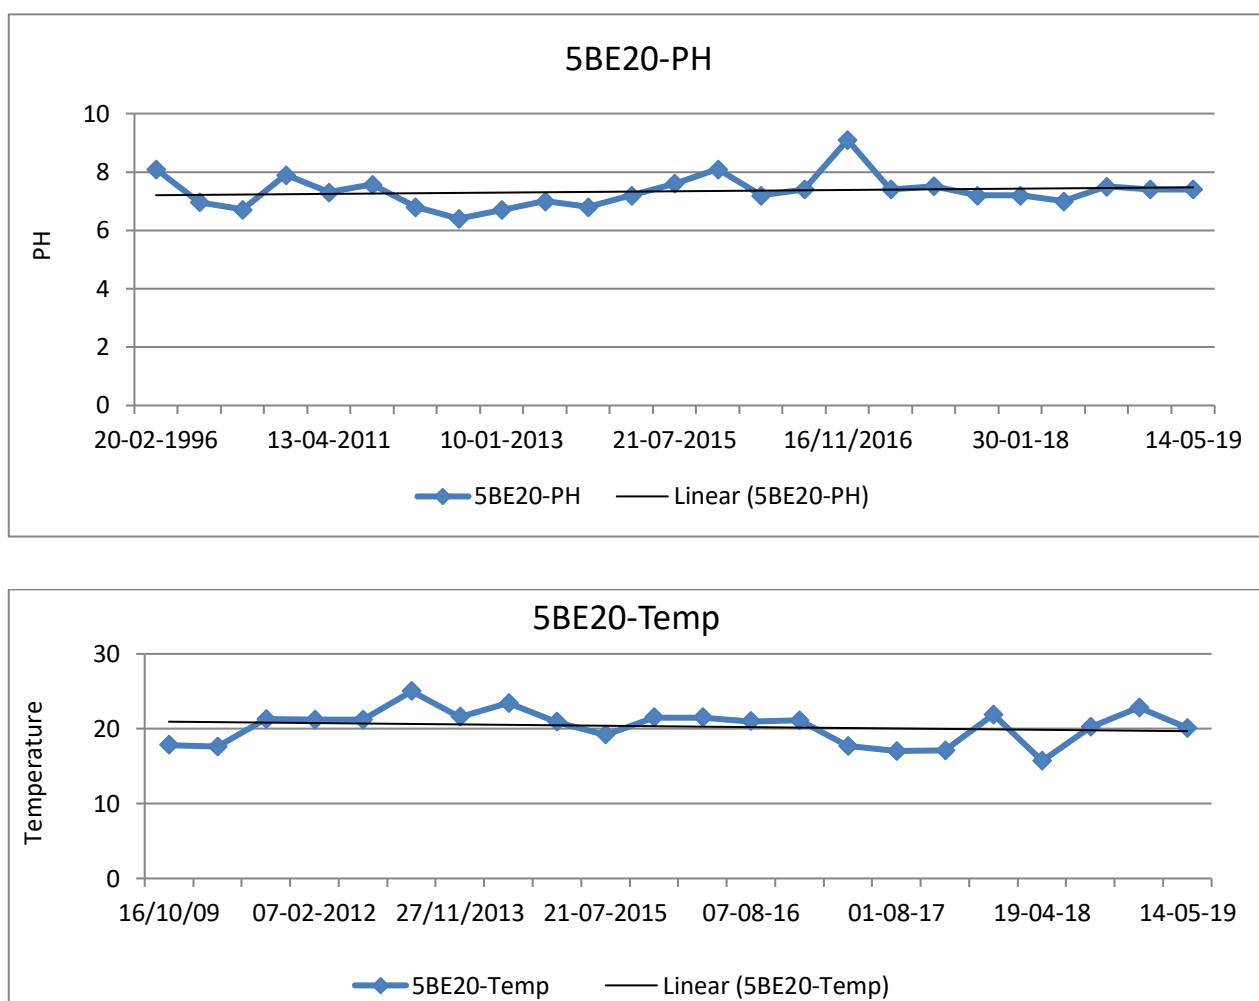
Figure 5.13: 5BE20-PH and Temperature

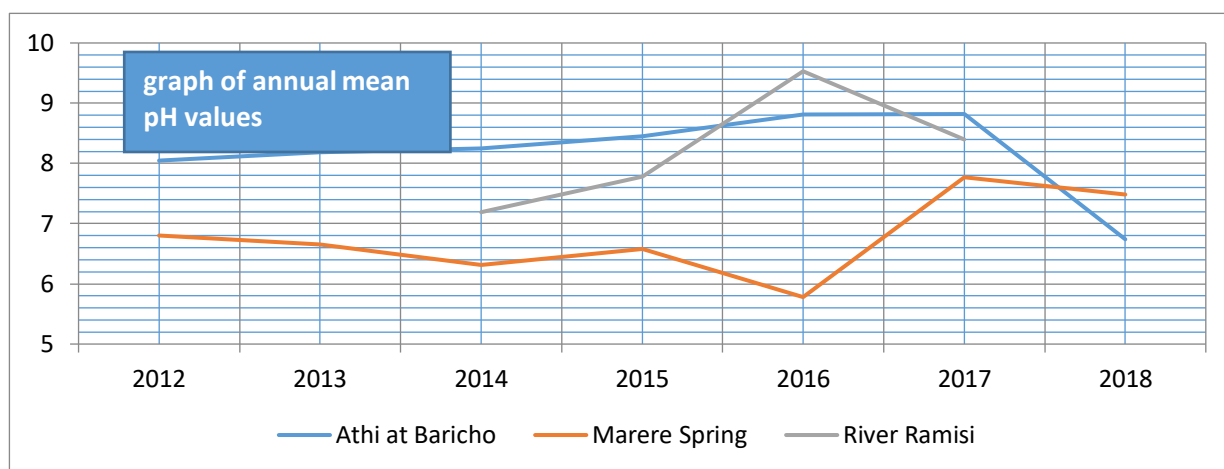
Figure 5.14: PH Trend for selected stations

- pH values in Athi River at Baricho (3HA13) remained relatively constant between 2012 (pH 8.18) and 2014 (pH 8.25) after which a gradual gentle increase is noted until 2016 (pH 8.25 to 8.81) before a decrease in the average value of 8.82 in 2017. The highest value for the station has also been recorded in 2017 at 9.3. This is an indication of increased loading of the river with basic chemical materials from upstream locations from a combination of point and non-point sources. Adequate corrective measures should be done upstream. The value of 2018 was taken during the wet season and this explains the low value.

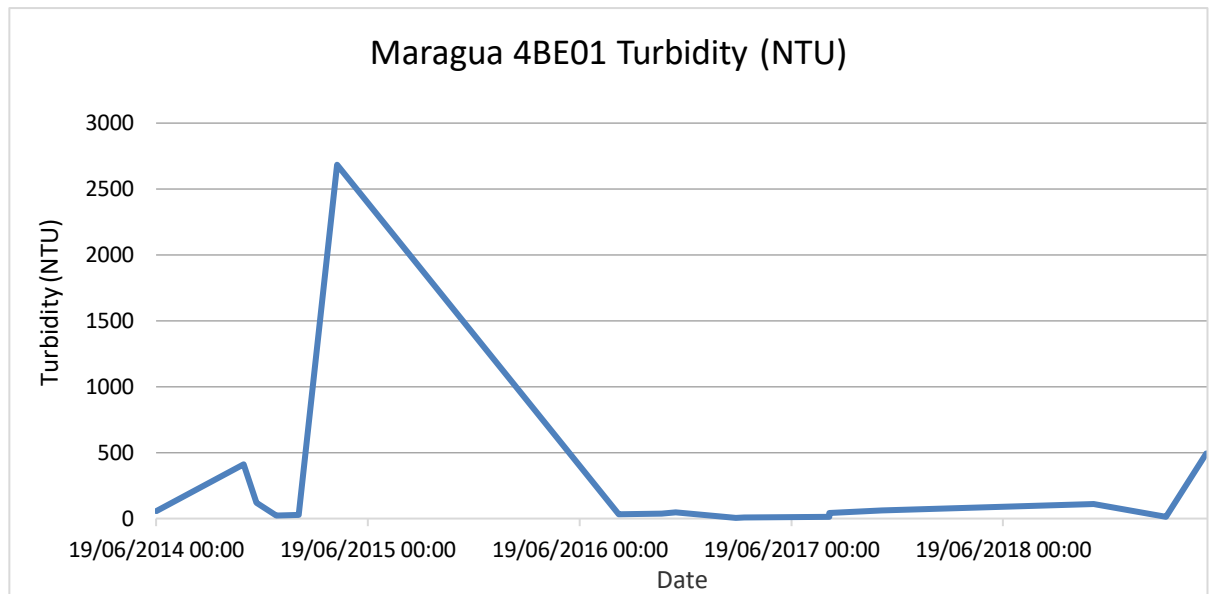
Figure 5.16: Year to Long Term Comparison for 4DA02, 4BC05 and 4BE01

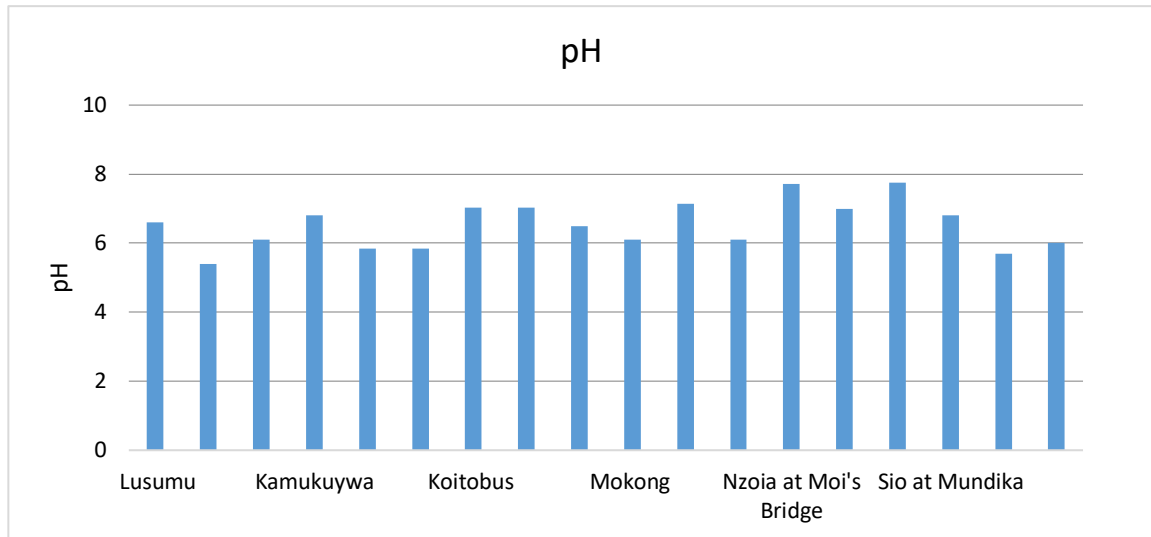
During the year under review, average pH ranged from 5.4 to 7.74 compared to 6.33 to 7.25 in previous year. Stations with relatively high pH included R. Rongai, Nzoia at Moi's Bridge and Noigamaget. All these are belonging to the larger Nzoia system. Stations with relatively lower pH included R. Garagoli, R. Yala at Tindinyo and Kimondi. Again, these happened to be all in the Yala system. Yala system therefore appeared to be generally slightly acidic than the Nzoia system. WHO has put pH range from 6.5 to 8.5 as the acceptable range for drinking water. There were no reported cases of negative impacts as a result of unfavourable pH. Figure 4.4. 3 shows pH for some of the stations in the region during the year under review

Figure 5.17: Average pH for selected stations in LVNCA

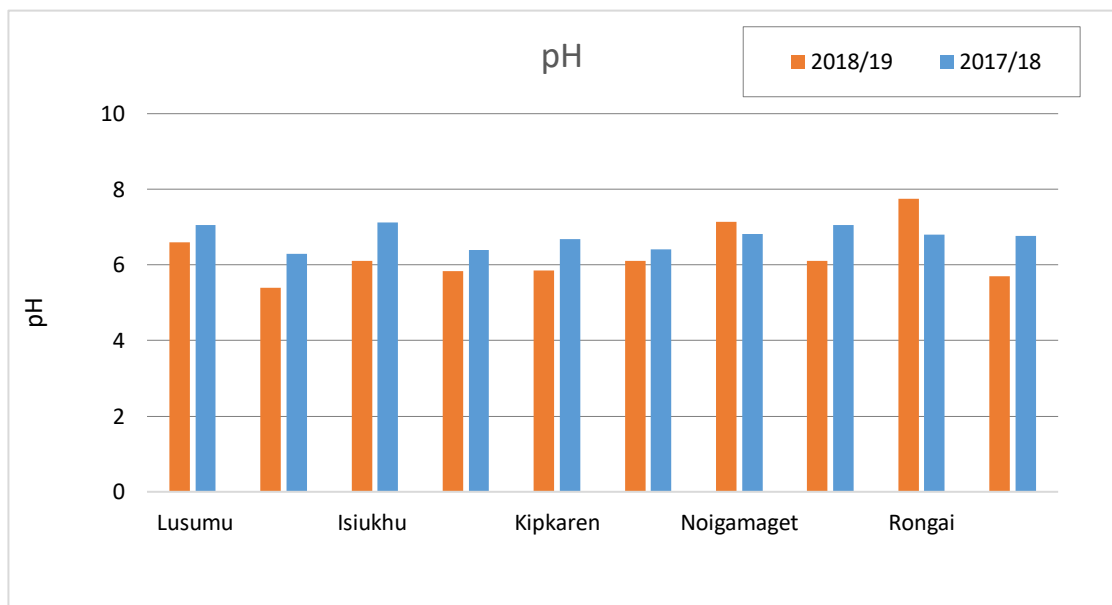
Compared to the previous year, pH in the year under review was lower than in the previous year in many of the monitored stations. This is illustrated in figure 4.4.4

Figure 5.18: Annual average pH for some key stations during 2017/18 and 2018/19

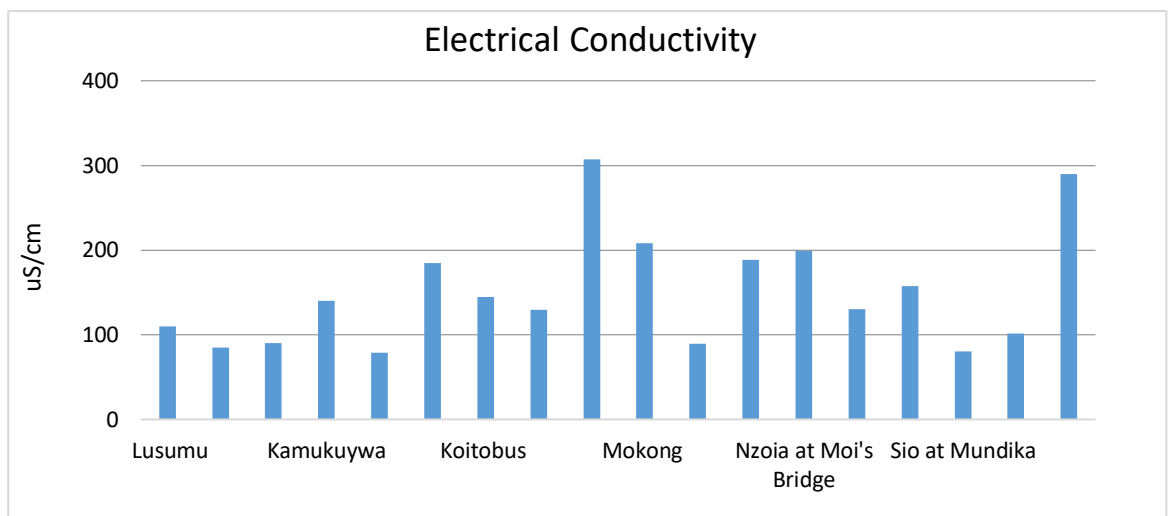
During the year under review the average Electrical Conductivity ranged from $78.8 \mu\text{S}/\text{cm}$ – $307 \mu\text{S}/\text{cm}$ with an average of $150 \mu\text{S}/\text{cm}$. The low range of Electrical Conductivity signifies low mineral contents in most of the surface water. WHO thresholds for drinking water is $2500 \mu\text{S}/\text{cm}$. Figure 4.4.5 shows the Electrical Conductivities for some stations in LVNCA.

Figure 5.19: Electrical Conductivity surface water for some stations

Stations with relatively high Electrical Conductivity were Moiben, and Sosiani. Sosiani drains Eldoret town and therefore the impacts of the town and its wastewater treatment facilities could be the reason for high EC. Low values were observed in the Yala system of Garagoli and Kimondi. Low average Conductivity was also observed in R. Sio.

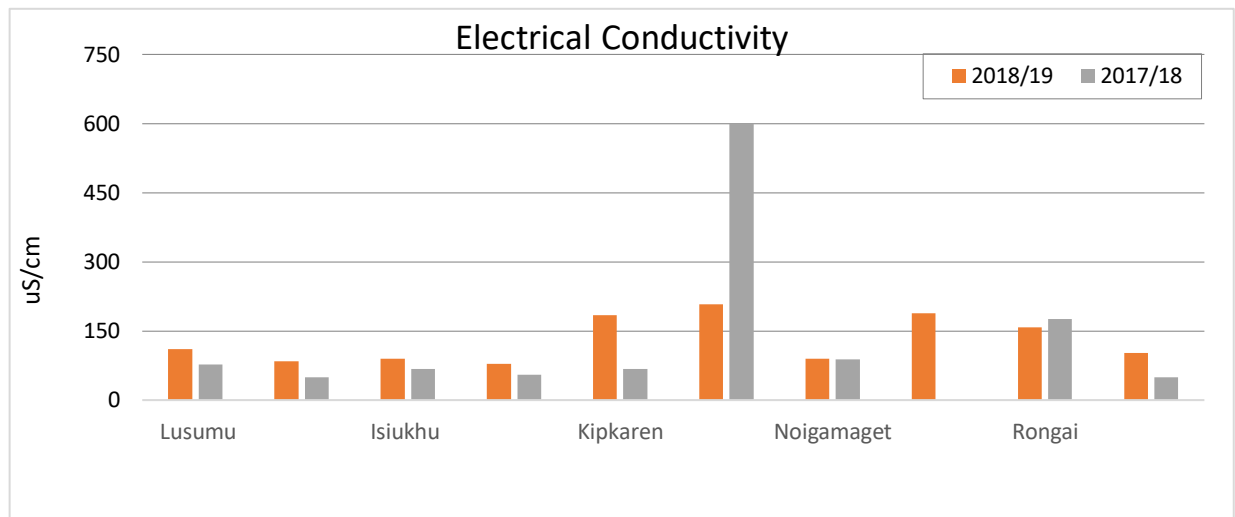
Compared to the previous year, no trend was established as there were stations that recorded higher values in the previous year while others recorded lower values. Outstanding observations were in R. Mokong and Kipkaren where the differences were so unique. This is represented in figure 4.4.6

Figure 5.20:Electrical Conductivity for selected rivers in 2016/17 and 2017/18

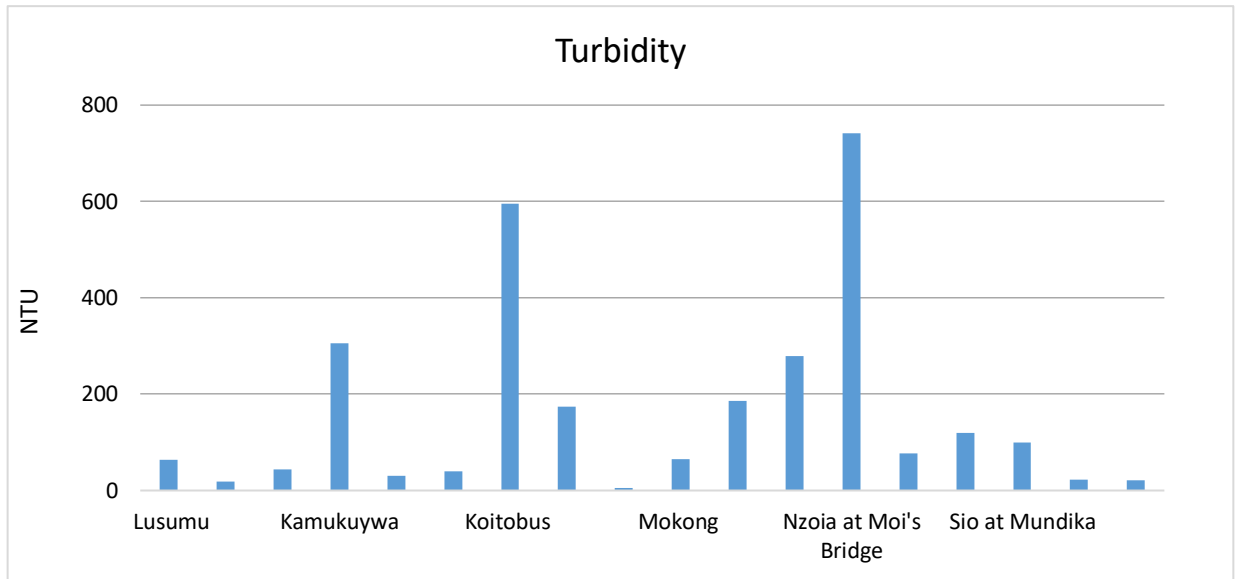
Figure 4.4.7 shows the average Turbidity for some major stations in the catchment during the year. The average turbidity ranged from 5.3 NTU to 740 NTU at Moiben and Moi’s Bridge respectively. Stations with high average Turbidity were R. Nzoia at Moi’s Bridge, Koitobus and Kamukuywa. The range was much higher than those observed in 2017/18. This could be due to the surface run off occasioned by the rains and facilitated by other factors in the catchment. The rivers which were relatively clear during the year included Moiben, Garagoli, Sosiani and Yala at Tindinyo.

Figure 5.21: Average Turbidity for some rivers in LVNCA

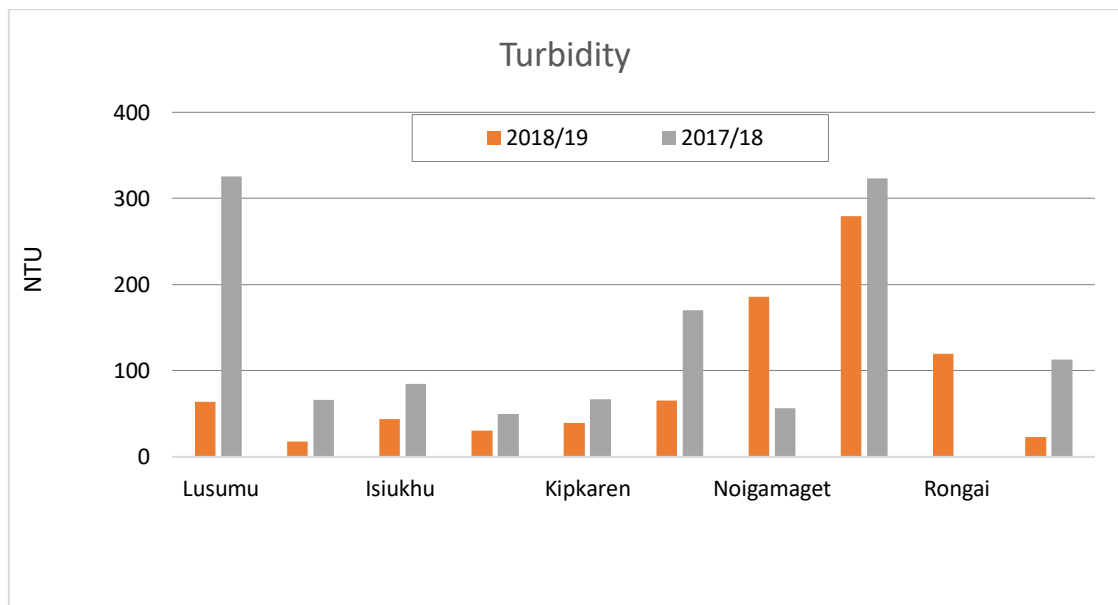
Compared to the 2017/2018, there was a general drop in Turbidity in 2018/19 compared to 2017/18 as shown in figure 4.4.8. Large differences were however observed R. Lusumu, Mokong and Tindinyo. The three stations recorded significantly low turbidity during the year.

Figure 5.22: Turbidity of some of the stations.

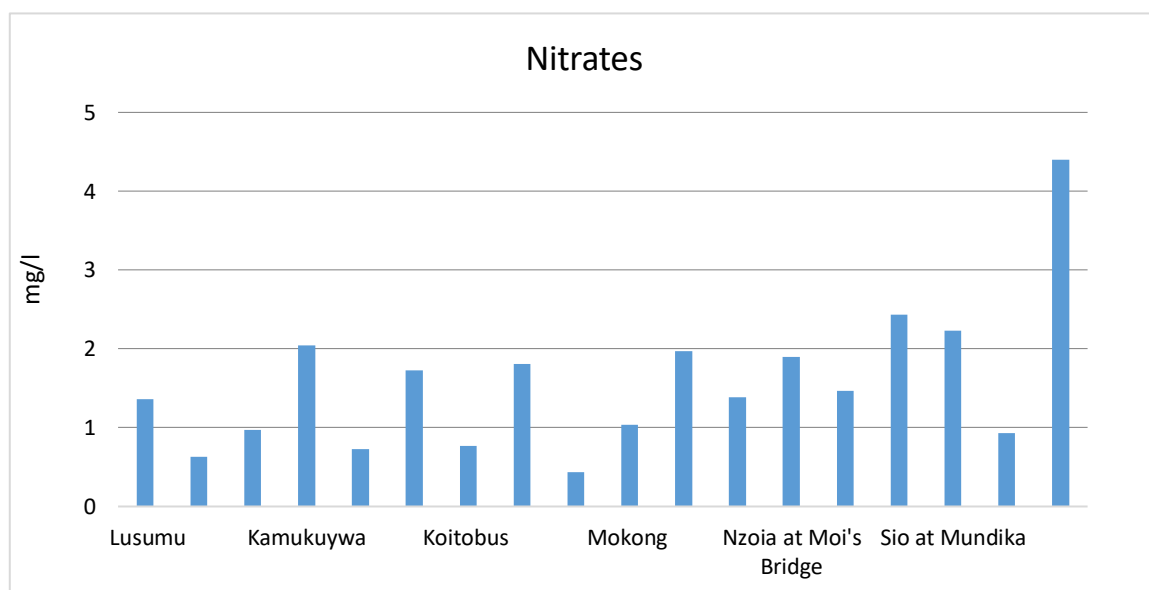
Figure 5.23: Concentrations of Nitrates

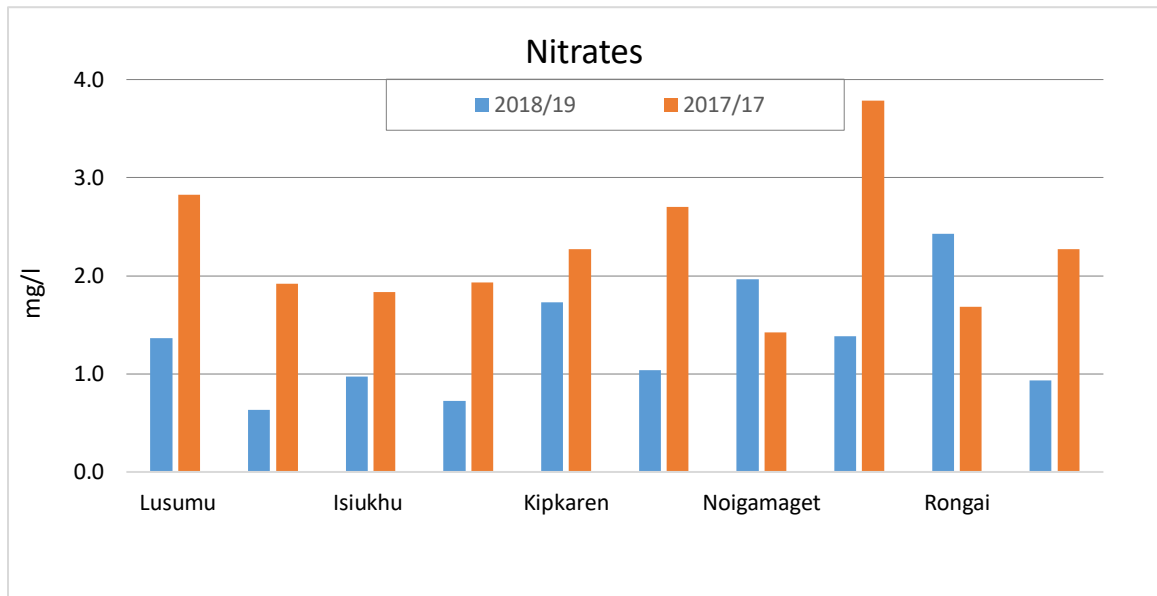
Figure 5.24: Concentrations of Nitrates in 2018/19 and 2018/19

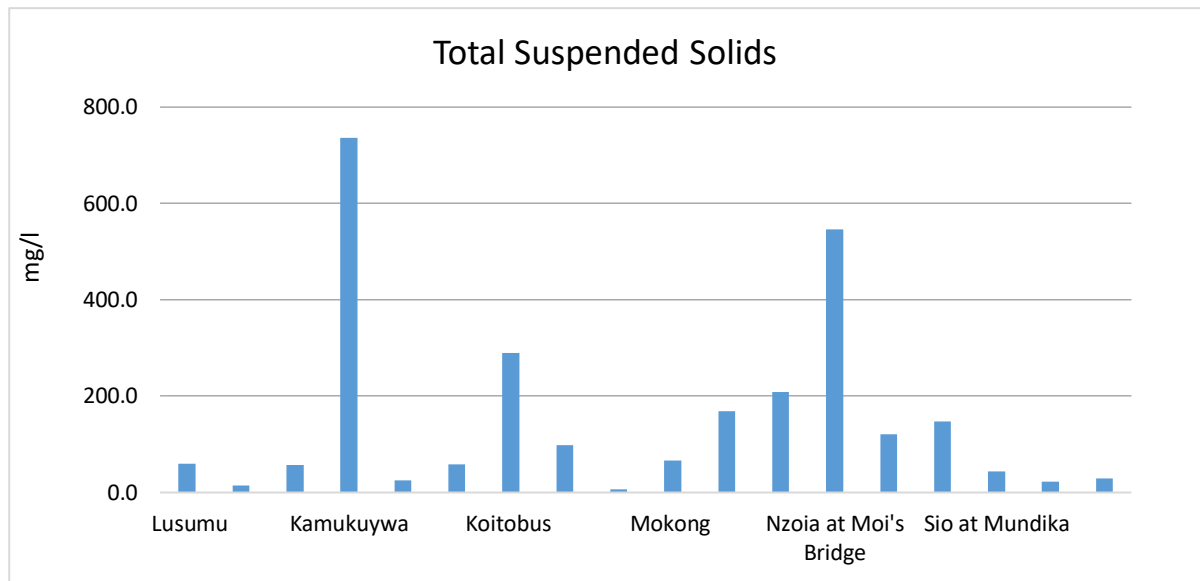
Figure 5.25: Average annual concentrations of TSS

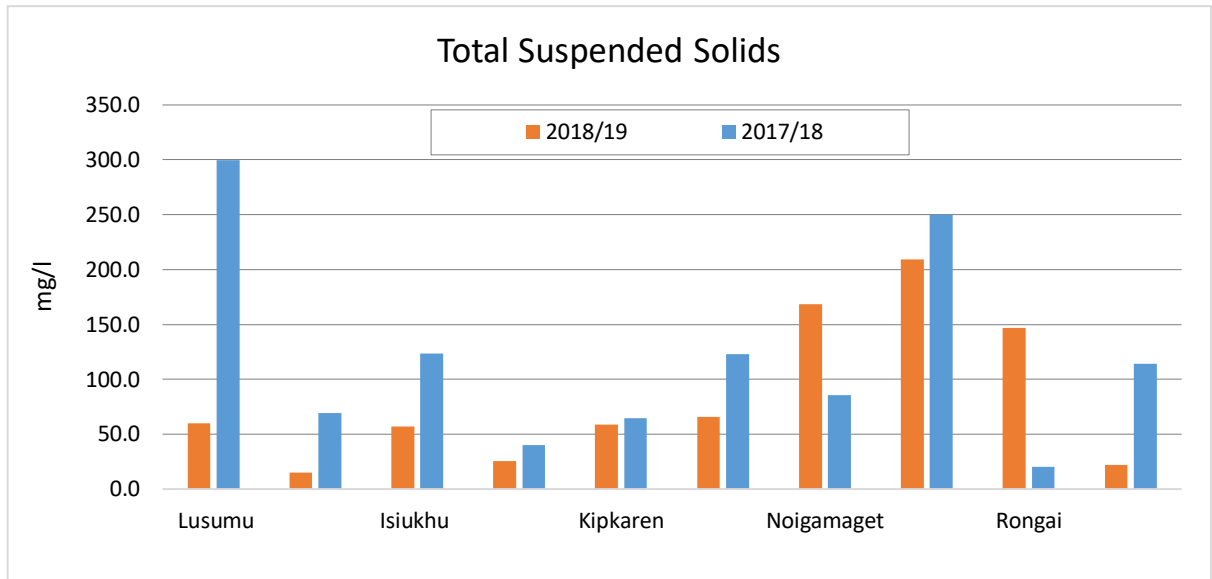
Figure 5.26: Concentrations of TSS in 2016/17 and 2017/18.

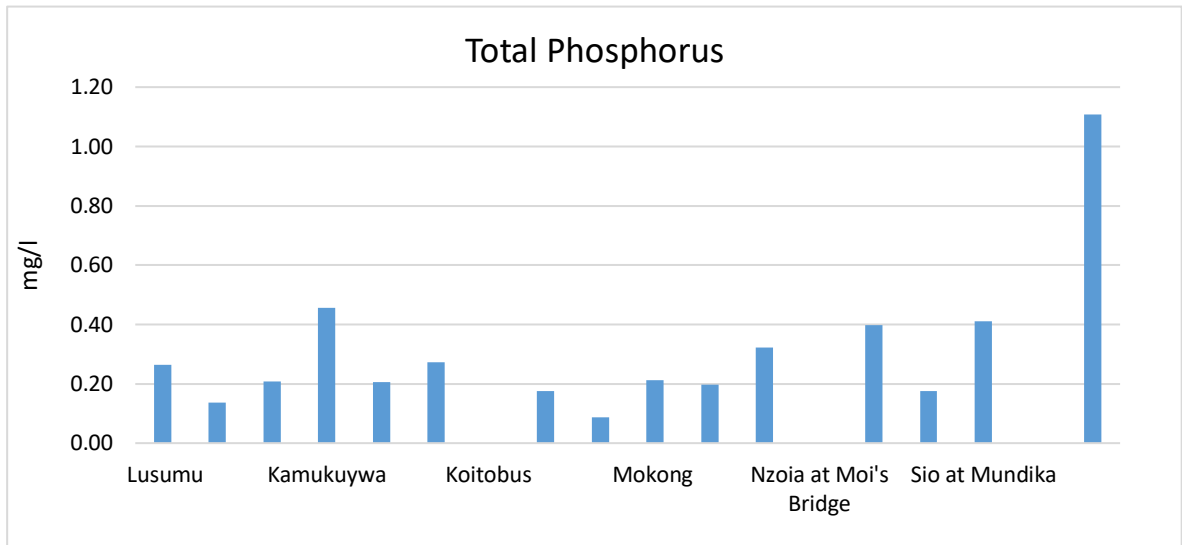
Figure 5.27: Annual average concentrations of TP for some rivers in LVNCA

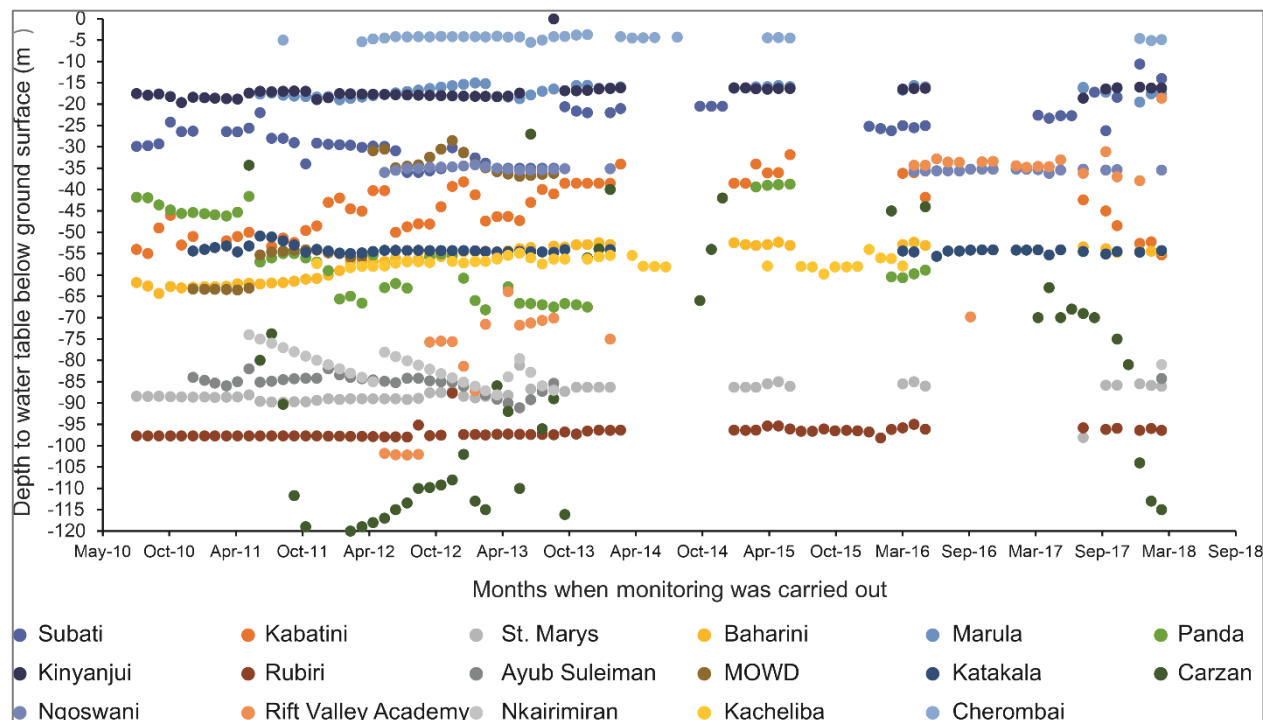
Figure 7.2: Rift Valley Basin Monitoring wells level trends for over 8 years

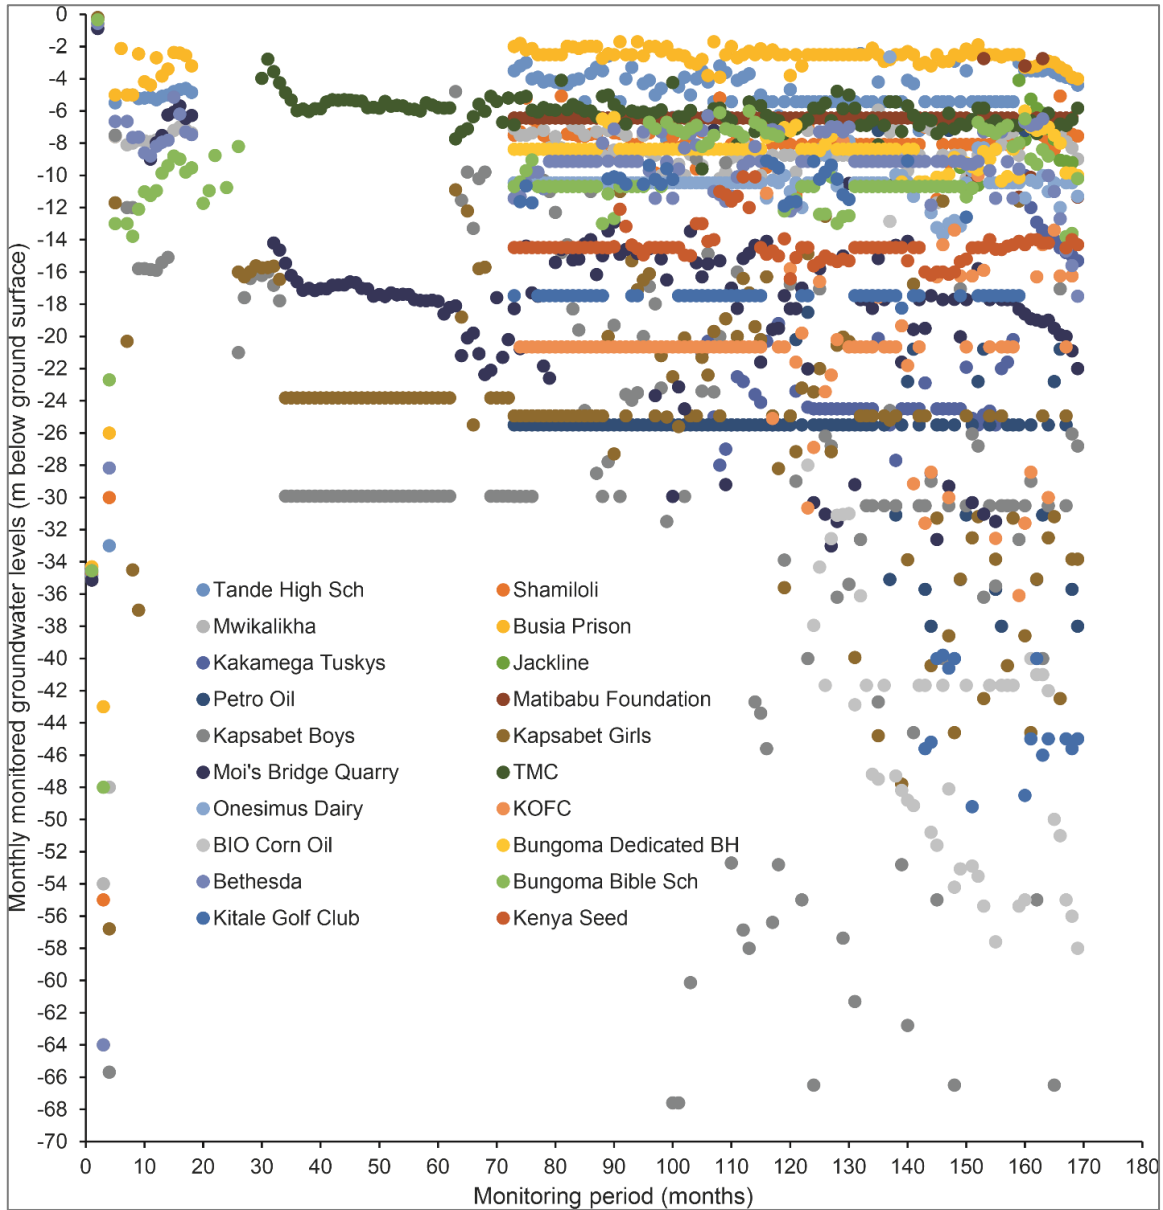
Figure 7.4: Lake Victoria North Basin area monitoring well trends for over 14 years.

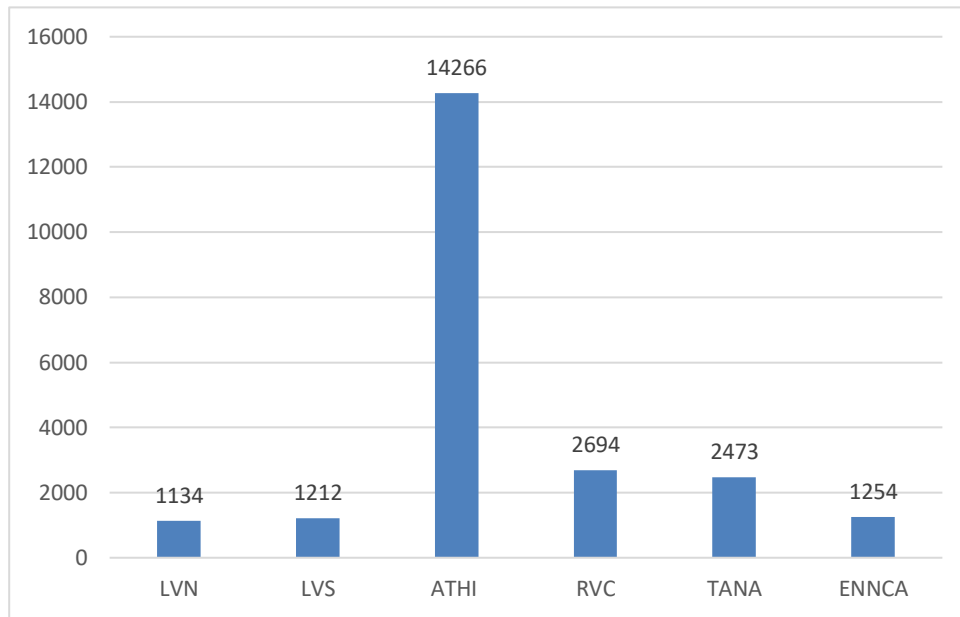
Figure 9.2: Cumulative authorizations by June 2019

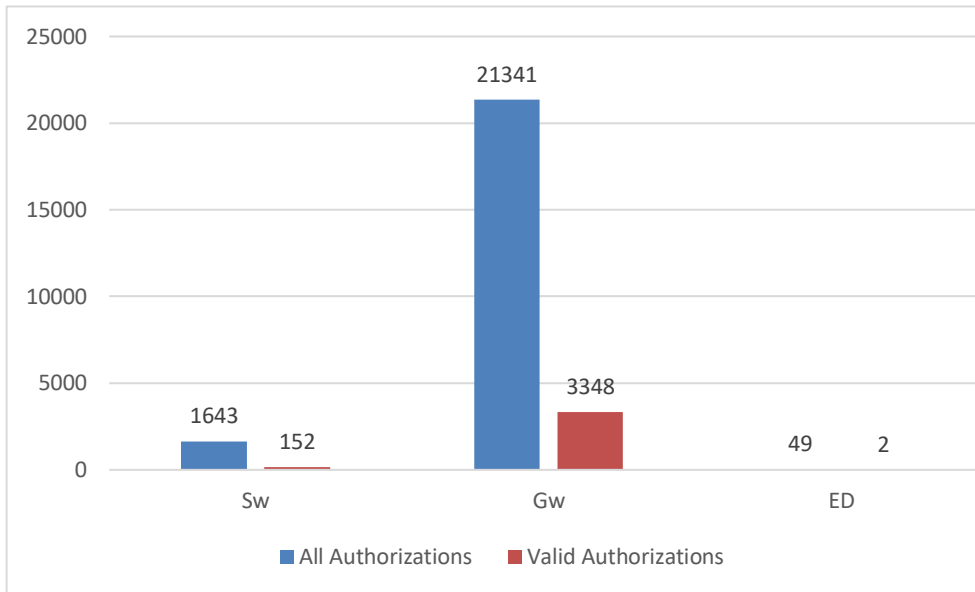
Figure 9.3: Comparison of Authorizations and Permits per region June GW/SW

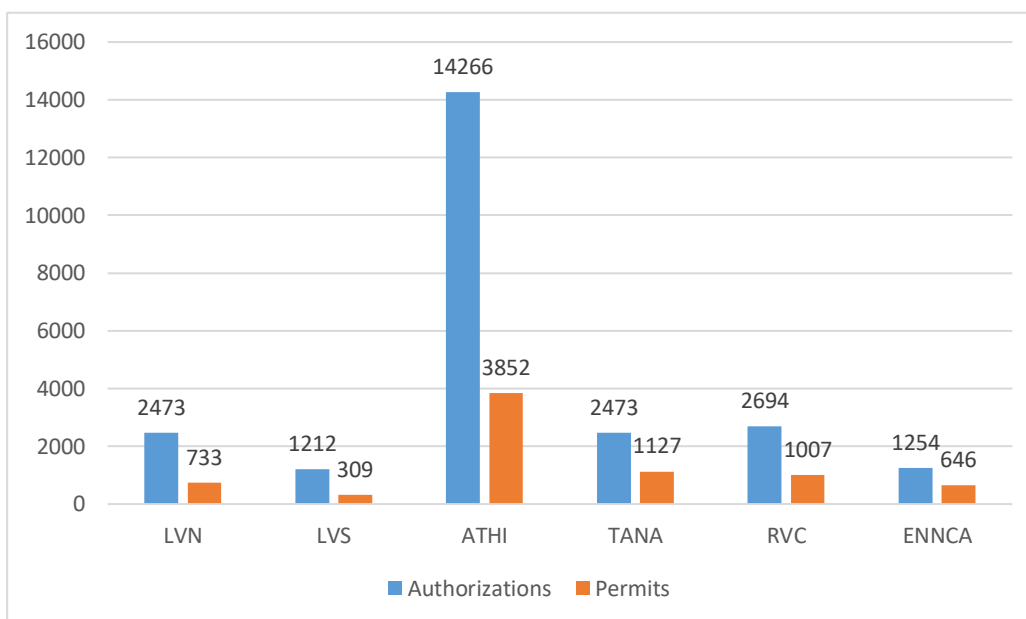
Figure 9.4: Comparison of Authorizations and Permits per region June 2019
