# **WATER RESOURCES SITUATION REPORT**

July 2019 to June 2020

**AUGUST 2020**

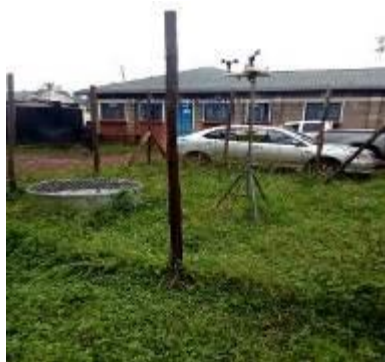
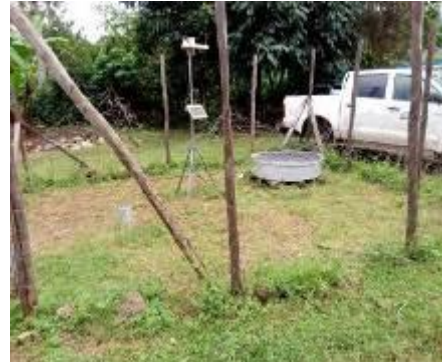
Figure 2.2: Maintenance of the Muranga Water Supply Met station (9037109)

Before Maintenance

During Maintenance

After Maintenance

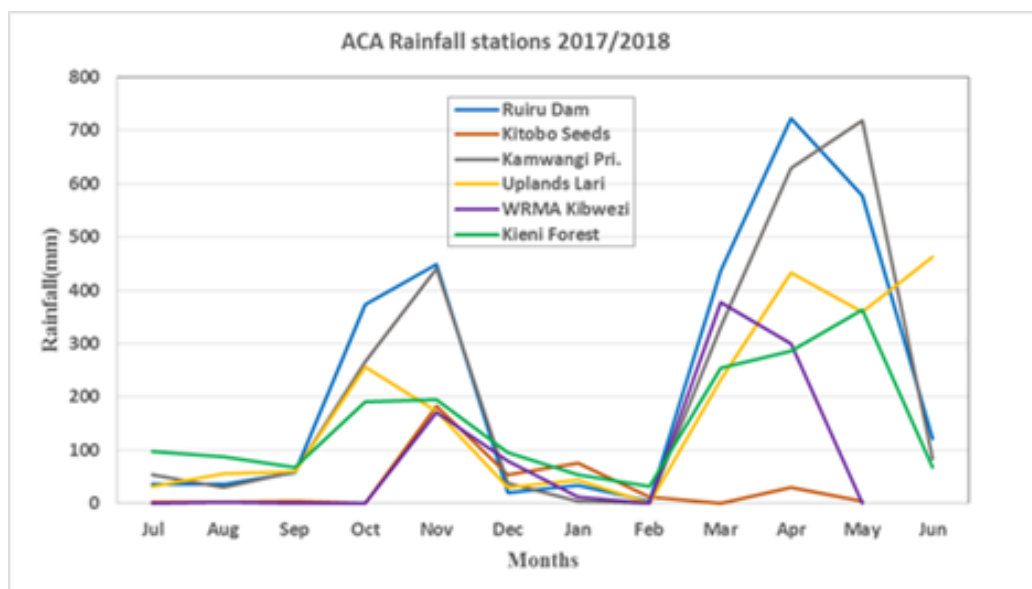
Figure 2.3: Monthly Rainfall totals for selected stations in Athi Basin for FY 2017/18

A comparative analysis of rainfall received from six monitoring stations within Athi catchment during the year under review is shown in Figure 2.3.

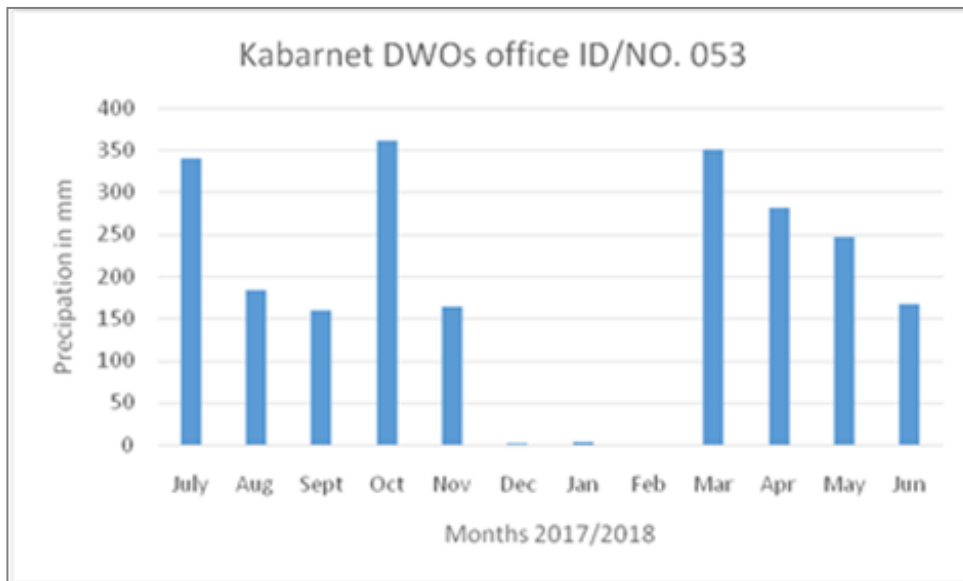
Figure 2.9: Kabarnet Water Yard Rainfall trend

Rift valley basin generally received high rainfall especially during the long rains of March to June season. Figure 2.9 shows monthly total precipitation at Kabarnet Water Yard for the period July 2017 to June 2018.

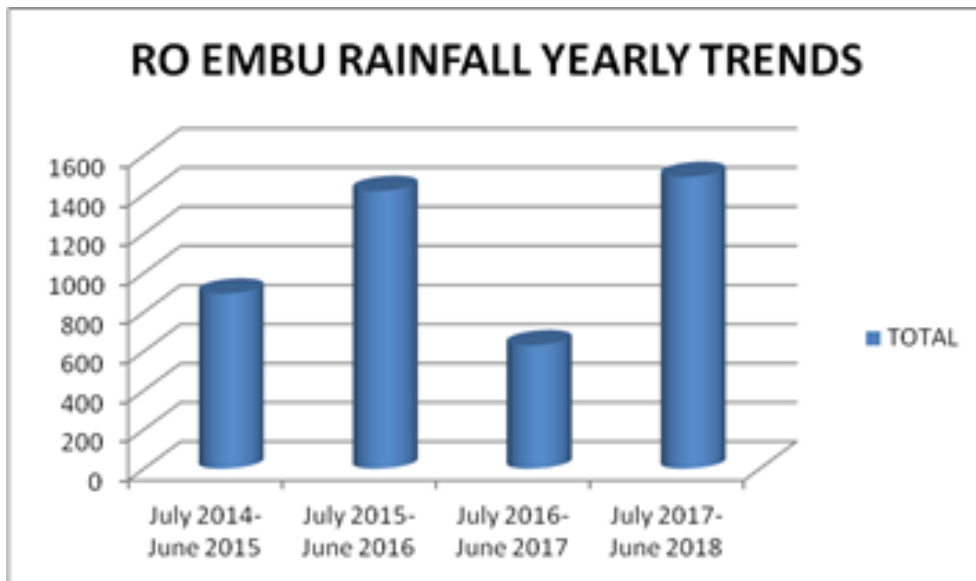
Figure 2.30: Embu RO Office Met Station 4 Yearly Trends

From Figure 2.10, the rainfall of 1,490mm received during in the FY 2017/ 2018 was higher than the previous three years. The lowest rainfall recorded during these four years was 630mm for the FY 2016/2017.

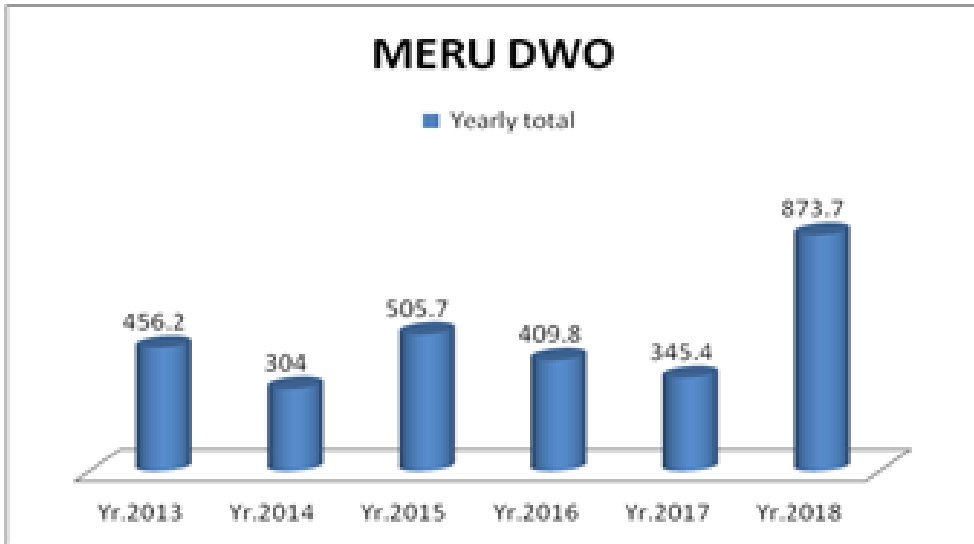
Figure 2.41: Meru DWO Rainfall station- Yearly Trends

A comparison of total annual rainfall in the last six years at Meru DWO rainfall station is given in Figure 2.11. The year 2018 had the highest rainfall with a total of 878.7mm while 2014 had the lowest total of 304mm. Flash floods were experienced in the months of April and May 2018.

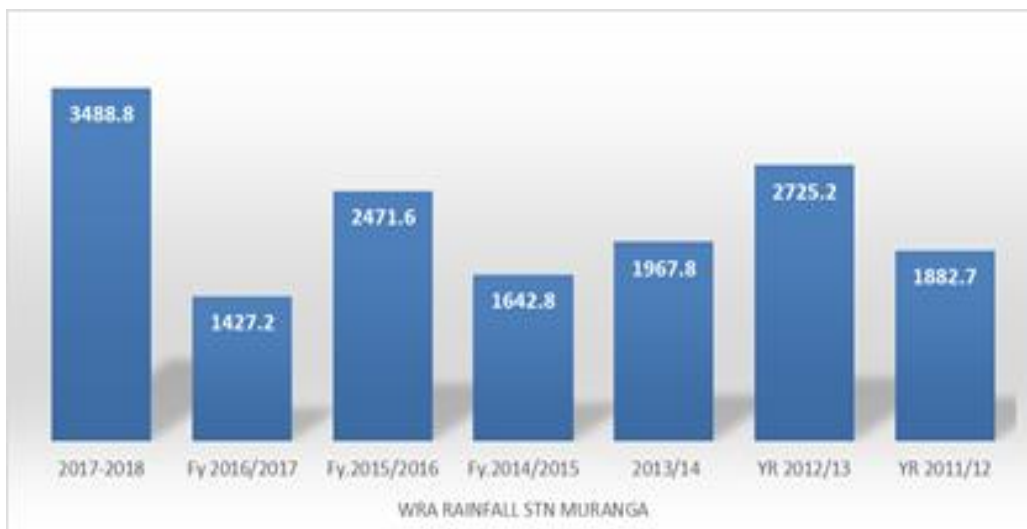
Figure 2.52: Murang'a DWO 9037109 Monthly Rainfall

Rainfall trends for the last seven years at Murang'a DWO rainfall station are shown in Figure 2.12. The highest rainfall of 3488.8mm was recorded in the period 2017/2018.

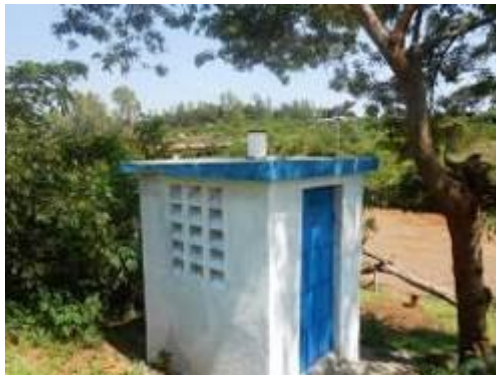
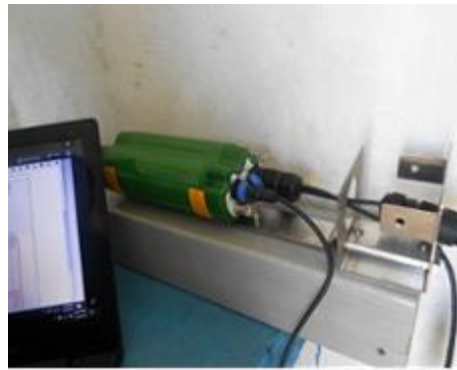
Figure 3.2: Recorder house and Equipment at RGS 1FG02 Yala River

The Yala River RGS 1FG02 is situated at the Bondo Water Supply Intake at the road crossing for Siaya Bond Road approximately 15 km for Siaya Town. This is a National station but it had not been upgraded and was only having manual gauges. The station was assessed in February 2017 for the purpose of upgrading. A Recorder house was constructed in August 2017 and the equipment installed on 17<sup>th</sup> September 2017. The equipment consists of a water level, rainfall and temperature sensors. Data is logged on hourly basis and transmitted to the server once every 24 hours.

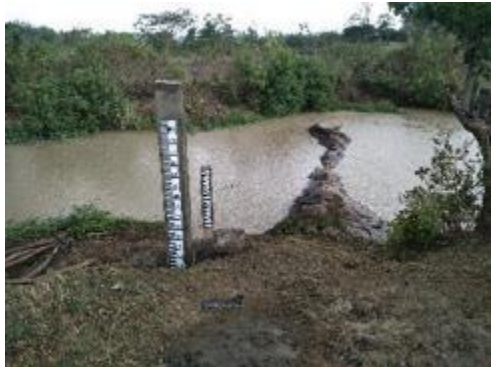
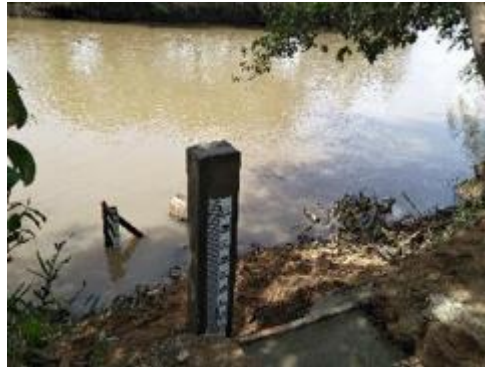
Figure 3.3: Rehabilitated RGSs 1AD02 Malakisi (left) and 1DA01 Nzoia at Webuye (right)

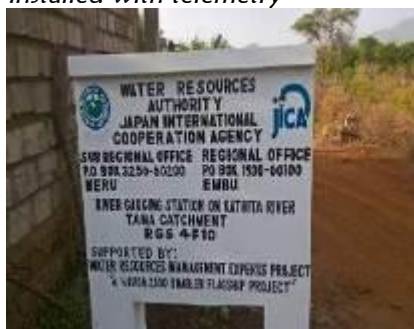
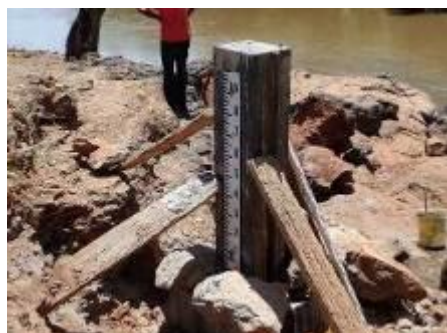
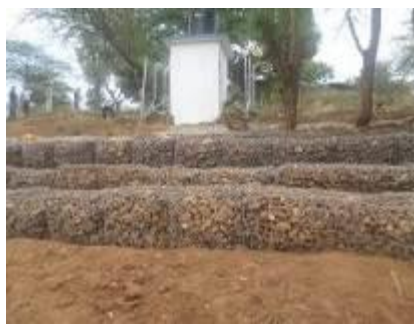
*4F10 Kathita rehabilitated and installed with telemetry*

*Logger at Chania canal of Sasumua dam.*

Figure 3.4: Rehabilitation of RGSs 4BE10 Tana at Rukanga (left) and 4F10 Kathita (middle) and Chania Canal (right)

Thirteen RGSs were rehabilitated including Tana Rukanga 4BE10, Thiba 4DD2, Kathita 4F10, Rupingazi 4DC6II, Rupingazi 4DC3, Thingithu 4F17, Thangatha 4F08, Mutonga 4EA6, URA 4F09, Amboni 4AB06, Maragua 4EB1, Garissa 4G01 and Garsen 4GO2.

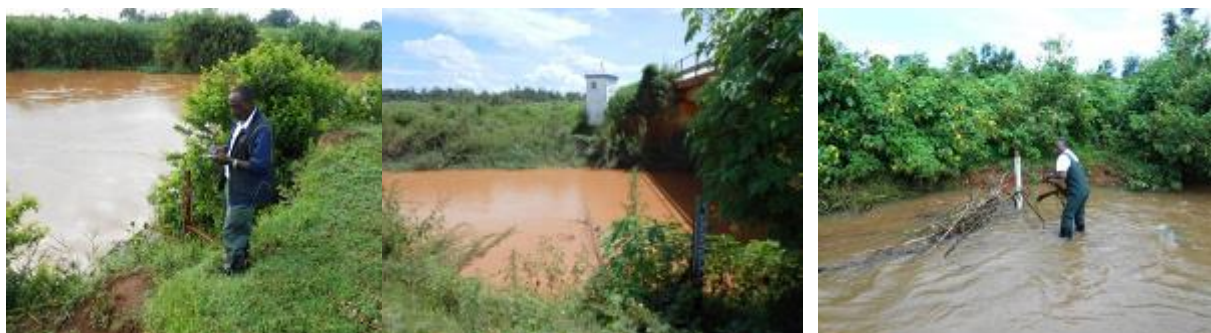
Figure 3.5: RGS Assessment: left and Centre 1EF01, Nzoia at Ruambwa and 1HA01Sio River respectively

Gauging campaigns are done to validate and improve rating equations. The gauging plan for the regions entails sustained discharge measurement at the newly installed or rehabilitated stations in order to develop and/or improve the rating curves. This was done quarterly by the regions but the data needs to be entered in the database for updating of the rating curves. Monitoring stations were maintained across the regions as follows; Lake Victoria North basin carried out maintenance at 10 stations while Tana basin monitored 30 RGSs. Special gauging campaigns were carried out in Athis basin by EGIS consulting firm at Uмба River 3KG01, Mwena River, Ramisi River 3KB1, Pemba/Manolo 3MH, Mwache River and Chigutu River.

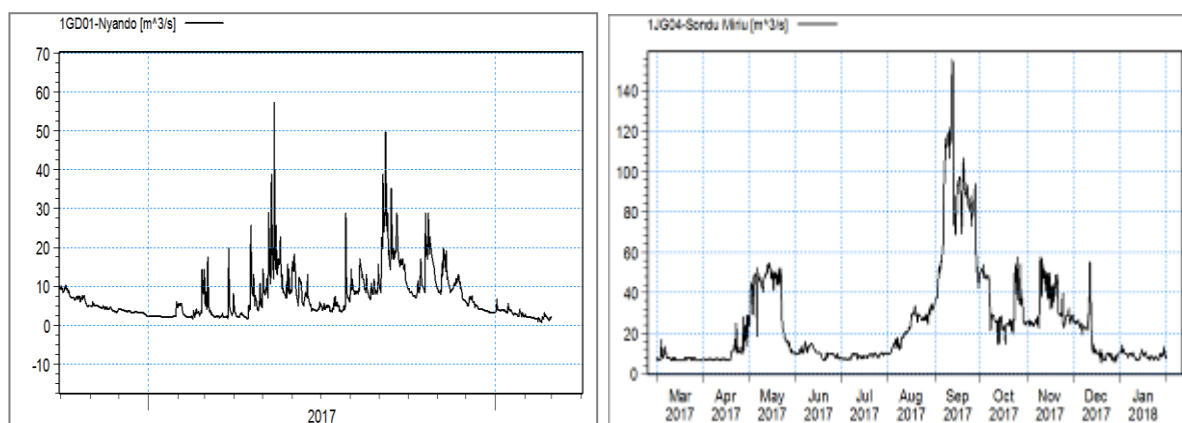
Figure 3.6: Streamflow hydrographs for Nyando 1GD03 and Sondu river 1JG04

1LA04 Marai, 1LA07 Sand River, 1LA08 Talek, 1LA03 Nyangores, 1LB02 Amala in Mara River basin, 1JA02 Kiptiget 1JG04 Sondu in Sondu River basin, 1GB05 Ainamutua, 1GB06A Mbogo, 1GC06 Kipchorian, 1GD02 Nyando, 1GD07 Nyando in Nyando River basin, 1HA14 Awach - Kajulu, 1HA11 Nyamasaria in Nyamasaria basin, 1HA01 Great Oroba, 1HD05 Awach Kasipul, 1HD06 Eaka Kioge in Tende Kibuo basin, 1HE02 Mogusii in Tende basin and 1KB12 Gucha in Gucha Migori basin were analysed.

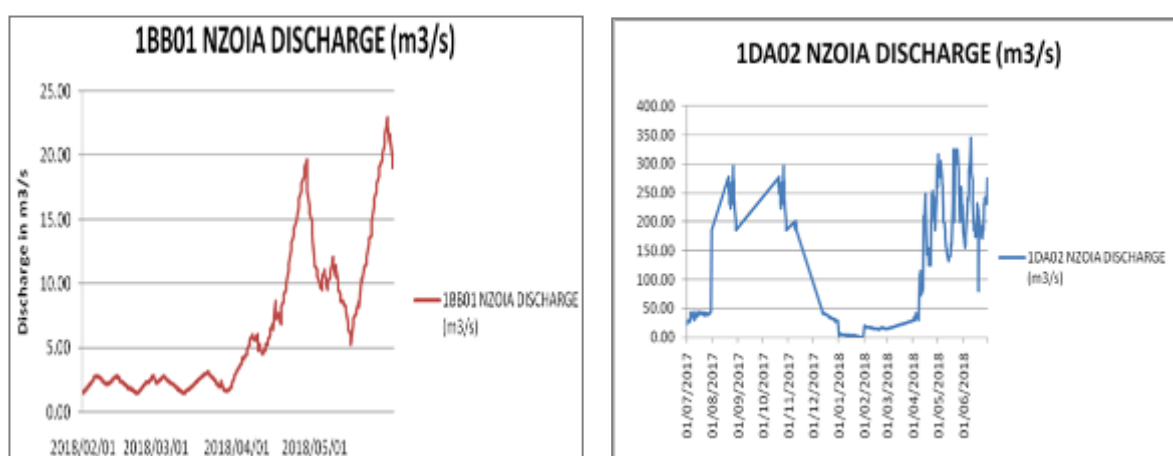
Figure 3.7: Streamflow variability at Nzoia river 1BB01 and 1DA02

Stream flow analysis for FY 2017-18 was dictated by data availability. Six stations were analysed, i.e. Malakisi River 1AB01 and Nzoia River 1DA02. 1BB01 Nzoia River. The analysis show that there was more flow in the year 2018 compared to 2017 at all Rivers monitored.

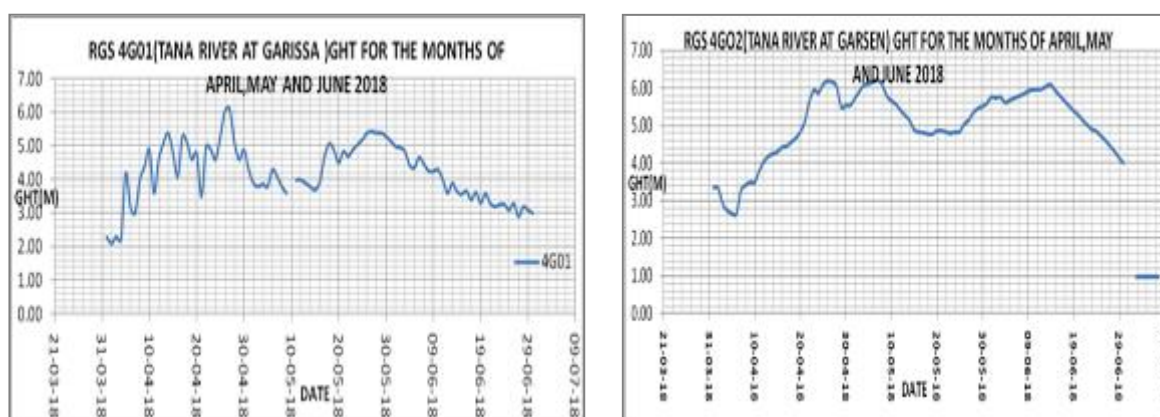
Figure 3.8: Water level hydrograph at Tana river 4G01 and 4G02

Analysis of water level hydrographs at Tana River 4G01 at Garissa and 4G02 at Garsen between the months of April and June 2018 shows that there was a steady rise at the beginning of the period and that the water level was maintained well above 3.5m which is the flood level threshold.

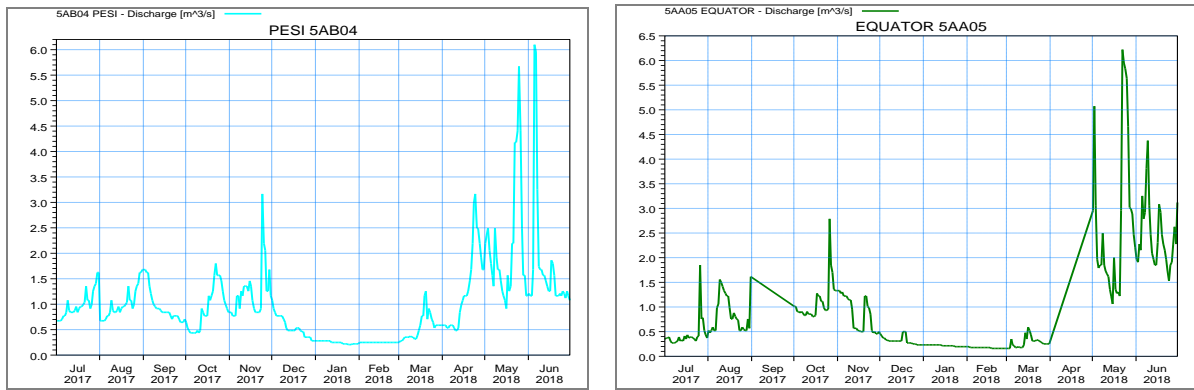
Figure 3.9: Streamflow variability at Pesi River 5AB04 and Equator River 5AA05

The four sub basins analysed depicted almost similar stream flow characteristics throughout the year. Among the three stations in the upper sub basin, Equator River had the highest flow recorded in the month of May 2018 which is contrary to long term mean and previous year 2016/17. This could be attributed to the extra ordinary rains experienced in the upper reaches at the onset of long rain period which extended to the month of June.

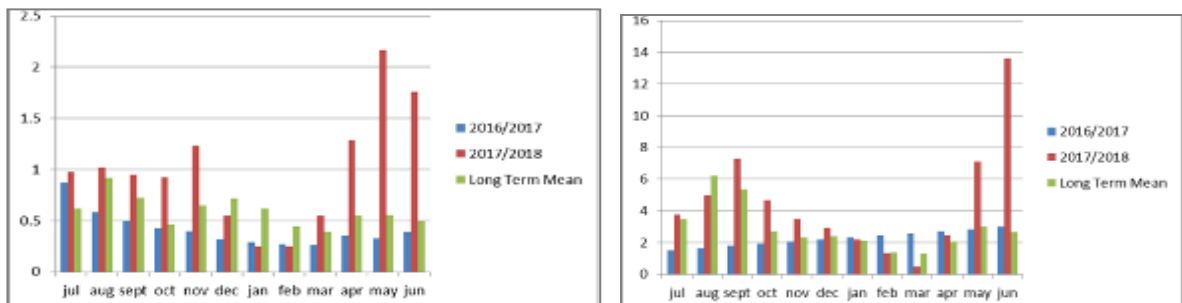
Pesi River had many months having flows more than the long term mean and the previous year. In all the months the mean monthly flows in the period under review for Ewaso Narok River was more than the long term mean and the previous year 2016/2017. The flows as observed gradually increased at the start of the period and rapidly to the end of the review period.

Figure 3.10: Comparison of long term mean flows vs monthly mean flows for FYs 2016/2017 and 2017/2018 at Pesi River 5AB04 (left) and Ewaso Narok River 5AC15 (right)

Temporal comparisons of flow for the year under review with the previous year at the four RGS in the Engare Narok Melghis catchment that is Pesi, Mutara, Equator and Ewaso Narok indicate increase in flow towards the end of the period. This could be as a result of the MAM rains in the sub catchment. The situation could be considered as stable compared to previous season.

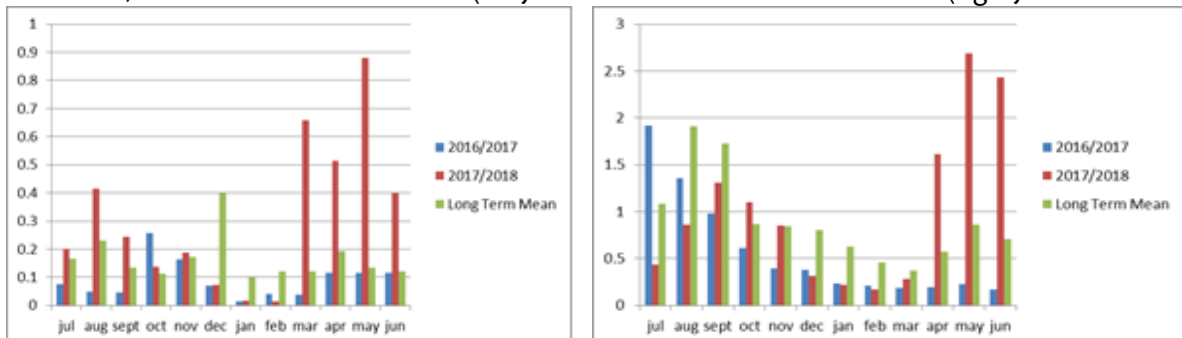
Figure 3.11: Comparison of long term mean flows vs monthly mean flows for FYs 2016/2017 and 2017/2018 at Mutara River 5AD04 (left) and Equator River 5AA05 (right)

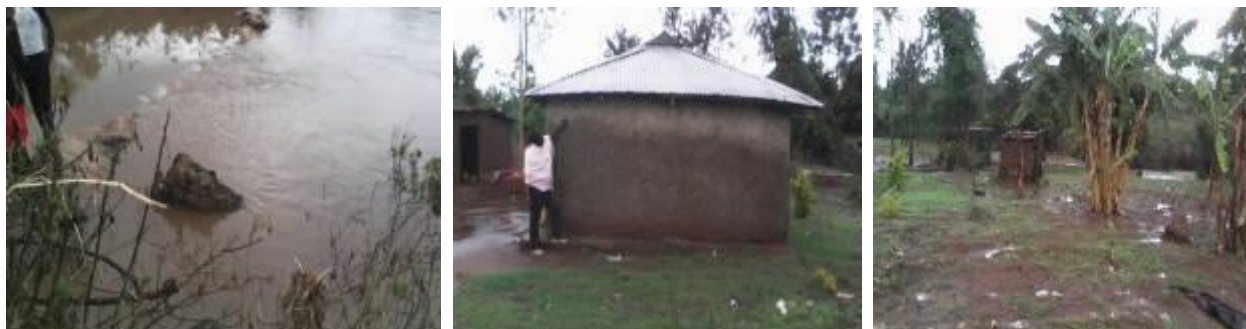
Flash floods were experienced within Malakisi river sub-catchment in mid-March for two days duration (15<sup>th</sup> and 16<sup>th</sup>) after the river burst its banks following a heavy down pour. The flood inundation depth was 1.2m. The floods are exacerbated by catchment degradation and siltation of the dams that were meant to mitigate against the menace i.e. Bukokholo, Butonge and Bitonge. Among the most affected areas were, Malakisi, Matisi (Sirisia Sub-county) and Kengatuyi, Kakoli, Aboloi and Kocholia (Teso North Sub-county). The losses incurred during the floods include; Destruction of maize and beans farms, loss of livestock, temporary displacement, houses being submerged and destruction of RGS station: 1AD02 at Kocholia. Figure 3.12 illustrates the flood menace.

Figure 3.12: Flooding at Kocholia: *Left*- Damaged gauge 1DA02 on Malakisi River. *Middle*- Level of water during the flood at Kocholia. *Right*-One of the maize farms destroyed by flood

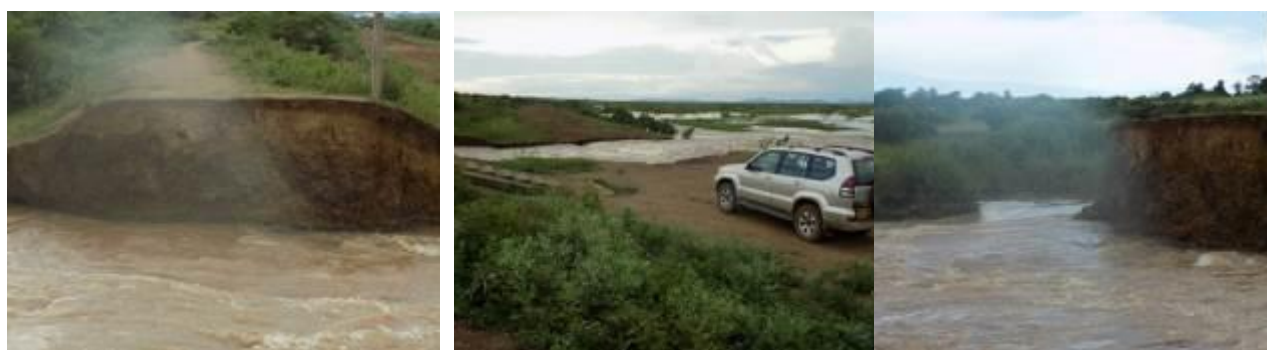
The remaining portions of the dyke seemed to be considerably weakened and likely to breach in case the rains continued, thereby threatening further the Dominion Farms and the nearby villages.

Figure 3.13: Flooding in Lower Nzoia: *Left*-Breached Dyke at Dominion. *Middle*-Flood flow into the farms. *Right* - Diverted river flow

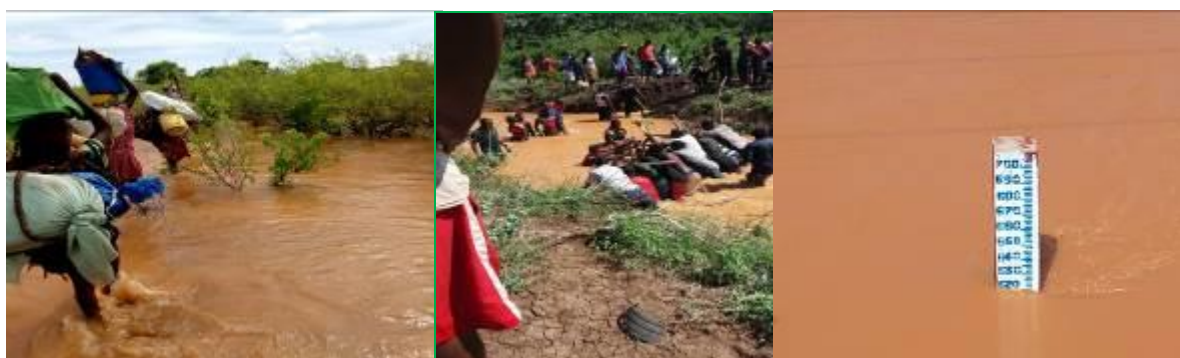
During the period under review, there were heavy rains in Meru, Kitui and Mwingi that resulted in massive flooding in Garissa and Tana River Counties. The flooding resulted in damage to infrastructure and displacement of populations. In Garissa County, the damages due to flooding were quantified as 2 submersible pumps at the GAWASCO intake lost, 42m length of 6" diameter rising mains at Ziwani borehole site washed away, 3km of distribution network ranging from 6" to ¾" diameter washed away, 4 boreholes at Ziwani submerged, old sewerage system blocked, causing backflow of sewage, about 1400 pit latrines collapsed, ponds for new effluent treatment plant submerged and water supplies along the Tana river either submerged, pumps washed away or made inaccessible.

Figure 3.14: Flooding in lower Tana: *Left*- community relocating at Garsen. *Middle*-Flood surveillance team at Salama location in Garissa farms. *Right* – RGS 4G04 water level above 6m

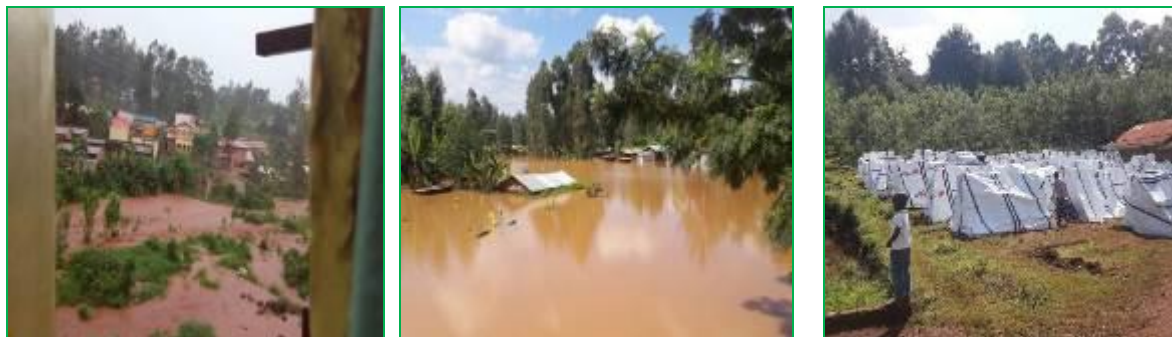
Normal to above normal rainfall episodes were experienced in the upper parts of the basin. This caused floods at different parts of the basin. At Riagicuna village of Kirinyaga East Sub County, depressed site experienced oozing of Sub surface water way after the rains had subsided. The water filled the swamp and streamed to the nearby farms destroying crops and feeder roads.

Figure 3.15: Flooding in Upper Tana: *Left*- Flooded parts of Murang'a town. *Middle*- Thiguku village in Kerugoya. *Right* – Evacuation site for Thiguku flood victims

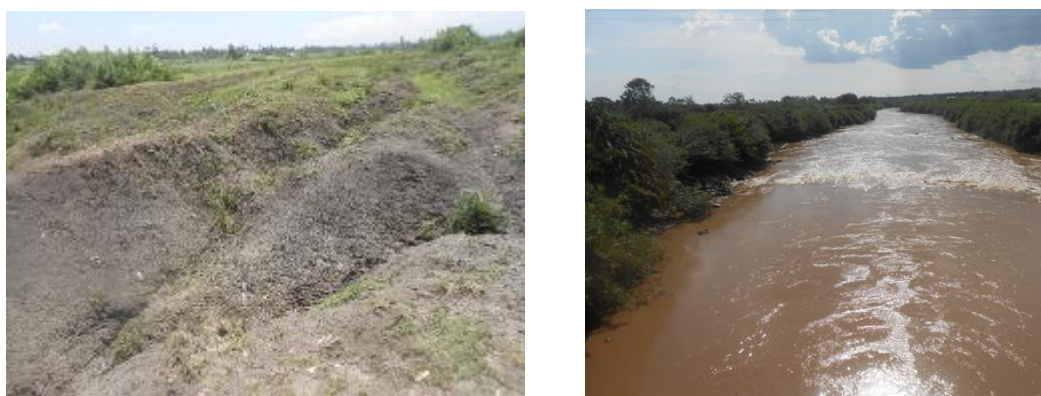
A physiographic study was carried out in January 2018 for the Nzoia River Basin to model erosion generation within the catchment in order to identify major erosion hotspots. The study also prioritized Water Resource User Associations (WRUAs) in the Nzoia Basin in terms of the sedimentation risk they pose to the Lower Irrigation Scheme.

Figure 3.18: Gullies within Mid Nzoia (left) and Nzoia River downstream of Musanda Bridge (right)

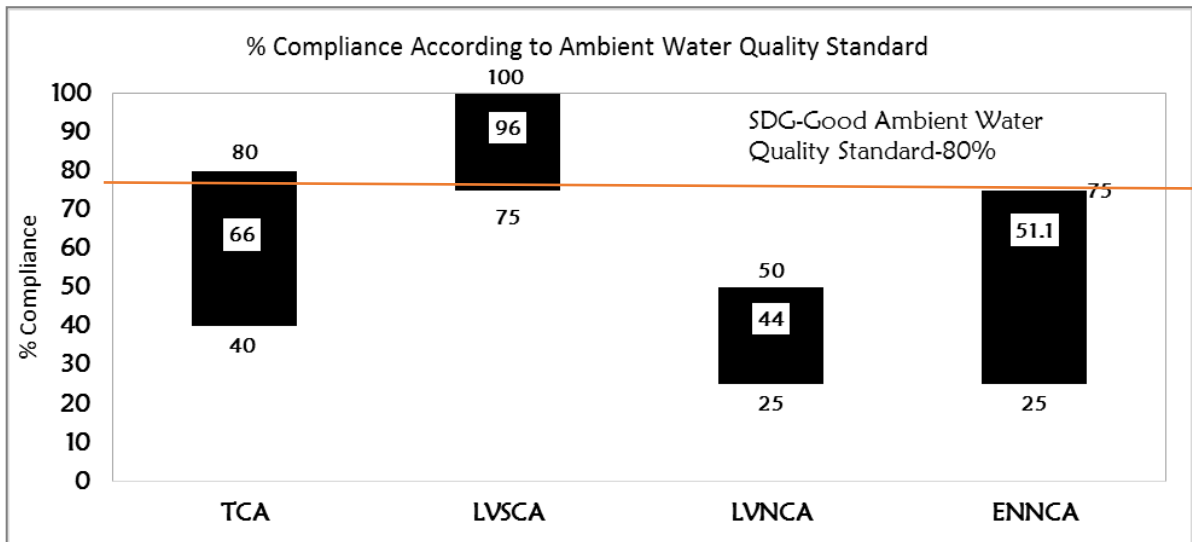
Figure 4.4: The ranges and mean (white values) performance in compliance of the station in each region to ambient water quality standards. The maximum value are on the top and minimum value on the bottom

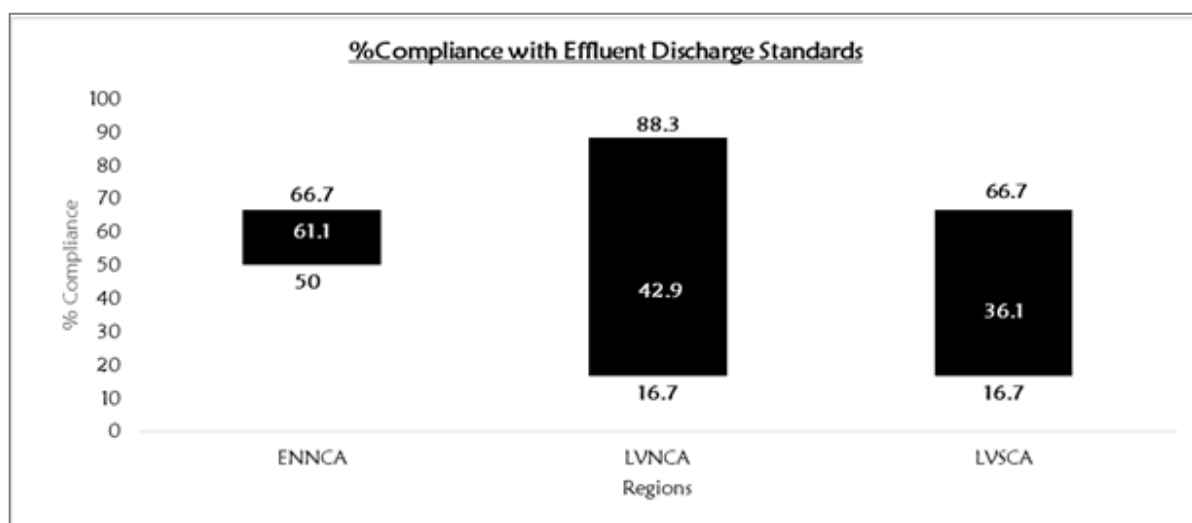
**Figure 4.7:** Compliance of the Effluent Dischargers to Effluent discharge Standards into water resources (WRM Rules 2007 Schedule 3)

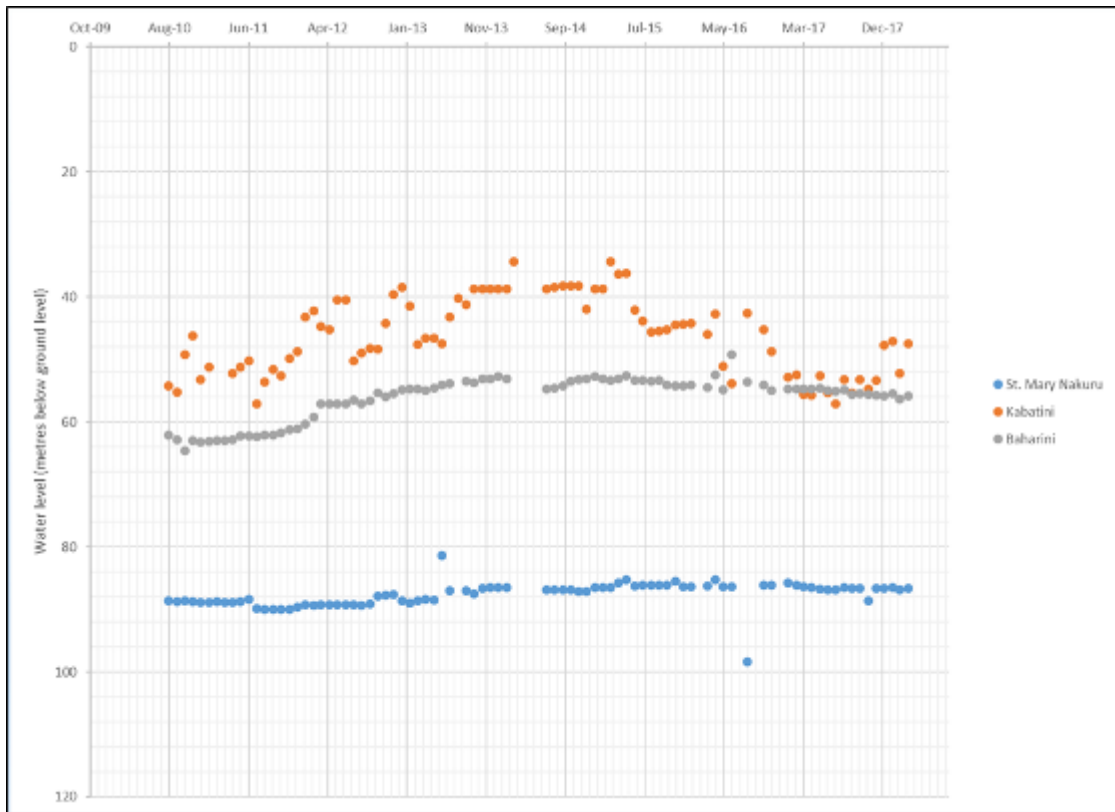
Figure 5.4: Noticeable Trends within Nakuru Monitoring boreholes

Declining water level trend were observed in the Rongai special aquifer. This is attributed to:

- Changes in land use around the area, hence increasing surface runoff and reducing infiltration.
- Reduced rainfall in the area affecting the groundwater recharge.
