Water Resources Management Authority

NATIONAL WATER RESOURCES SITUATION REPORT FOR FY2015/2016

30TH JULY 2016

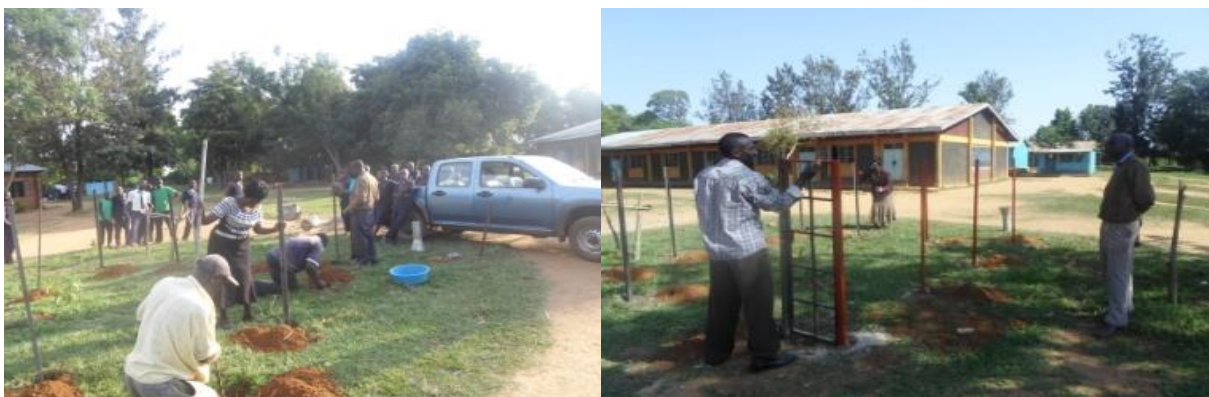
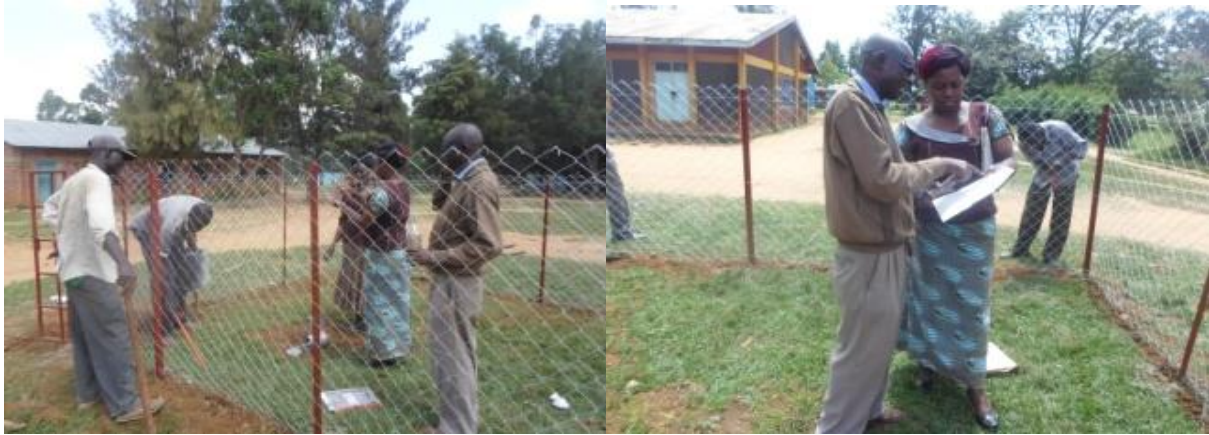
Figure 2.2 Site preparation and fencing at Chebosi H. School Bungoma , Rain-gauge setting and sensitisation of teacher

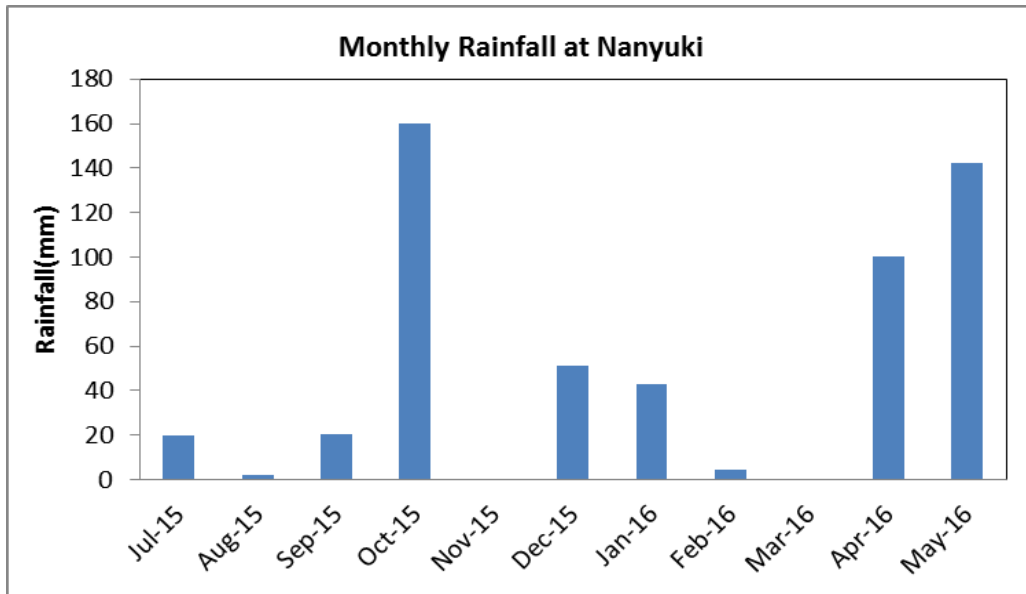
Figure 2.7 Nanyuki monthly rainfall for 2015/16

The data for the months of November 2015 and March 2015 were missing. However, the available data showed that the months of August 2015 and February 2016 received the lowest rainfall of 42mm while high rainfall of 160.3mm was recorded in October 2015. The long rain and short rain periods received moderate rainfall.

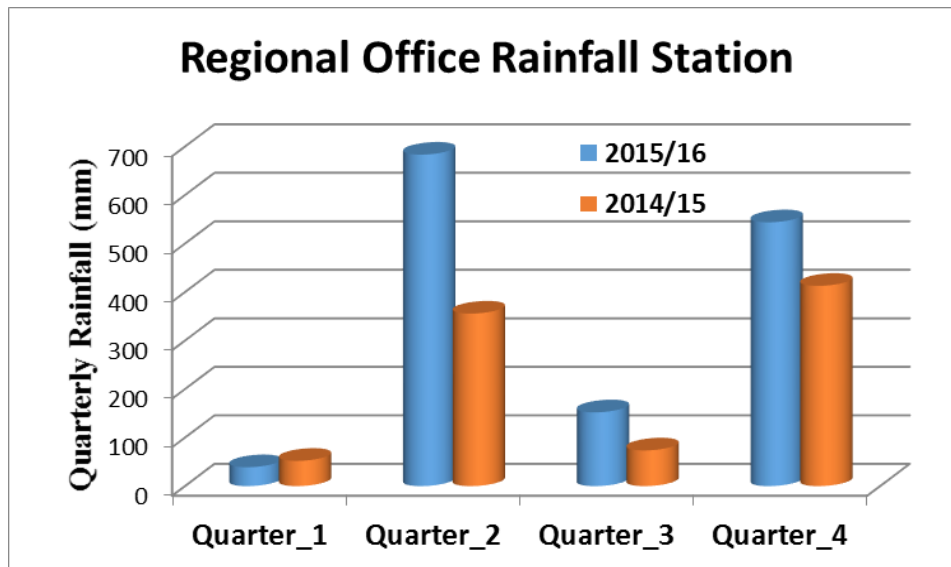
Figure 2.8: Tana Region office rainfall comparison for 2 years

The highest rainfall occurred in quarter 2 at Embu Region rainfall station. Overall the year under review recorded more rainfall than the previous year.

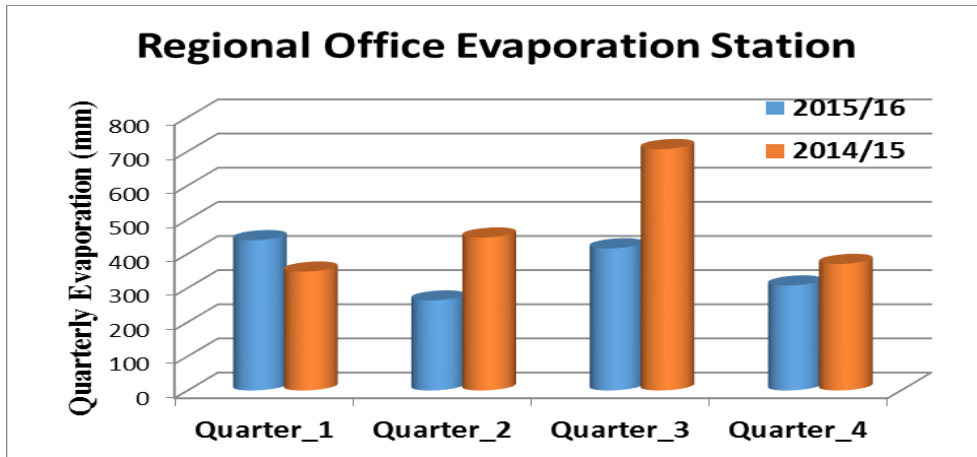
Figure 2.9 Tana region office evaporation comparison for 2 years

Evaporation at the Regional Office station indicates that the highest rainfall amounts occurred in Quarter 2. Evaporation amounts during the report period were lower than similar period the previous year.

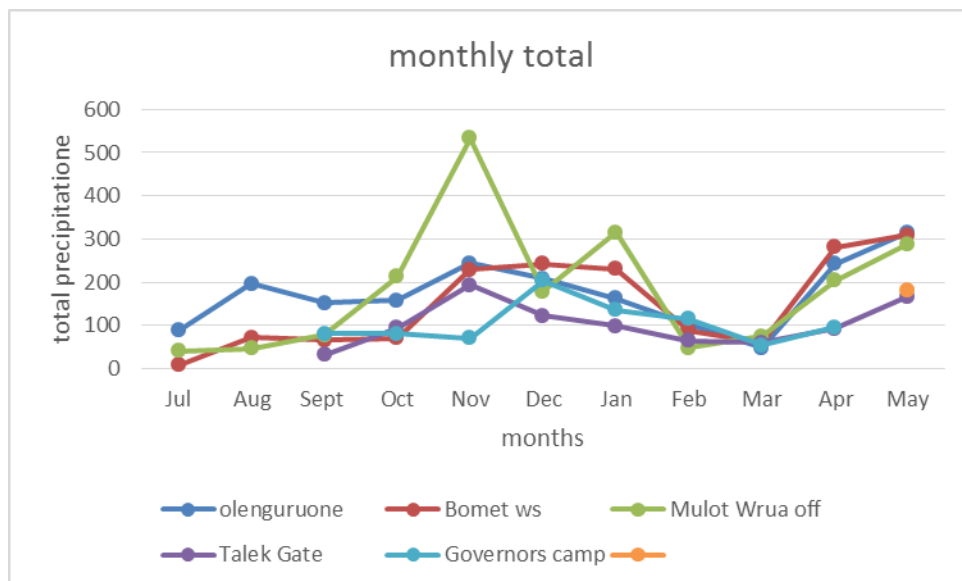
The first quarter of the year experienced dry weather but the situation changed when the expected elnino rains arrived in the month of November which continued to early January 2016. Again in the season of the long rains, the catchment received medium to high rainfall. This implies that there was enough water in the Rivers, pans and other storage facilities that satisfied the requirements for all uses.

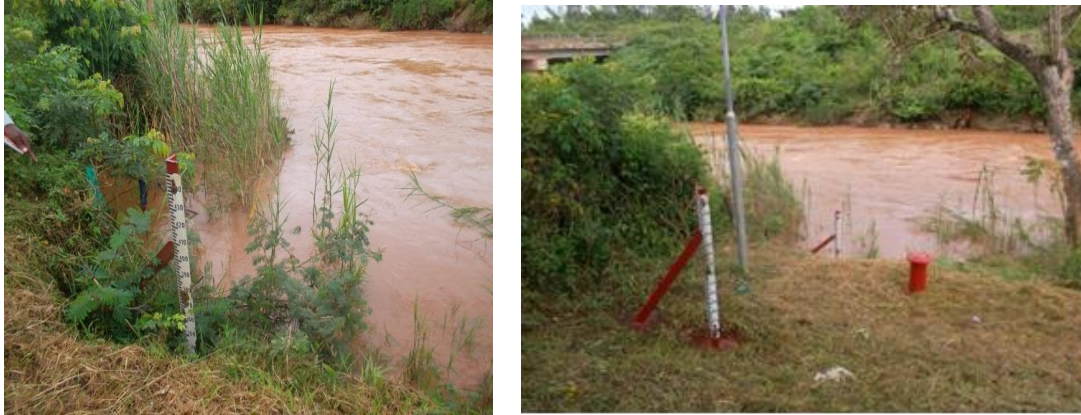
Figure 3.3: Rehabilitation works of Yala at Bondo Station (1FG02) in LVSCA

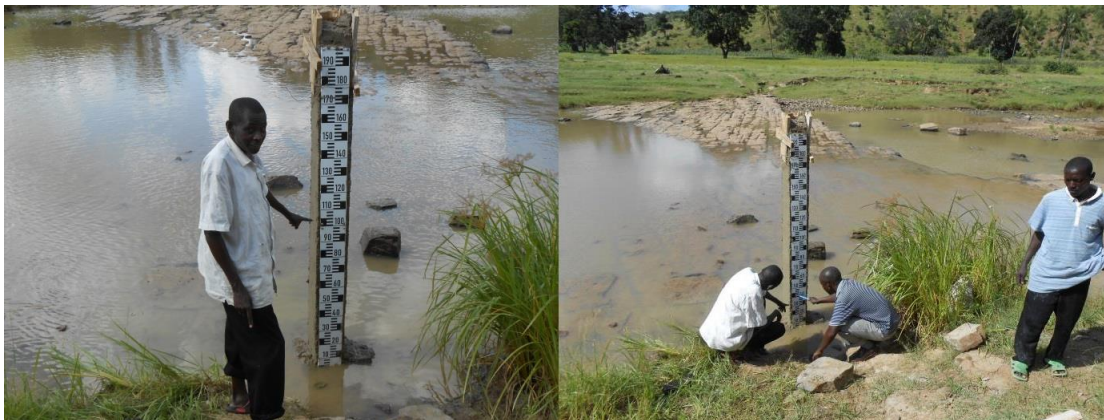
Figure 3.4: Concrete post installed at Mwache 3 MB02 and Gauge reader being trained reading in Athi Catchment.

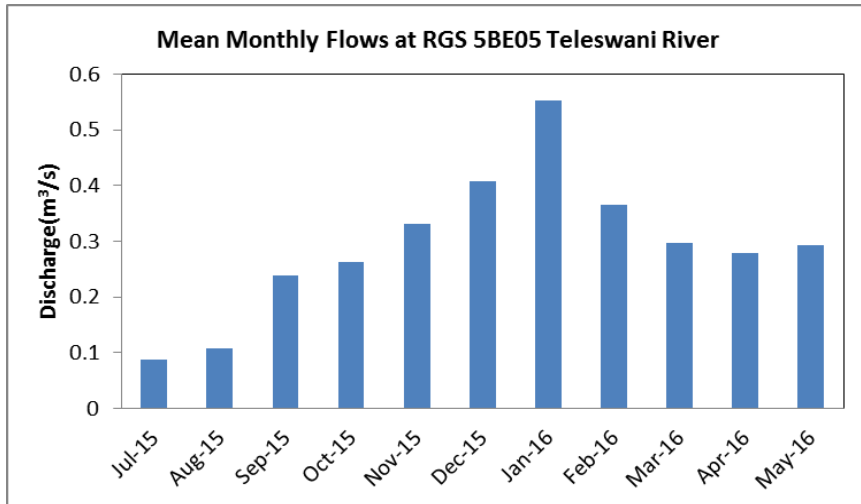
Four different sub catchments were analysed in Ewaso Nyiro North and depicted different stream flow characteristics throughout the year. Teleswani River had the highest flow recorded in the month of January 2016 which contrary to expectations of low because the month is normally dry. This could be attributed to the rains experienced in the upper reaches at the onset of short rain period which extended to the month of January.

Figure 3.6: Mean monthly flow at RGS 5BE05, Teleswani River

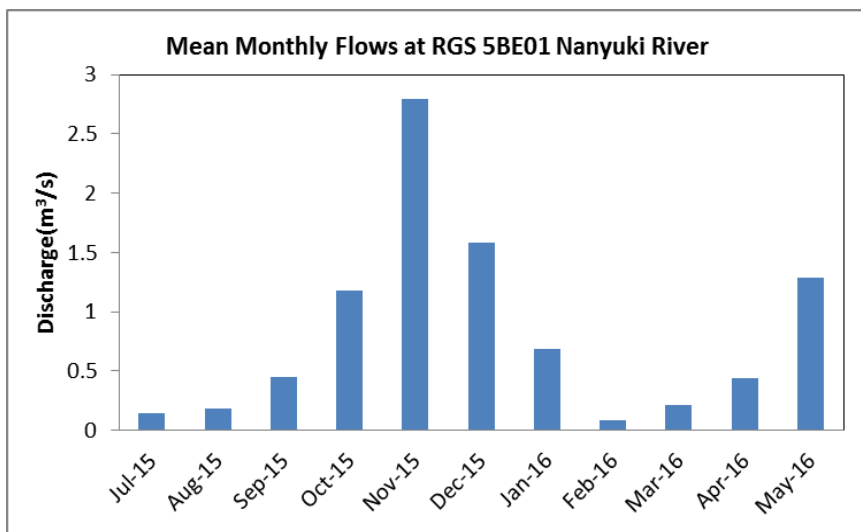
Nanyuki River displayed a typical trend which conformed to the rainfall trend in the catchment with the months of October, November and December receiving high flows. This river has stable flow and does not dry up at this point. The river flow diminishes downstream due to increased farming activities.

Figure 3.7: Mean monthly flow at RGS 5BE01, Nanyuki River

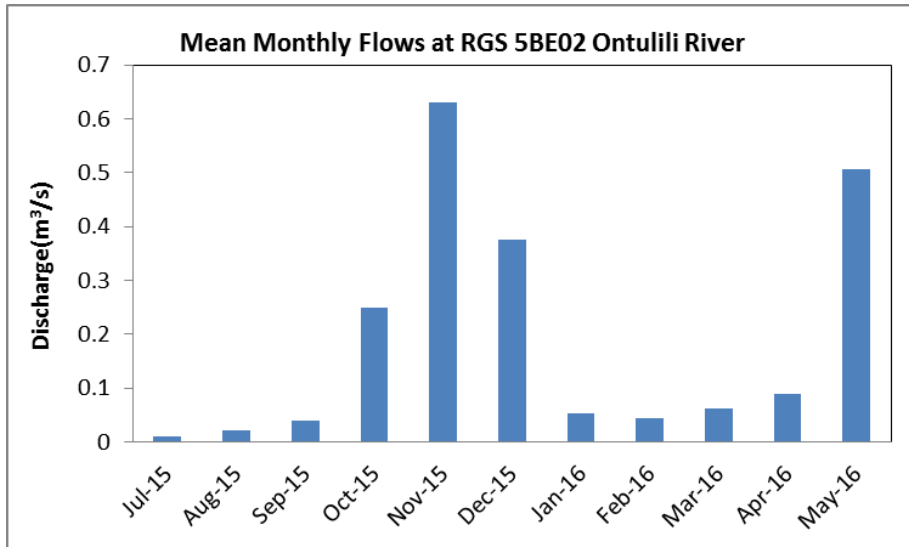
Ontulilii is a small river whose normal flow is normally less than 0.5m³/s. It displayed similar characteristics as Nanyuki River with high flows recorded during the OND period. The highest flows were recorded in the month of November 2015 which had a mean flow of 0.63m³/s.

Figure 3.8: Mean monthly flow at RGS 5BE02, Ontulili River

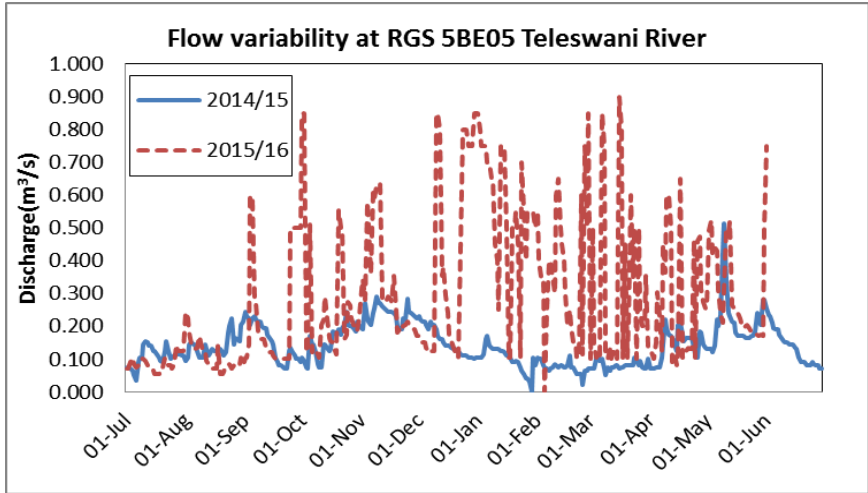
Temporal comparisons of flow for the year under review with the previous year at the four RGS indicate an increase in flow as demonstrated in Figure 11. The hydrograph of RGS 5BE05, Teleswani River however shows erratic flow during the 2015/2016 as opposed to 2014/15 which display the typical rain seasons; high flows in MAM and OND and low flows in July to September and January to February.

Figure 3.10: Comparison of flow in 2014/5 and 2015/16 at Timau River

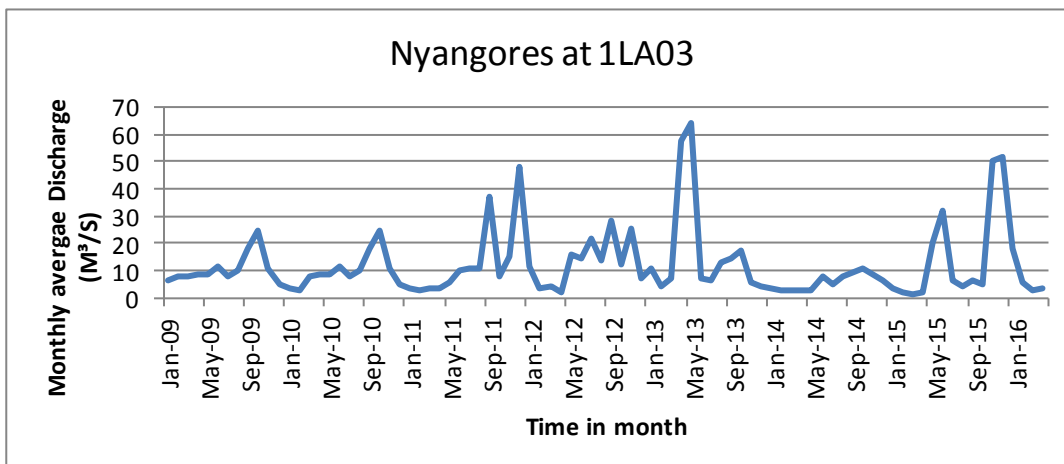
Fig 3.13: Flow Variability for Nyangores 1LA03

The flows for the period under review were above average for river Nyangores in Lake Victoria South Catchment compared to the previous years.

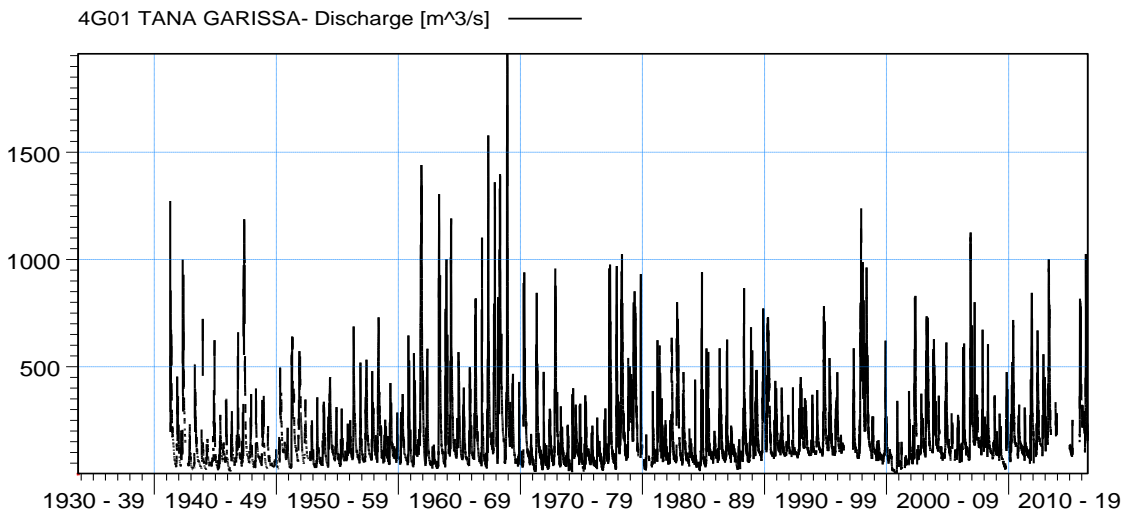
Figure 3.16: Long term discharges at RGS 4G01 – Tana at Garissa

Average discharges were recorded in Tana River at garissa during the year under review.

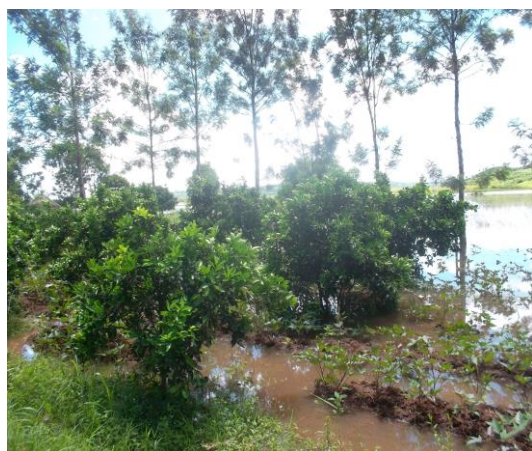
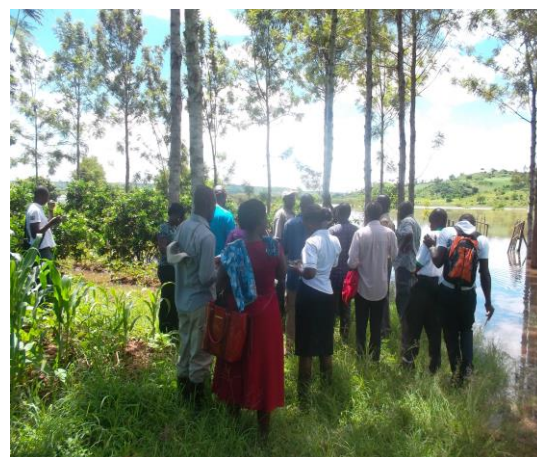
Figure 3.18: Backwater flow from Yala River around Aduwa area in Bondo Sub County on 12/5/2016.

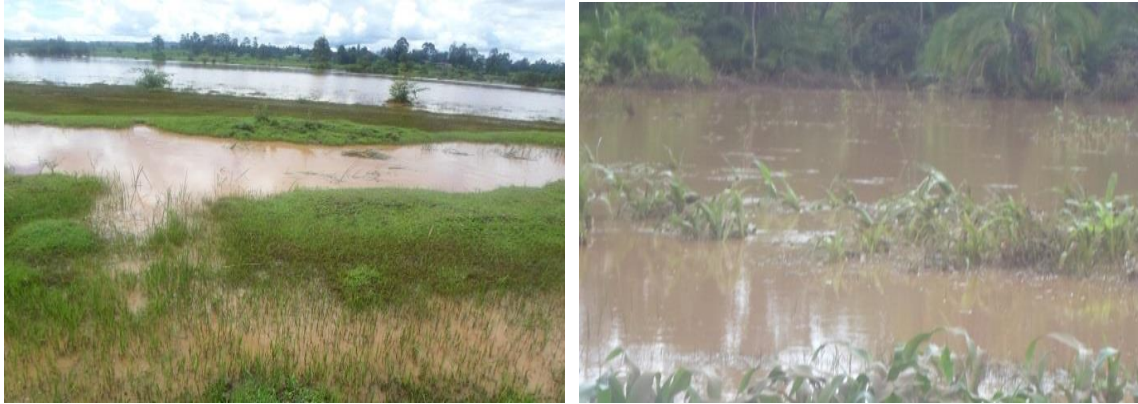
Figure 3:19: maize farm flooded at Maliki and maize farm flooded at Taito

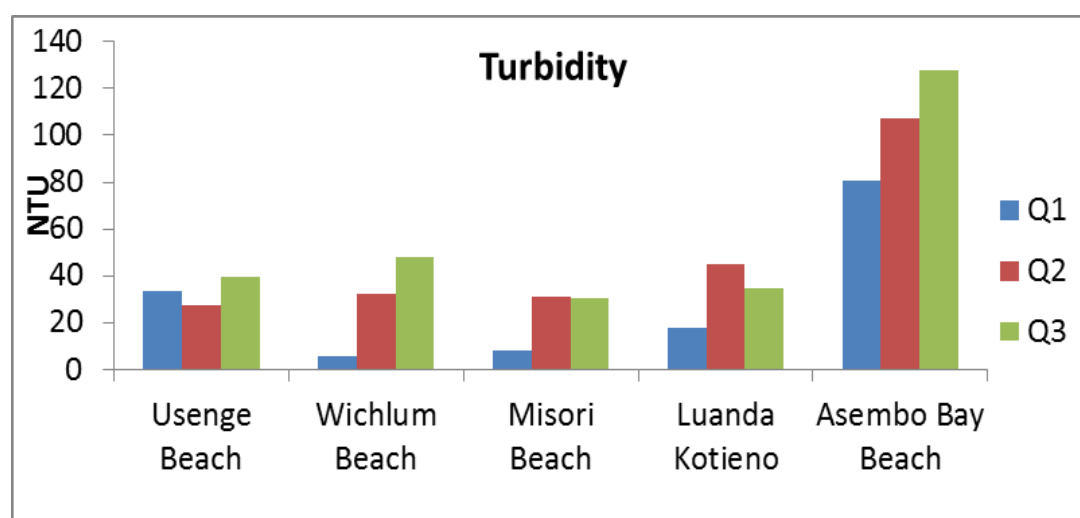
Figure 4.3: Water turbidity at beaches in Lake Victoria (quarterly data)

All the beaches showed higher turbidity in quarter 3 compared to quarters 1 and 2. No assessment was done in quarter 4. The turbidity could be influenced by the dominant wind at the time of determination. In the afternoon, there is a strong wind from the Lake onto land and this creates a high turbulent at the beaches. The turbulences stir up both the settled and suspended sediments at the beaches and also drift the algae blooms to the shore causing high turbidity at the beaches. There is also the impact of rotten vegetation at the beaches. All this coupled together may cause a significant impact on turbidity. The scenario may change in the evening or morning when it's calm.

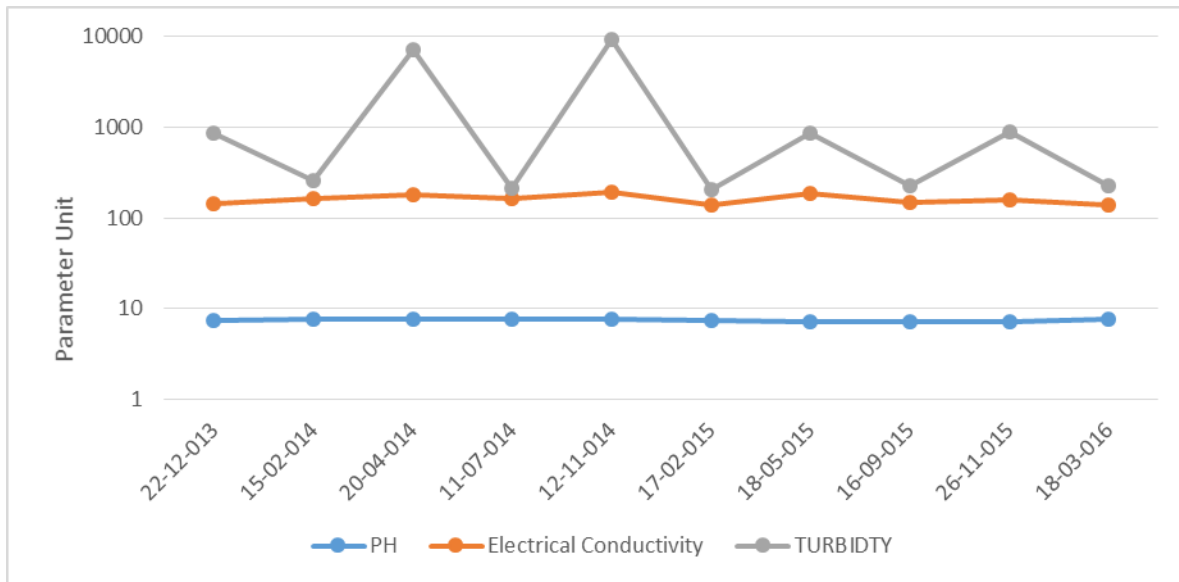
Figure 4.4: Conductivity, Turbidity and pH of River Tana at Garissa (RGS 4G01)

The higher Turbidity was noticeable in the wet months of April, May and November. This may be due to erosion via runoff in the Upper Tana catchment attributed to degradation of the catchment. The pH and conductivity remained unchanged indicating that there were no major high mineral inputs. There is no data for lower Tana where the situation may be different.

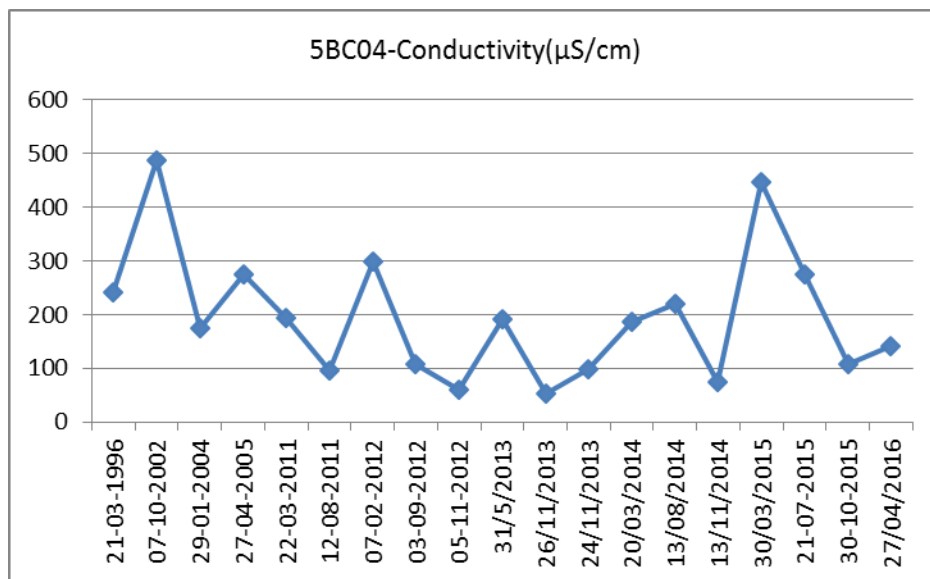
Figure 5 shows the electrical conductivity of Ewaso Ng’iro River at 5BC04, Depatas (Laikipia). The station monitors part of Abadare and part of Mt. Kenya areas. Irregular monitoring results in data gaps that making it impossible to discern trends.

Figure 4.5: Ewaso Ng'iro River at 5BC04, Depatas in Laikipia - Conductivity

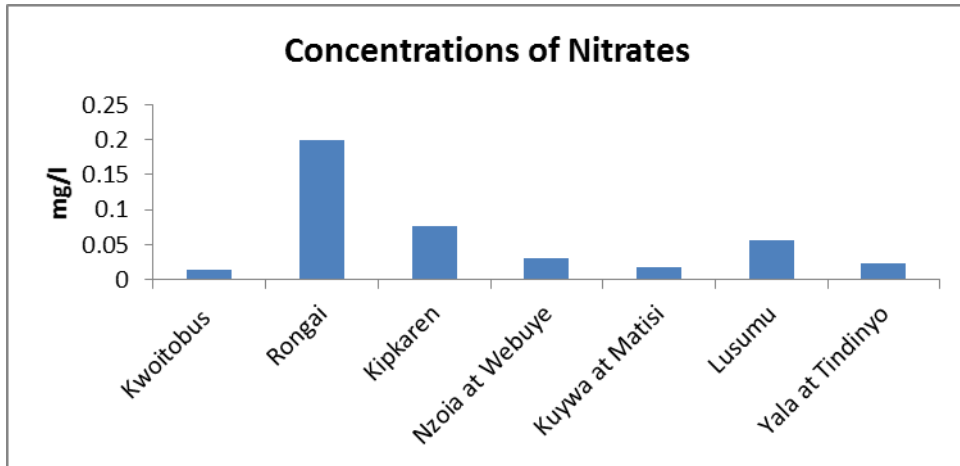
Figure 4. 9: Concentrations of Nitrates in various rivers, LVNCA

The average concentrations of Nitrates (NO₃) ranged from 1.2 mg/l to 4.08 mg/l in R. Yala at Tindinyo and R. Nzoia at Webuye respectively. Management Unit stations that registered high average concentrations of Nitrates were Rongai and Kipkaren while those with low concentrations included Lusumu and Kuywa. R. Rongai is a river draining most of the farm lands of Trans Nzoia and its environ.

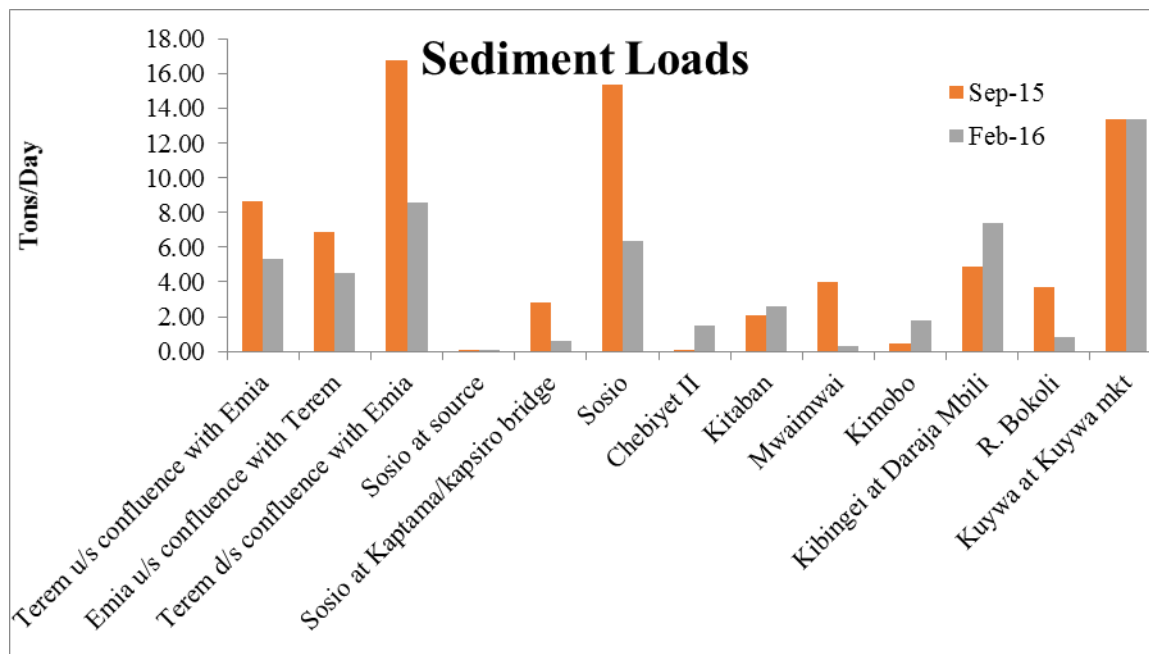
Figure 4.12: Comparative sediment Loads in the Kuywa Terem sub-catchment

The highest sediment load was registered at Kuywa market. Other stations with high sediment loads were Kibingei and Terem downstream the confluence with Emia at Kopsiro bridge at 7.4 tons/day and 8.6 tons/day respectively. Comparing the two assessments, in February all the stations recorded lower loads compared to September except for Kitabani, Kibingei, Kimobo and Chebiyet II. The largest difference was observed in Kibingei at Daraja Mbili at 2.5 tons/day. The difference could be as a result of cattle being driven to be watered directly in the river. This may cause the release of the sediments from the stream banks and beds. No differences were observed at Sossio at source and Kuywa at Kuywa market. Sossio at source is a reference station situated at the forest and there are limited human activities despite encroachment into the forest.

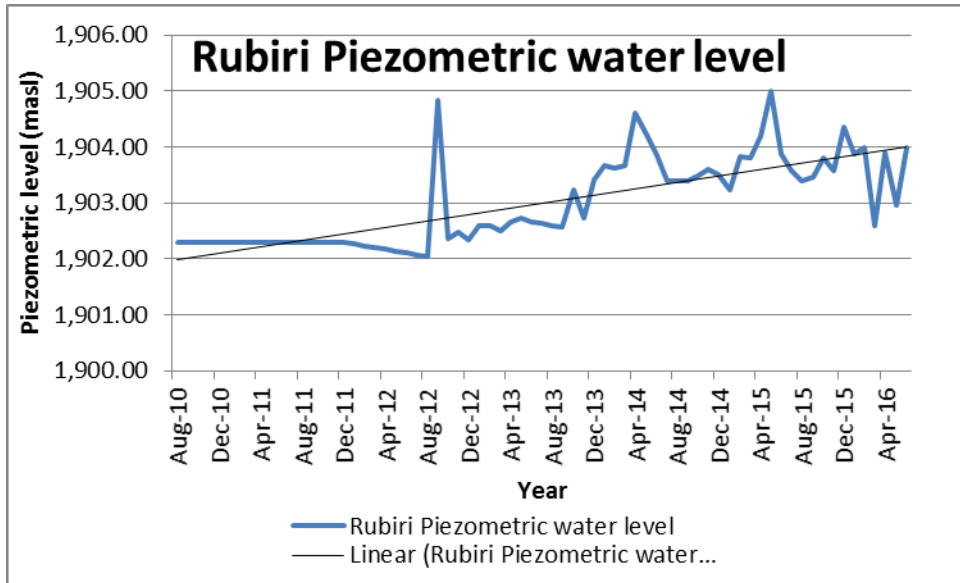
Figure 5.9: Water levels for Rubiri borehole

Trends of the Rubiri Community borehole from the year August 2010 to date were used. The water levels depict a gradual rise in Water levels, showing a higher rate of recharge compared to abstraction.

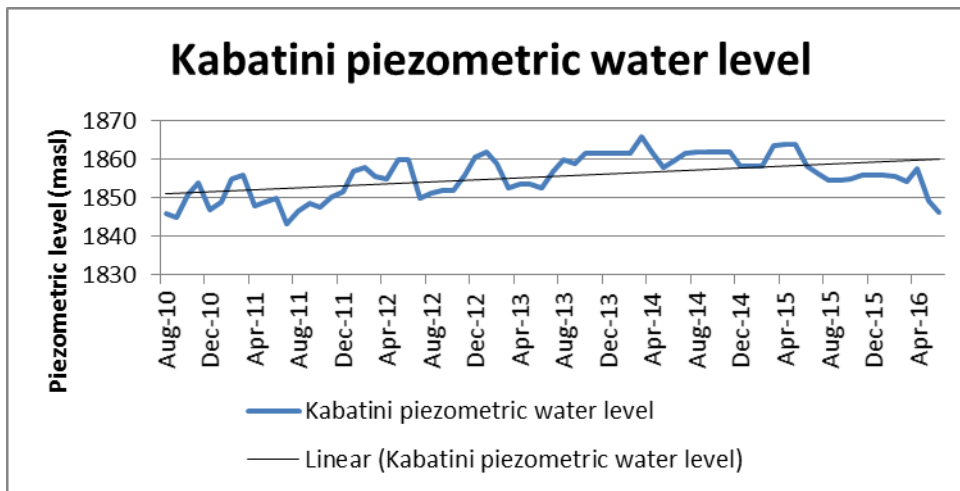
Figure 5.10: Water levels for Kabatini Borehole

Trends of the Kabatini borehole from the year August 2011 to date were used. The water levels depict rising water levels after December 2012.

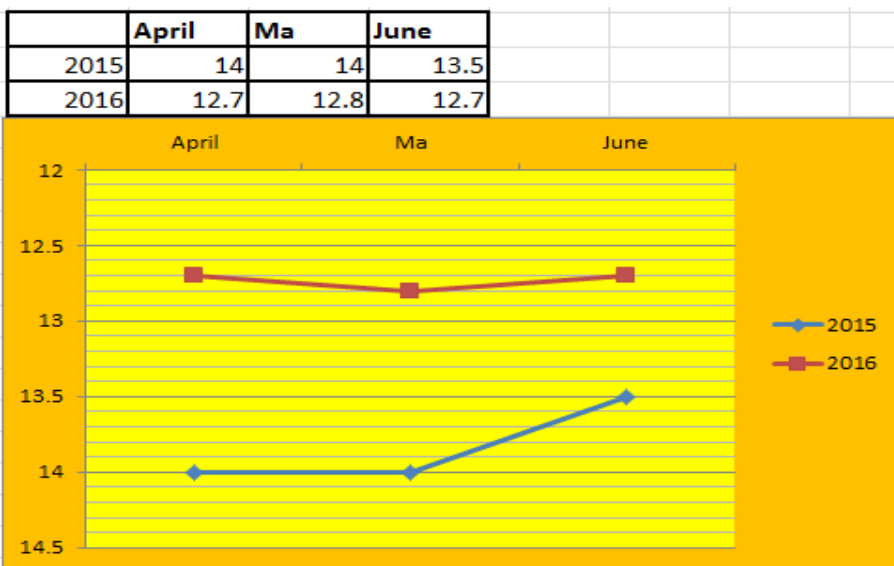
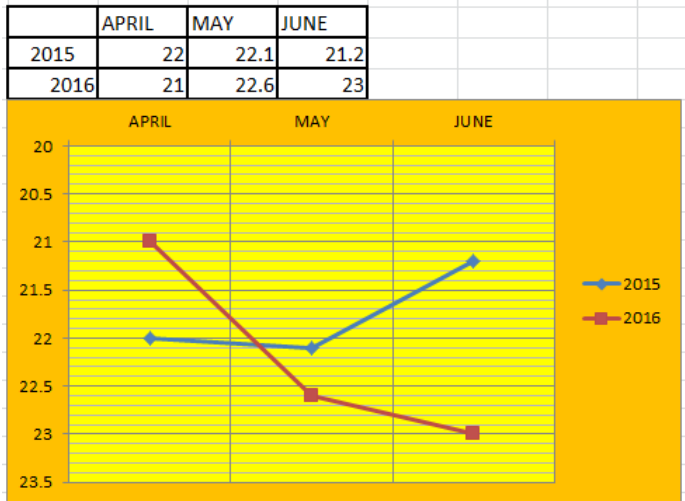
Figure 5.12: Comparison Of Water Rest Level For 2015 And 2016

Figure 5.13: Comparison Of Water Rest Level For 2015 And 2016

A comparison of water levels for the same period in 2015 and 2016 shows a rise of approximately 1.5 metres in Subati 3 borehole and a drop of the same margin in Subati 5 borehole. This could be attributed to abstraction rates for the two boreholes or instrumentation error but further investigations are necessary to establish the true cause for this kind of trend.

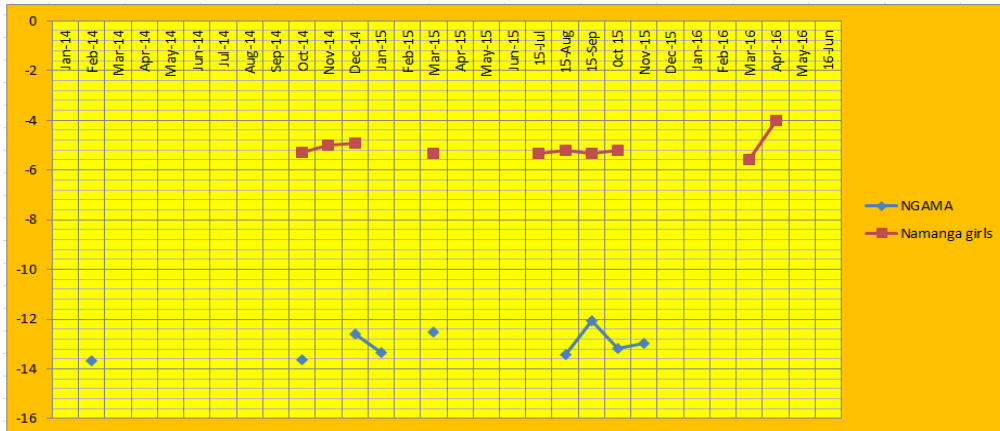
Figure 5.18: Comparison of Water Rest Level for Boreholes in Nolturesh Lumi

The general trend shows a relatively stable conditions indicating a relative balance between abstraction and recharge.
